# COMMERCIAL CONDENSATION & MOULD TESTING REPORT

**Surveyor Name:** Bianca Hedesiu  
BSc (Hons) CSTDB WRT ASD

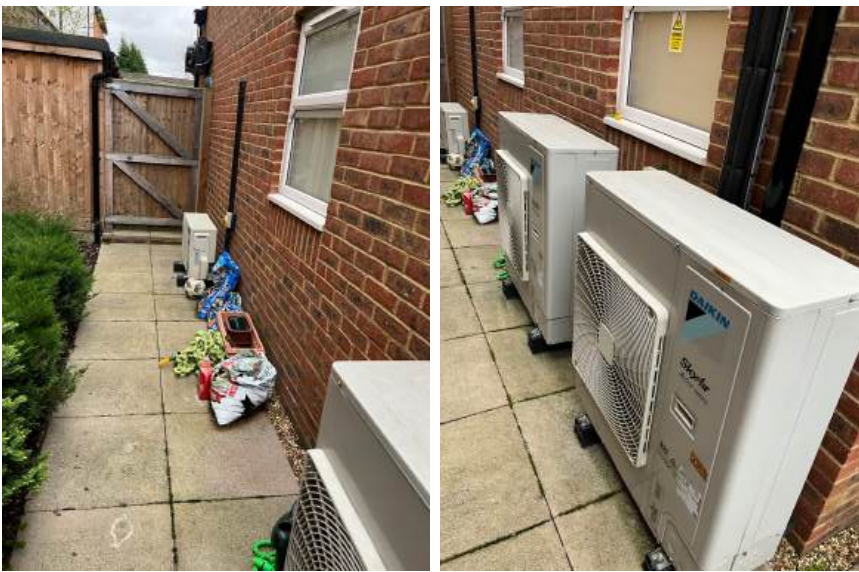
Two air-conditioning units were noted on the external elevations, directly adjacent to affected internal wall in the women's toilet. These units likely create localised cold spots on the internal walls, increasing the risk of condensation and contributing to mould growth.

Evaluate the placement of the air-conditioning units on the external elevations. Consider adding thermal insulation to the internal walls adjacent to the units to reduce the impact of cold bridging.

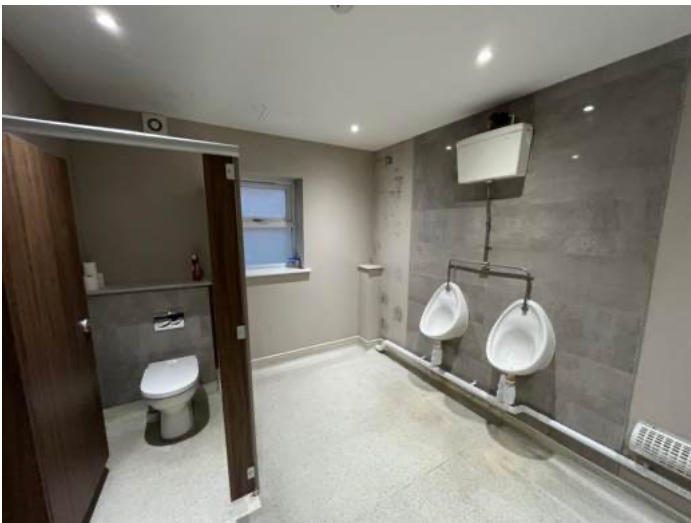
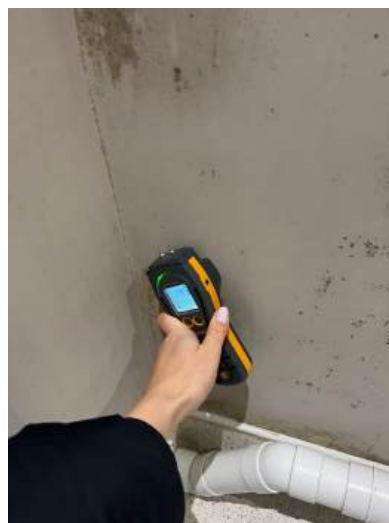
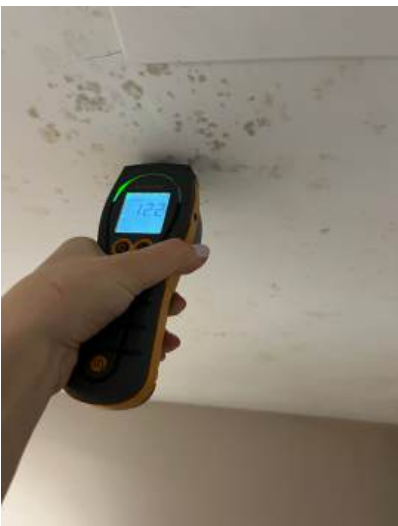
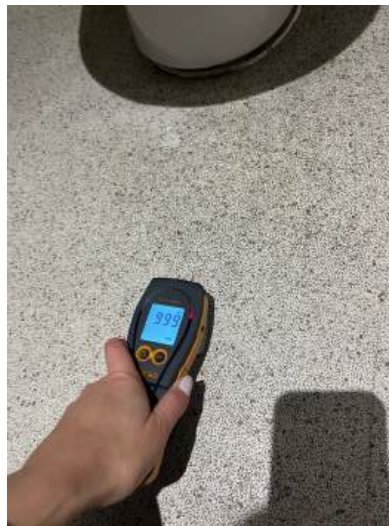
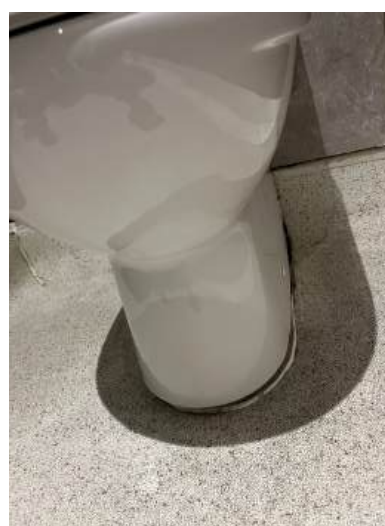
Plasterboard Wall (Abutting the Fridge/Cold Room): Extensive mould growth was observed on this wall.

The cold room's cooler creates a significant temperature differential, leading to condensation forming on the adjacent warm surface of the men's toilet wall. This is likely exacerbated by insufficient insulation on the cold room side.

Mould was also observed on the inside of the external wall.

Elevated damp readings were noted on the floor around the WC, suggesting a likely hidden plumbing leak (potentially from the WC waste connection). This leak contributes to increased humidity levels, further exacerbating condensation issues in the room.

- Install thermal insulation boards (e.g., PIR panels) on the cold room side of the wall, ensuring that it is continuous and properly sealed to prevent thermal bridging.
- Apply a vapour barrier to the warm side of the insulation to prevent moisture ingress from the toilets into the cold room walls.
- Ensure the men's and women's toilets have adequate ventilation (e.g., humidity-controlled fans) to manage humidity levels and reduce the likelihood of condensation.
- Ensure the cooler is not blowing directly onto the dividing wall, which could exacerbate the cold surface effect. Consider repositioning the cooler if necessary.

Investigate and repair the suspected leak in the men's toilet floor, particularly around the WC waste. Once repaired, the floor should be dried out professionally, and any damaged materials should be replaced.

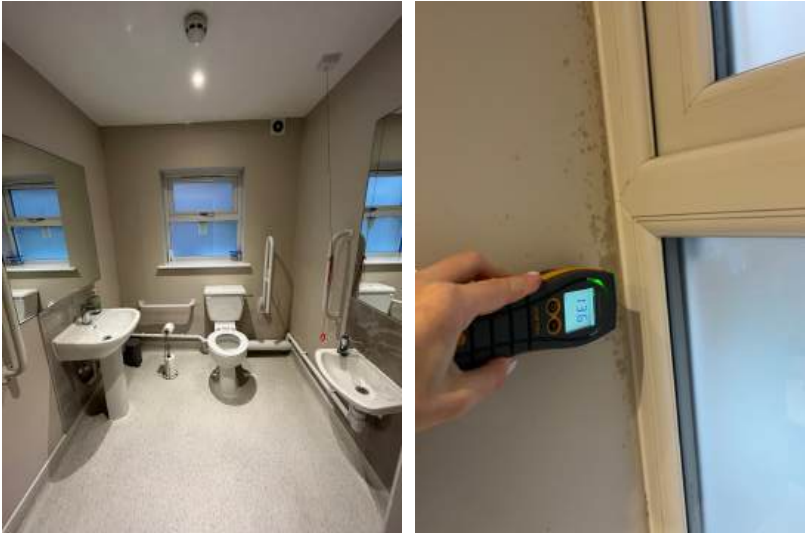
Mould was observed on the internal walls and window surrounds, likely due to high humidity levels combined with inadequate ventilation, but also due to possible cold bridging from the air con units and pipes which run just outside the affected areas.

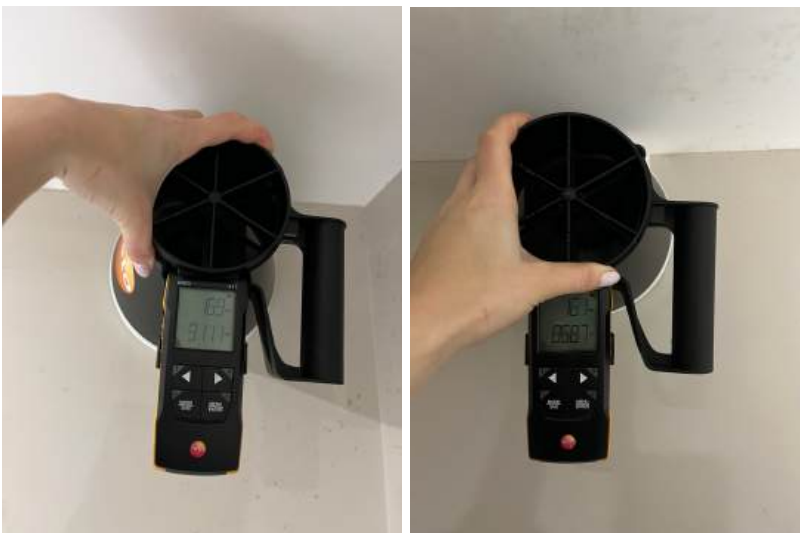
Shared Observations for Both Toilets: The extractor fans in both toilets are light-switch-operated, meaning they remain off when the social club is closed for multiple days, allowing condensation to accumulate in the absence of active ventilation.

-Replace the light-switch-operated extractor fans in the toilets with humidity-controlled or intermittent fans that activate automatically based on moisture levels. This will ensure adequate ventilation, even when the social club is closed. Ensuring they are properly ducted to the exterior. Care should be taken to ensure the extractor is rated to the length of ducting necessary (the longer the ducting, the greater the resistance). The rating is typically given in linear metres, i.e., the number of metres the extractor is rated to push the air through.

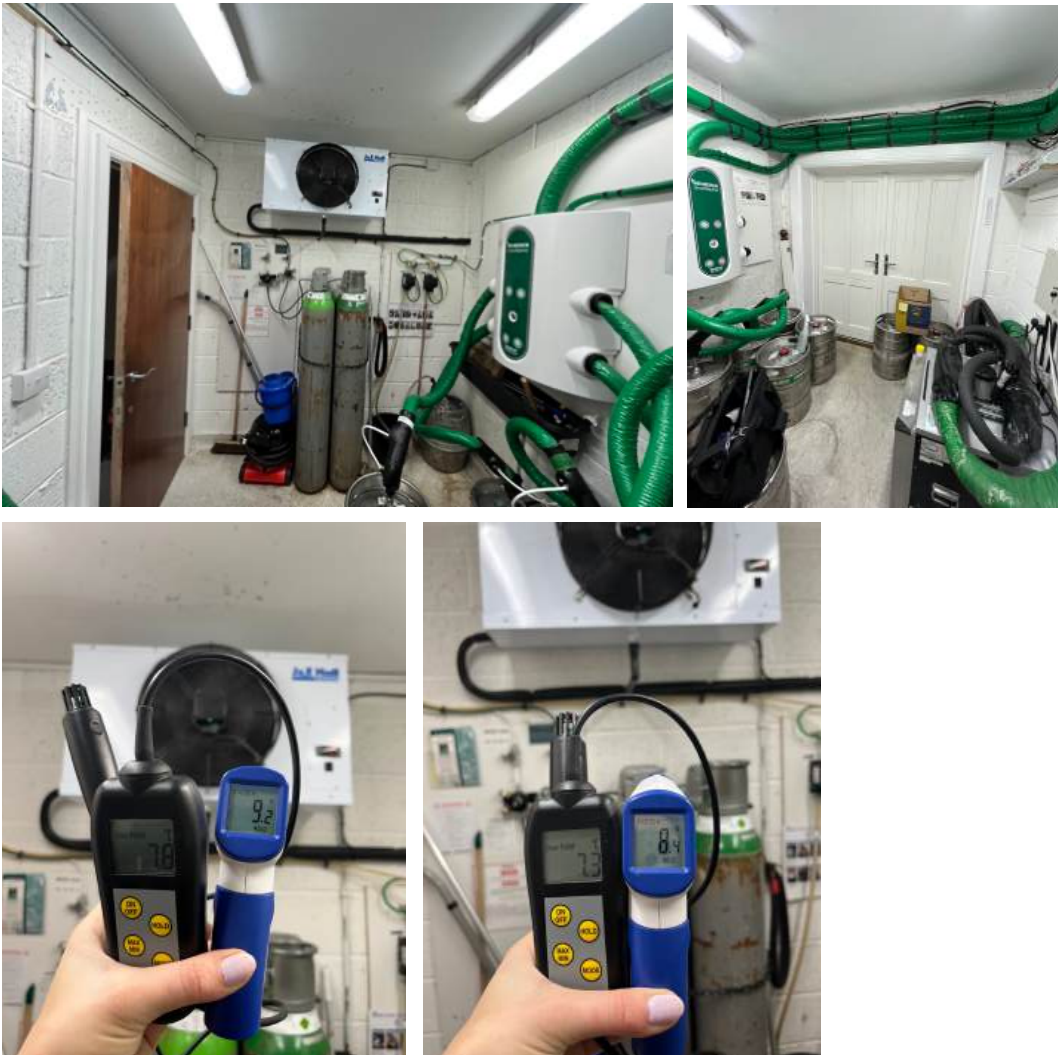
The cold room, designed to maintain a constant temperature of 11°C for beer storage, creates a significant temperature differential with the adjoining rooms. The cooler unit, positioned on the internal wall dividing

the cold room and men's toilet, increases the coldness of the wall and ceiling, further contributing to condensation.

Mould growth was noted on the ceiling area above the cooler unit, likely due to moisture carried by air cooled by the cooler.

The cold room cooler maintains a low temperature and creates cold surfaces on the internal dividing wall. These cold surfaces come into contact with the warmer, moist air from the men's toilet and other rooms, resulting in condensation and subsequent mould growth.
