# SAMPLE DAMP SURVEY REPORT

Report Reference number: 0000000

The subject property is a large Edwardian building converted into 12 residential flats and two ground-floor commercial units—a driving test centre and a jewellery and bullion shop. The construction is of 9 inch (215mm) solid wall construction using soft red bricks with limestone quoins and decorative window surrounds.

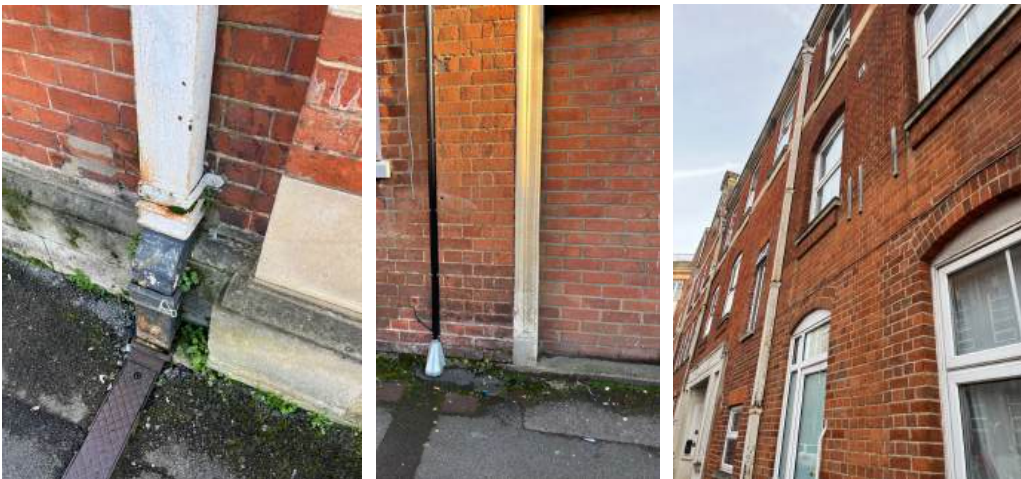
- Front Elevation London House and Front Elevation of Anugraha Bullion: The cast-iron downpipes and hoppers show significant corrosion, most likely allowing for leaks on the external elevations below.

-The channel drains responsible to directing the water from the downpipes into the street, show extensive moss growth and vegetation growth around them, which could indicate blockages. This is likely allowing water to pool at the base of the walls and on the adjoining tarmacked pavement, which is also evidenced by the moss growth on the tarmacked areas at the floor-wall junction. This has likely contributed to damp ingress on the other side of the front elevation, including the areas in the Office in the Test Centre, but also in the two Entrance Hallways to the flats.

-With the acceptance of the council, it is recommended that a channel drains are cleared and tested to ensure they flow property into the road's drainage system. Remove all vegetation and remove moss from the areas using a biocide such as SoluGuard (Safeguard Europe) or similar.

- Replace or repair all defective cast-iron downpipes on the front elevation. Ensure proper alignment and sealing to prevent leaks and pooling at the base of the walls.
  - Clear vegetation and debris from gutters in the courtyard and inspect all hoppers for leaks.
- Clear vegetation and debris from all gutters.

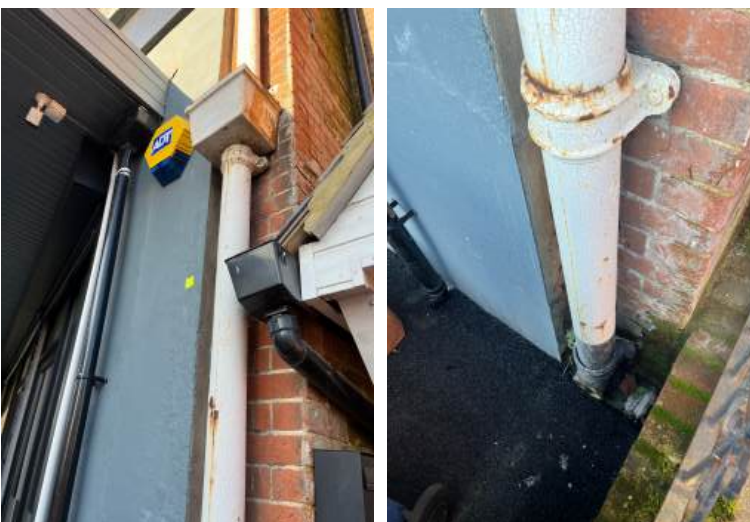
- A cast-iron hopper and down pipe on the front right-hand side corner of Anugraha Bullion was observed to show signs of leaks in the form of blown render on the areas adjoining the hopper and down pipe. This defect is almost certainly the cause for the damp issue found in the Office of Anugraha Bullion on the other side of the affected wall area.

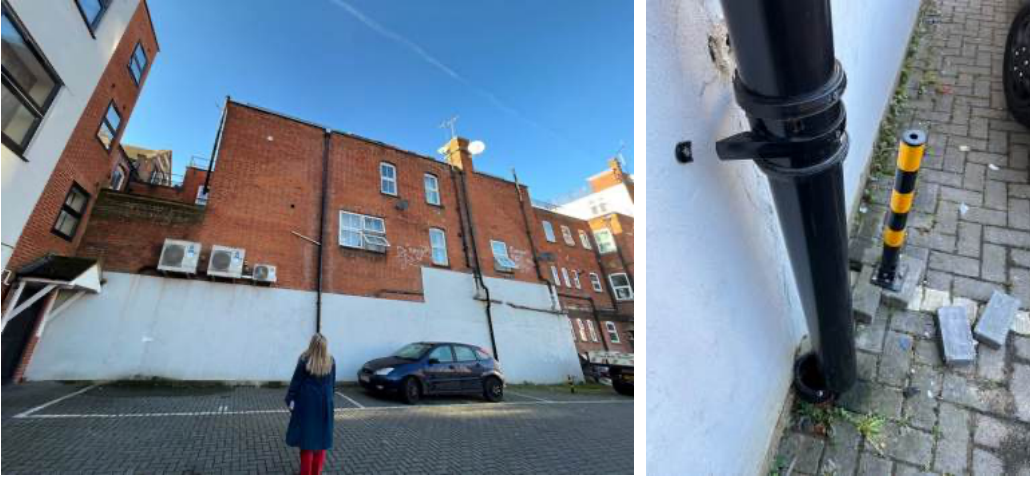
- Rear Elevation: Hoppers and downpipes were replaced several months ago, as confirmed by the landlord's management team. Prior to this replacement, water damage would have affected the solid wall

construction, allowing moisture ingress into the soft red brickwork, which is highly porous and prone to saturation. Water marks and efflorescence are still visible behind the new downpipes. In addition, one of the downpipes was found to be disconnected just above ground, which will allow water to discharge at the bottom of the wall and likely cause internal damp.

An old cast-iron hopper and downpipe still remains of the rear elevation.

-The downpipe on the rear which was disconnected above ground level should be reconnected as a matter of urgency.

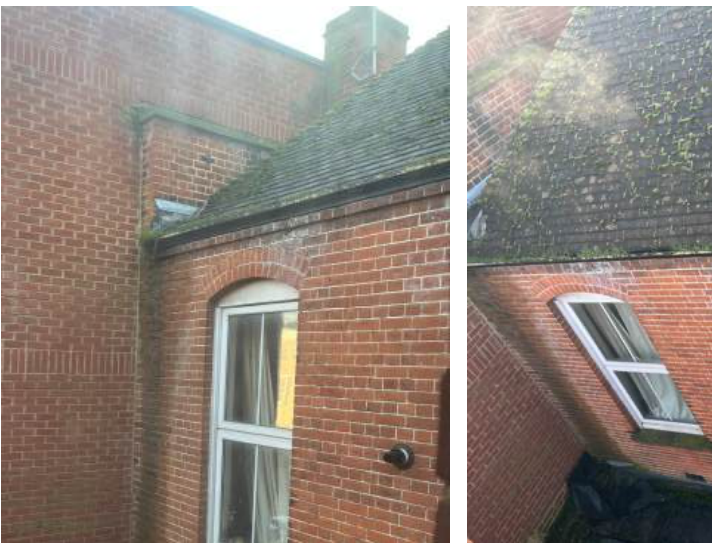
- Courtyard Gutters: Gutters in the courtyard are filled with vegetation, indicating poor maintenance. Overflowing water from these gutters has left visible watermarks below, evidencing prolonged exposure to leaks. These defects are likely to allow water to seep into the walls, further compromising the internal areas. Evidence of this was noted in flat 9.

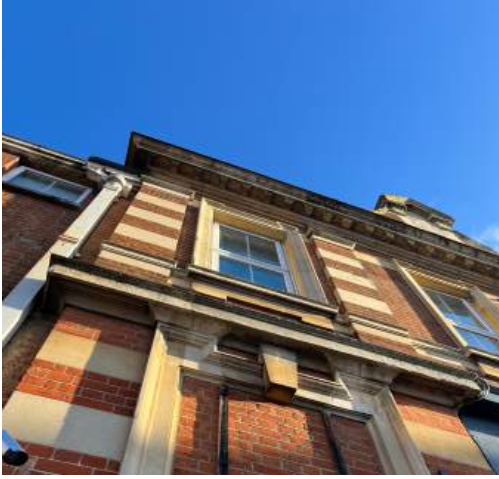
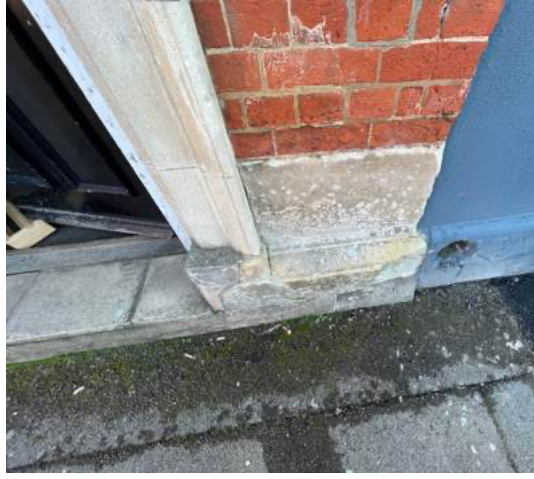
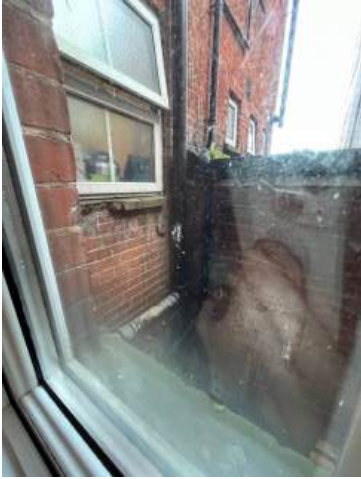
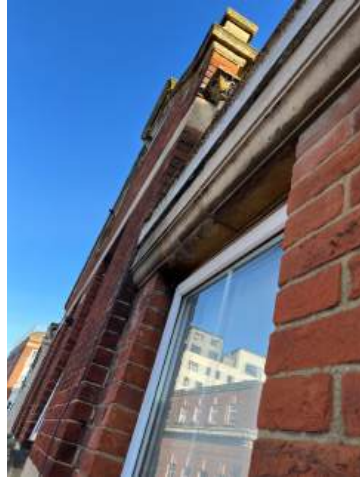
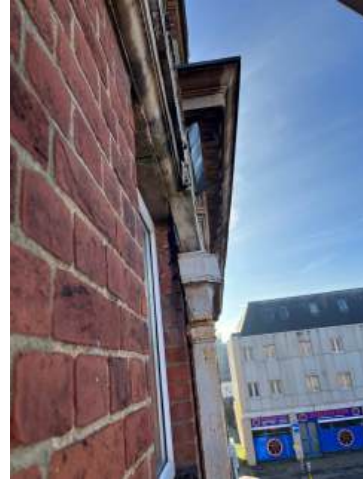
- The building's solid walls are constructed using soft red bricks, which are prone to water saturation. Prolonged water exposure, particularly from defective rainwater goods, would weaken the structure and contribute to dampness internally.

- Several limestone window surrounds and features were noted to show signs of crumbling and deterioration. Pieces of crumbled limestone were noted, especially on the front elevation. Deteriorated stonework creates gaps where water can penetrate the walls, leading to internal damp issues.

- Repoint areas of deteriorated mortar using a lime mortar mix no stronger than the bricks or other existing pointing in order to avoid bricks delaminating.
- Repair or replace crumbling limestone features around windows, ensuring that these areas are properly sealed to prevent moisture ingress.
- Where necessary, remove moss and clean brickwork using a biocide such as SoluGuard (Safeguard Europe) or similar.

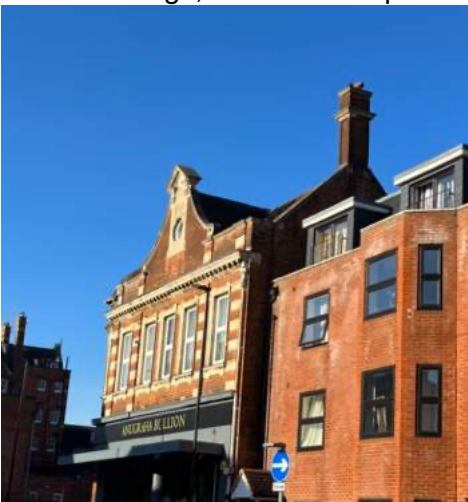
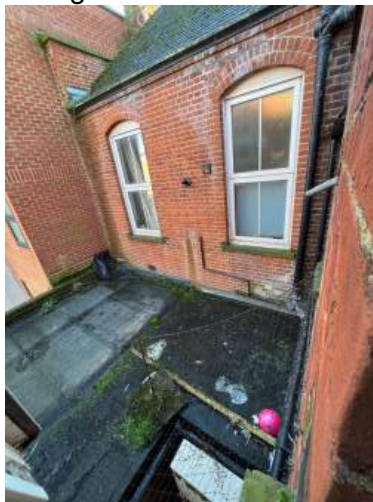
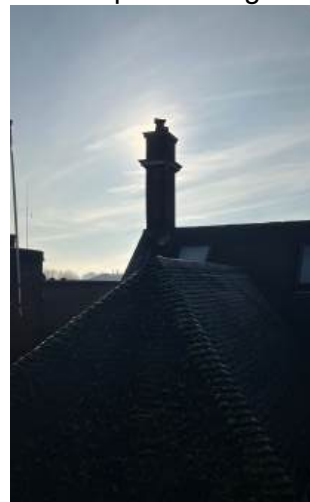
- Moss growth and deterioration were noted on the chimney stacks. These issues suggest a lack of maintenance and point to potential defects, such as compromised flashings or perished mortar joints. Such defects could allow water to penetrate into the chimney stack and the moisture is likely to be migrating down into the chimney breast and surrounding areas. This is consistent with elevated damp readings found in flat 11 but also flat 4.

-The torch felt covering in the courtyard elevation shows extensive moss growth which could indicate water pooling on the membrane which can shorten its life expectancy. Moss growth was also noted on the tiled roof coverings, which can trap moisture against the roof tiles and allow for penetrating damp.

- Inspect and repair any defective flashings.
- Remove moss and lichen growth from the chimney stacks and clean stacks using a biocide such as SoluGuard (Safeguard Europe) or similar.
- Rake out any perished pointing from the stacks. Repointing brickwork using a lime mortar mix no stronger than the bricks or other existing pointing in order to avoid bricks delaminating. Spalled brick faces to be repaired using a brick filler tinted to match the surrounding bricks.
- Moss to be removed from the roof coverings.

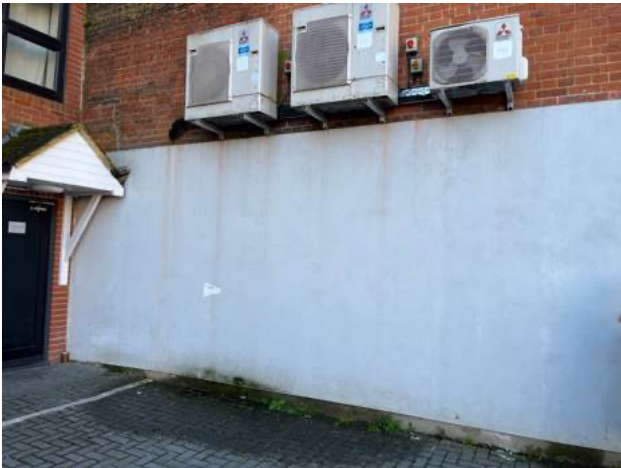
- An air-conditioning unit installed on the rear elevation is leaking directly onto the wall and ground below. This is likely causing a localised damp issues which can allow for moisture ingress if left unattended to.

- Repair or replace the leaking air-conditioning unit on the rear elevation.

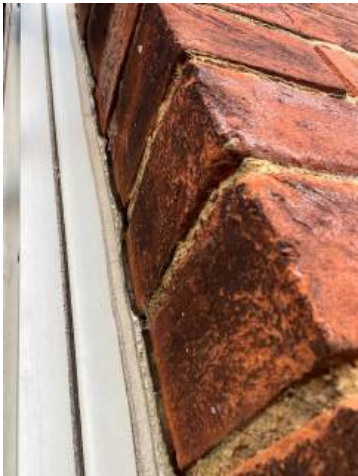
- Window fillets and mastic seals around some windows were noted to be cracked, creating pathways for moisture ingress around window openings. Evidence of this was noted in flat 7.

- Repair cracked window fillets and mastic seals around affected windows to prevent water ingress into internal areas.

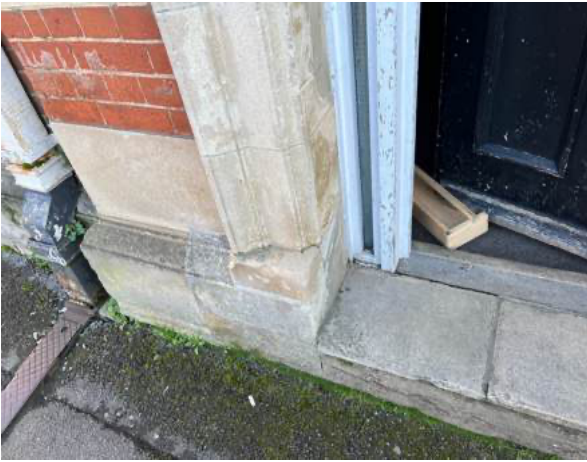
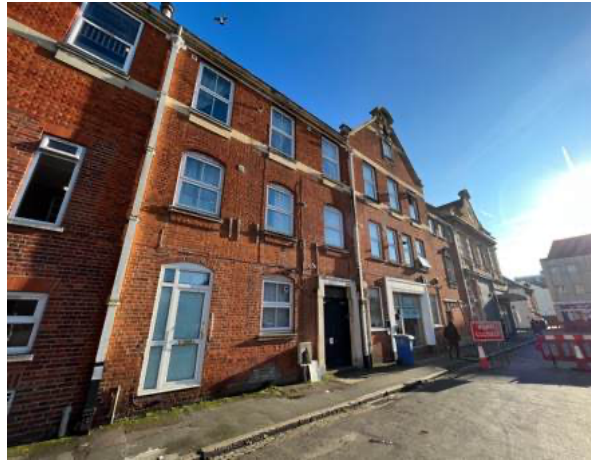
We were unable to see a DPC, however, we believed that due to the age of construction, the property is likely to benefit from a slate DPC.

Despite this, the DPC is likely to be below the external ground levels, given these appear too high, meaning the DPC is almost certainly bridged by the high external ground level or by the render on the rear elevation which extends down to ground level. This is likely to be allowing moisture to rise into the wall through the capillaries of the bricks into the wall areas above DPC. The British Standard recommends for an 150mm separation between the ground levels and the Damp Proof Course (DPC). Evidence of this was noted in the Test Centre and two Entrance Hallways to the flats (at the front) and vacant room (at the rear).

-Inject new chemical damp proof course using Thixotropic cream/other water-based water repellents injected into mortar joints at correct height in line with the floor level internally.

-New plaster to a minimum thickness of 12mm and up to 1.2m up the wall. Plaster should be the correct specification of 3:1 sharp sand/ cement mix incorporating a salt retardant and water proofer

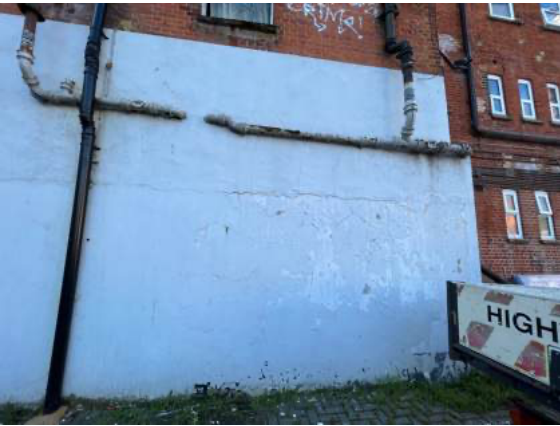
The cementitious render on the rear elevation of the ground floor is showing extensive cracking, particularly in areas where hoppers and downpipes had been removed following previous leaks. These cracks can allow moisture ingress into the solid walls beneath.

- Rear Elevation Render: Tap test render for blown areas and repair cracks and other areas where render has delimited from the wall to prevent further moisture ingress.

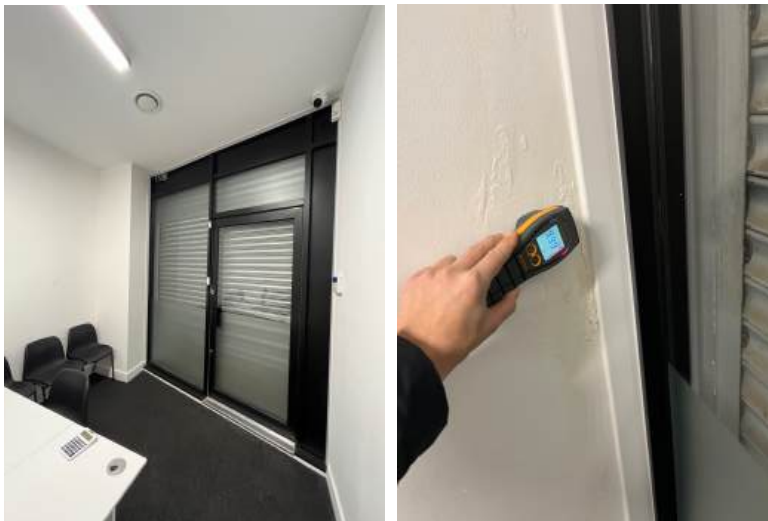
Elevated damp readings were noted on the inside front elevation (of Anugraha Bullion) in the far right-hand side corner, in a small localised area over the whole height of the wall, but appearing to be coming from top-down. Paint was noted to be blistering in the area too.

Issues with the hopper and downpipe suspected to be leaking and overflowing onto the wall behind as evidence by the deteriorated render are almost certainly responsible for the damp.

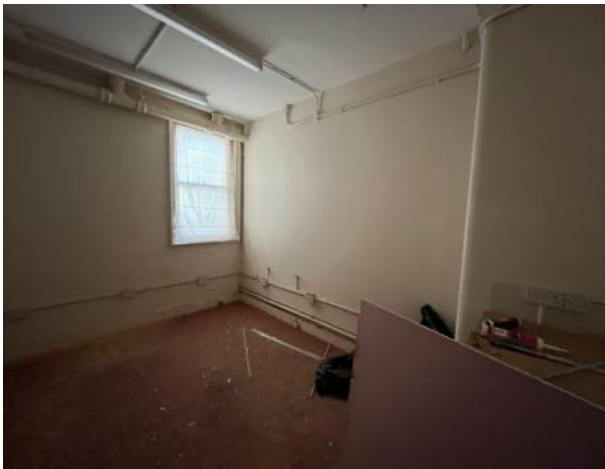
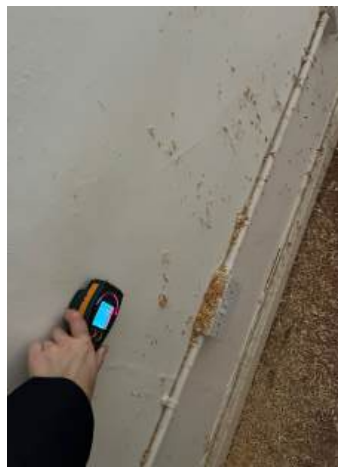
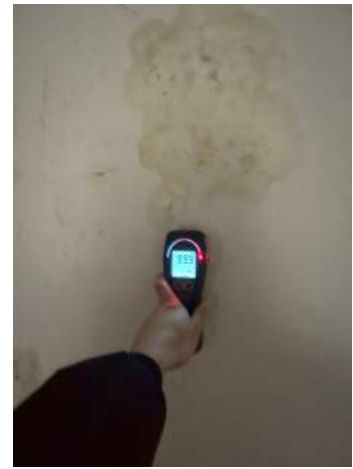
- Vacant Store Room: Elevated damp readings and signs of water damage including blown internal plaster, water marks and peeling paint were noted on the inside of the external rear and side elevation. External defects to the render and historical and present defects to the rainwater goods are almost certainly responsible for this.

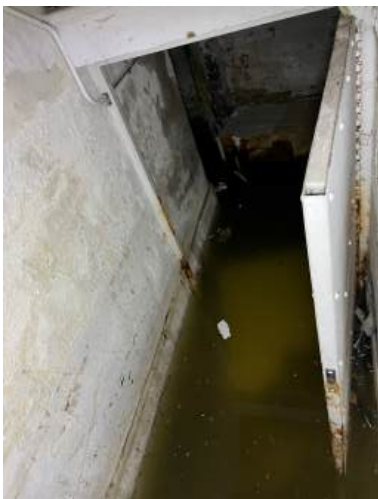
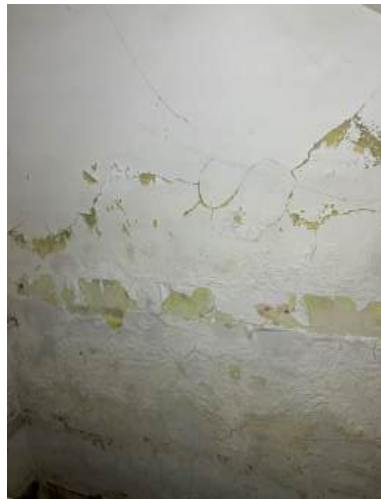
- Basement/Cellar: The basement was found to be flooded and standing water prevented close inspection. Signs of water damage, including blown plaster, watermarks, and peeling paint, were noted on multiple walls.

Victorian basements often flood due to their original construction, which lacked modern waterproofing. Built with porous brickwork and mortar, these basements were never designed to stay completely dry. Over time, issues like high water tables, poor drainage systems, and structural degradation (e.g., cracks in walls or deteriorated mortar) increase vulnerability.

-The standing water in the basement should be pumped out as this will likely lead to further issues including secondary issues with mould growth and contribute to damp on the lower parts of the ground floor.

To prevent flooding in the basement, modern waterproofing solutions will need to be employed.

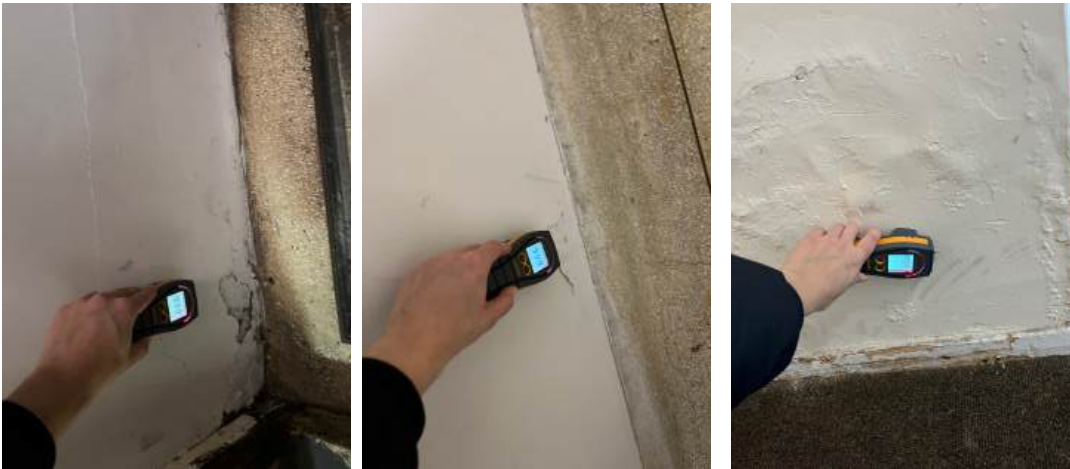
**Communal Areas:** Elevated damp readings and signs of water damage were recorded at low levels in the walls in the Entrance Hallways and stairwell. External defects to the bridged DPC and flooding to the basement below are almost certainly responsible for these readings.

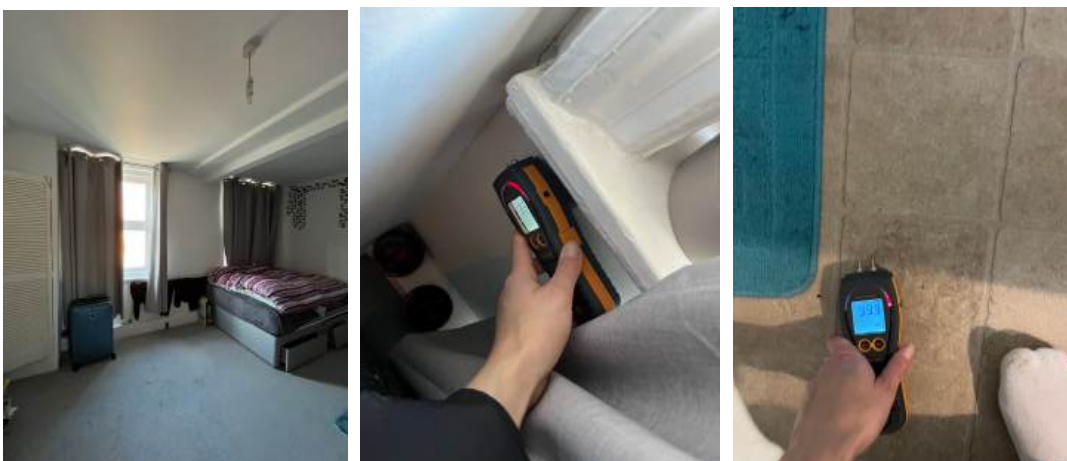
Elevated damp readings were recorded in two small localised areas below the window sills in the two bedrooms on the inside of the front elevation wall. External defect to the rainwater goods and limestone sills are likely responsible for this.

The property also is suspected to suffer from a bathroom leak due to elevated damp readings on the floor by the bath.

- Identify and repair the bathroom leaks in those flats and ensure any water damaged timbers are exposed and checked for decay or woodborer infestation.

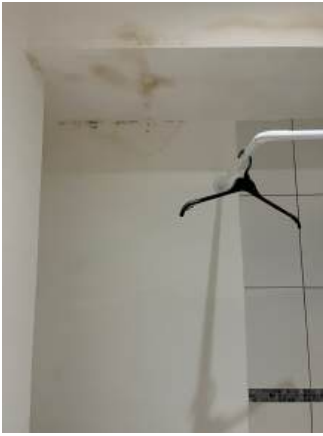
- Flat 3: Ceiling watermarks observed, corresponding to a suspected leak from the bathroom in flat 7 located directly above.

**Flat 7:** Assess the ceiling in flat 3 below for further damage and implement necessary repairs.

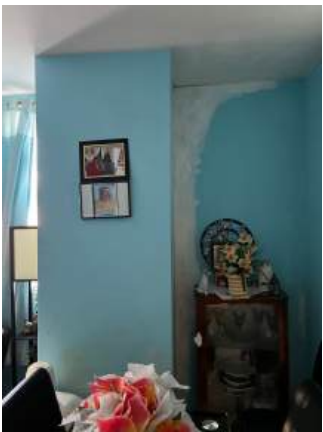
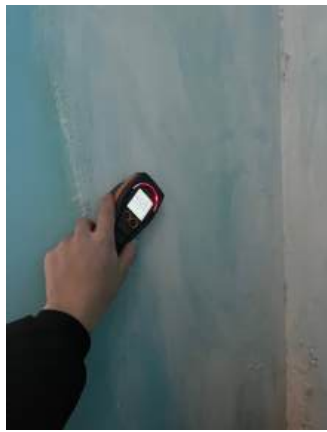
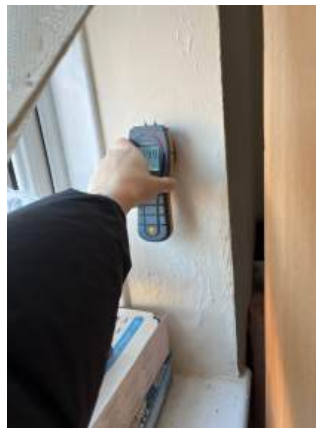
Elevated damp readings were recorded in the living room and bedrooms, on the inside of the rear elevation wall which includes the chimney breast in the living room. Water damage in the form of blistering paint was noted also. The historical hopper and downpipe leaks and chimney stack defects are likely responsible for this.

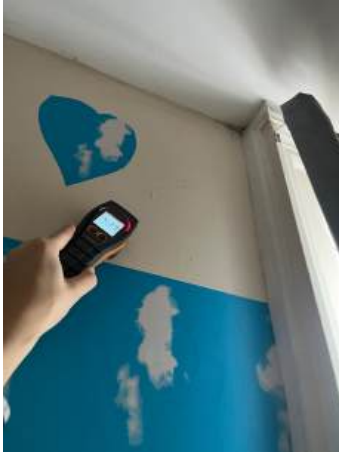
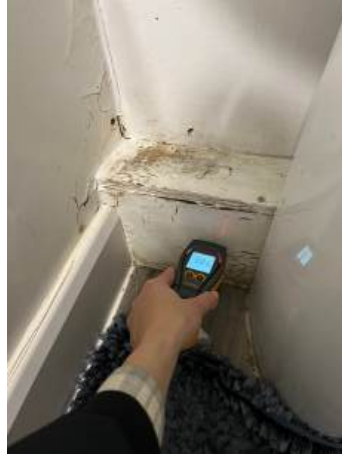
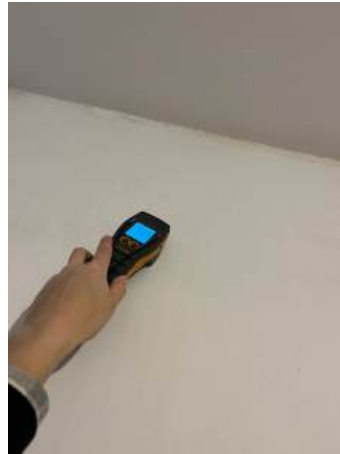
- Flat 6: Elevated damp readings were recorded in the living room and bedrooms, on the inside of the rear elevation wall. The historical hopper and down pipe leaks and chimney stack defects are likely responsible for this.

Mould was also noted on some of the wall areas, especially in the left-hand side bedroom.

Bathroom leaks are suspected due to the elevated damp readings in the floor and boxing in. And this is likely to have caused water damage in the adjoining communal area, directly opposite flat 8's entrance.

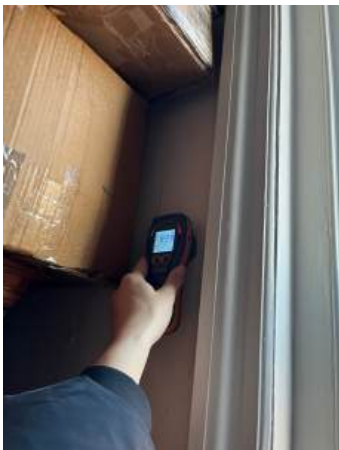
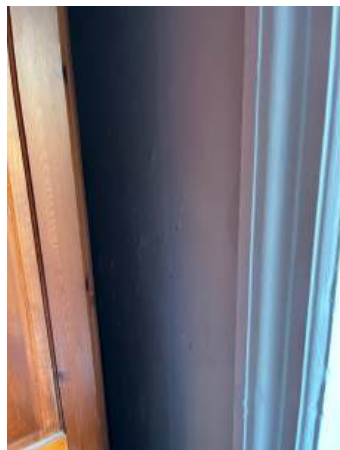
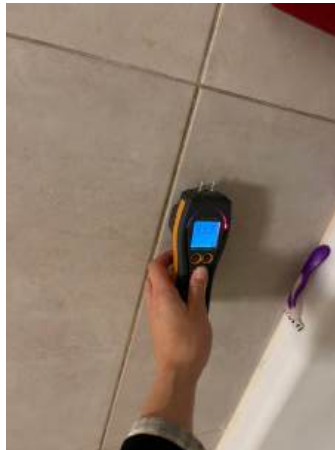
Suspected bathroom leaks noted, causing water damage to the ceiling of flat 3 below and to the communal area outside flat 7's bathroom.

Elevated damp readings were also recorded in a small localised area, on the inside of the front elevation in the bedroom. External defect to the window fillet/ mastic seals and rainwater goods are likely responsible for this.

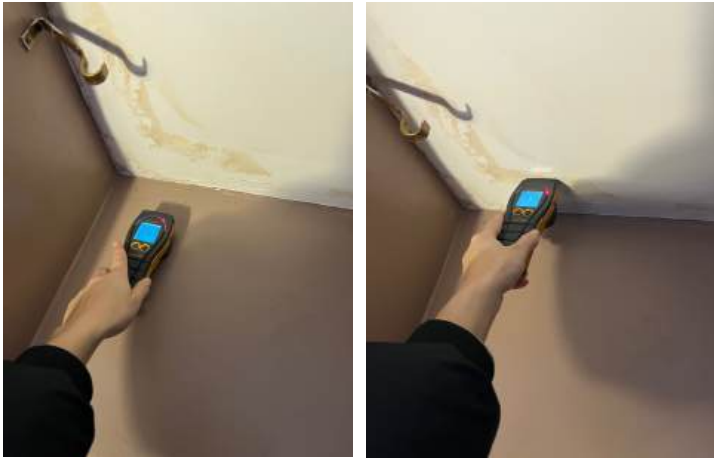
Elevated damp readings were recorded in a small localised areas on the inside of the front elevation and adjacent ceiling. External defect to the rainwater goods, limestone detailing & lead flashings are likely responsible for this.

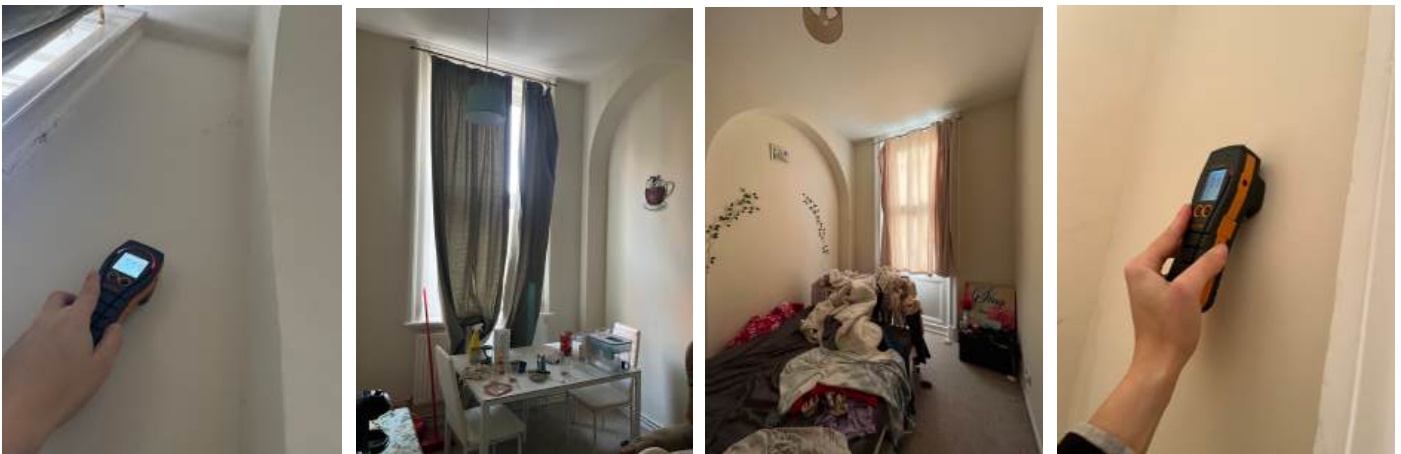
- Flat 9: Elevated damp readings were recorded on the inside of the right-hand side elevation in the bedroom (Victoria Road). External defect to the rainwater goods and limestone features are likely responsible for this.

Elevated damp readings were also recorded on the inside of the side elevation in the courtyard, where external defects to the gutters were noted.

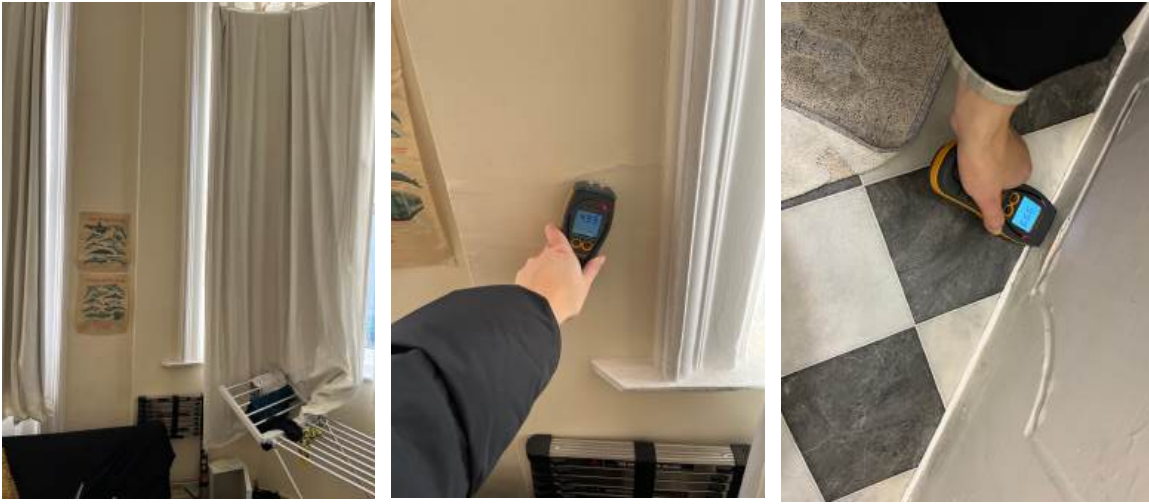
- Flat 10: Elevated damp readings were recorded on the inside of the right-hand side elevation and adjacent front elevation in the living room. External defect to the limestone sills & window surround and lead flashings are likely responsible for this. The property also is suspected to suffer from a bathroom leak due to elevated damp readings on the floor by the bath and in the bath panel.

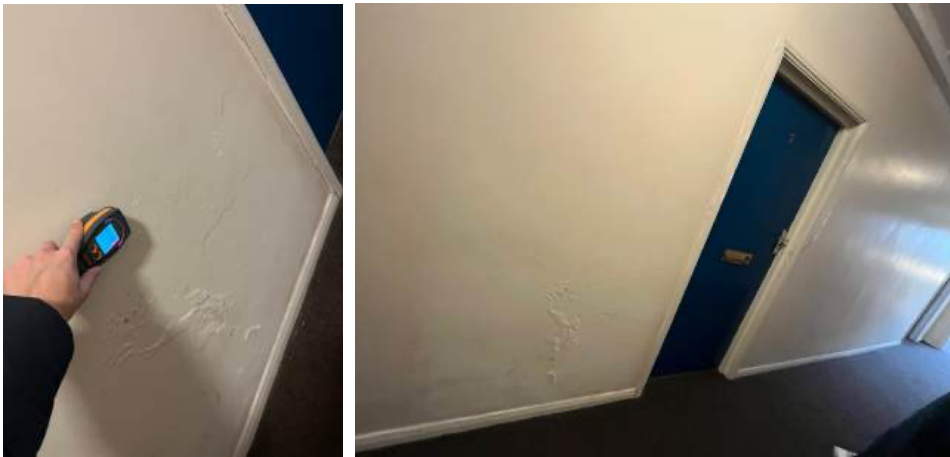
- Outside Flat 7 Bathroom: Significant water damage noted in the communal area caused by the suspected leak from flat 7's bathroom.

- Repaint and restore the communal area outside flat 7's bathroom after the source of the leak is resolved.

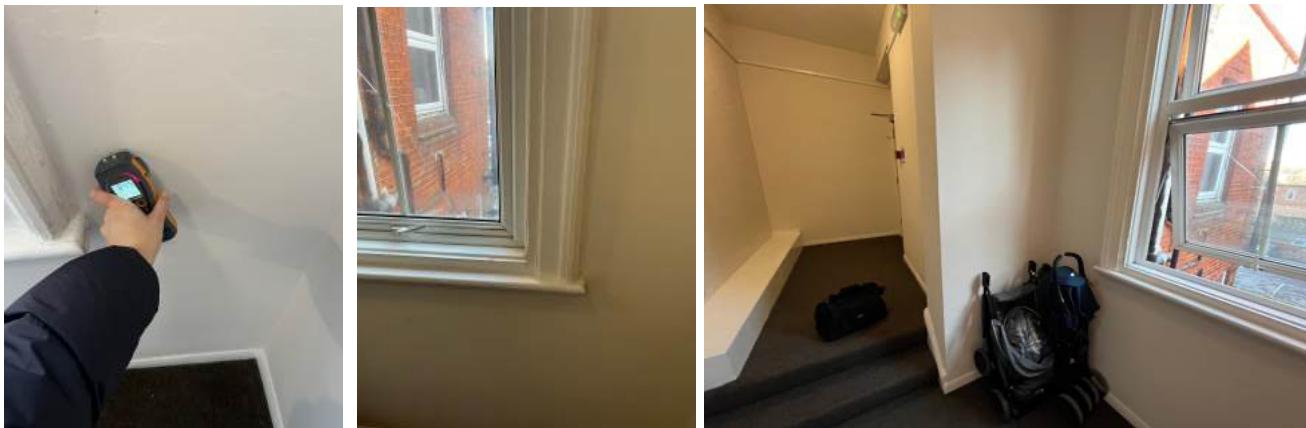
- Opposite Flat 8 Entrance: Water damage observed due to both external gutter defects and suspected leak from flat 6's bathroom.

**Flat 6 Bathroom Leak:** Repair the water-damaged ceiling in the communal area opposite flat 8's entrance.

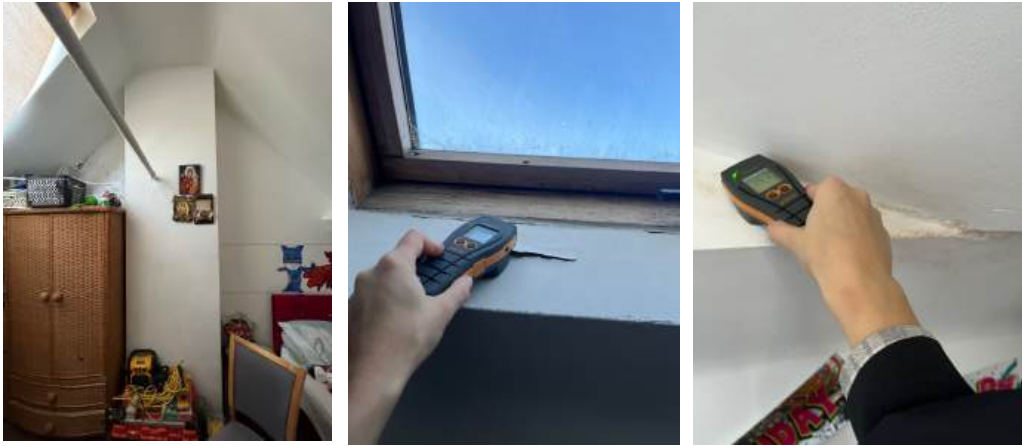
- Flat 11: Elevated damp reading and signs of dampness on the chimney stack wall were noted, almost certainly due to external defects, such as defective flashings, pointing, or junction issues with the adjacent block of flats.

Other signs of water damage was noted in the other rooms at the eaves, and around the Velux windows which included water stains and blistering paint. Despite this, the readings were found to be dry during our visit, indicating some of the damage might be historical.

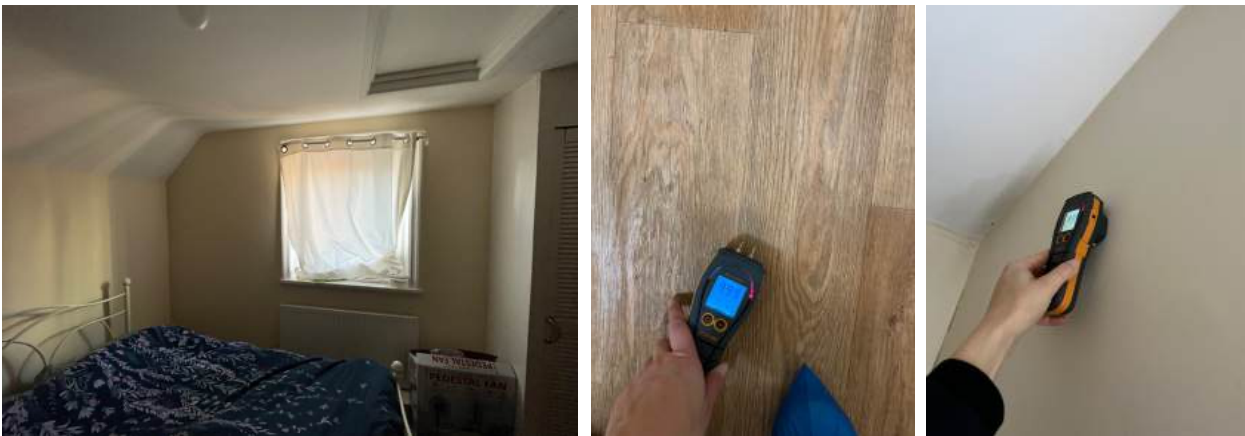
- Flat 12: Elevated damp readings were recorded on the inside of the front elevation in the bedroom and adjacent skellings. External defects to the lead flashings on the gable end, limestone features are likely responsible for this.

The property also is suspected to suffer from a bathroom leak due to elevated damp readings on the floor by the bath and in the bath panel.
