DAMP & CONDENSATION SURVEY REPORT

Damp & Condensation Survey Report

The property survey is a	Detached
Assumed to have been constructed in the	Interwar Period (1918–1939)
Assumed floor construction comprising of	Timber suspended floors
Assumed wall construction comprising of	Early cavity walls

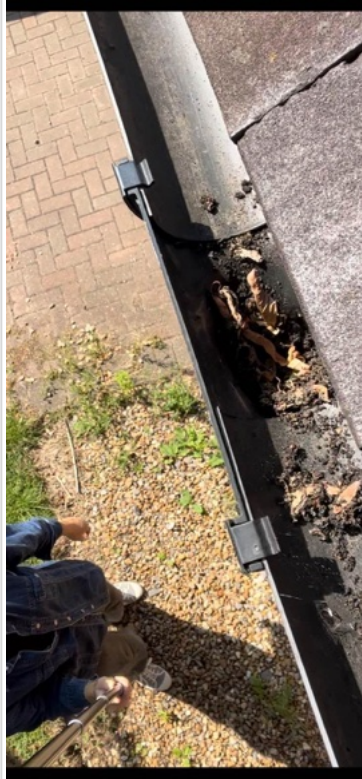
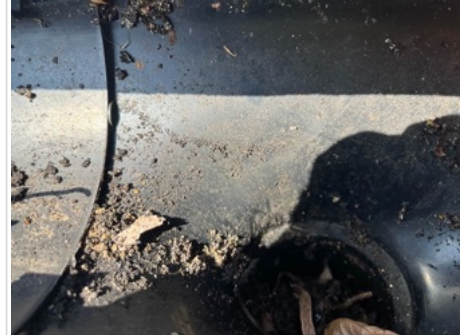
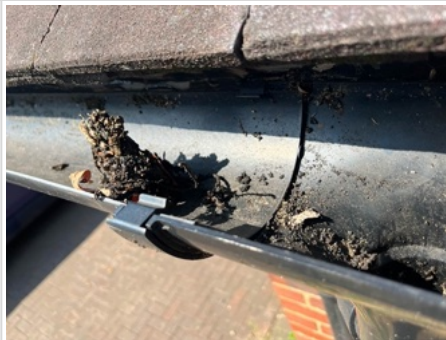
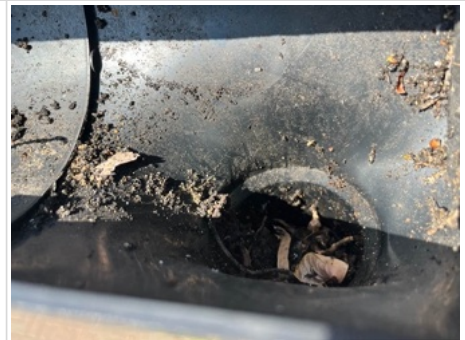
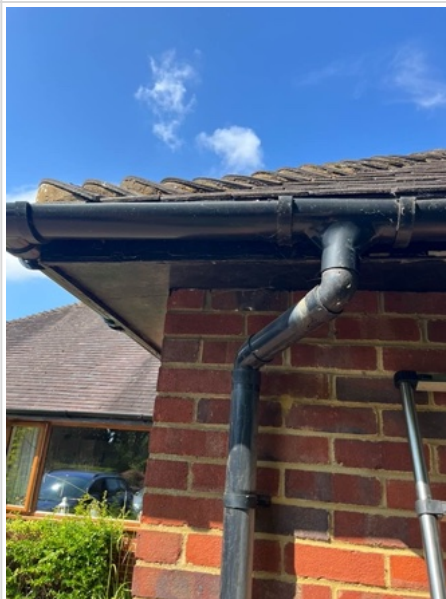
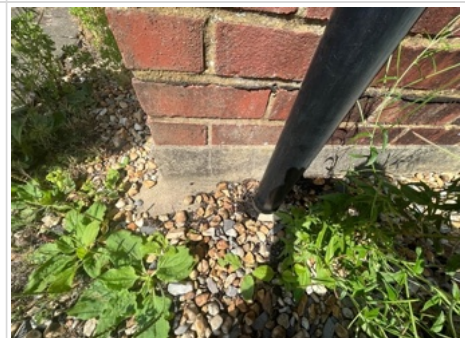
Defects Identified Relating To Other Types of Damp	Rainwater Goods
Other Defects	Front Elevation Downpipe & Guttering defects noted:
In more detail:	<p>Upon inspecting the guttering and down pipe more closely, we have observed that the outlet of the guttering is blocked by debris and vegetation.</p> <p>This is almost certainly allowing for water to overflow the gutter during heavy rain due to the obstructions in the downpipe. This in turn is likely allowing for moisture to get into the cavity wall and cause excess humidity to build up inside the cavity wall, contributing to the condensation and mould growth noted in the front bedroom.</p> <p>Water was visible around the same downpipe, at its base, which is going directly into the ground with no visible connection to the draining system. This could also mean, that water could be discharging improperly and causing saturation at low levels of the wall.</p> <p>A small internal area, at low levels of the wall was noted to show elevated damp readings and localised mould growth, on the other side of the downpipe entering the ground, which could be related.</p>

External Recommendations:	<p>External Repairs Downpipe & Guttering</p> <p>-Disconnect the downpipe and clean it thoroughly. This will ensure the guttering will no longer overflow which has likely allowed for moisture to get into the cavity and contribute to the condensation issues in the bedroom by the ceiling wall junctions where mould has also been noted.</p> <p>-Establish the connection to the drainage system. If one is not present, excavate the area and connect this to the stormwater drains or by creating a soak away in the front garden area in order to ensure the rainwater is being discharged away from the property.</p>
Condensation Recommendations:	<p>Condensation Risks & Associated Works</p> <p>-In the short term the mould can be cleaned off with soapy water, however, the following works will be necessary in order to ensure that the condensation mould growth do not return.</p> <p>-Irrespective of whether someone is in the room or not, the room should be heated during the colder months and temperatures should not go much lower than 18 to 20°C to reduce the risk of condensation and mould growth.</p> <p>You can install humidity monitors to ensure that the temperature is maintained at the recommended threshold.</p> <p>-The bathroom extractor should be serviced or replaced with a new humidity controlled extractor fan with a rate of extraction at 7 L per second or if light switch operated the rate of extraction extraction should be 15 L per second.</p> <p>The kitchen filters should be cleaned to get the rate of extraction closer to the recommended 30 L per second floor kitchen extractor hoods.</p> <p>The occupants should be encouraged to use the extraction in the kitchen and bathroom whenever they are using the specific room for cooking or showering etc.</p> <p>-Even in the winter months the room should also be ventilated by opening the door for a couple of minutes every say and opening windows on opposite sides of the property which is going to allow for air to exchange and stop any built up of humid air, therefore reducing the risk of condensation further.</p> <p>-If mould returns in the winter months, a dehumidifier can also be used in the room to keep the humidity at a healthy level.</p>

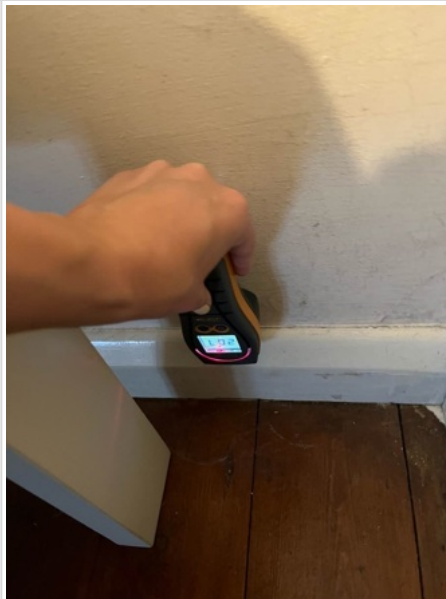
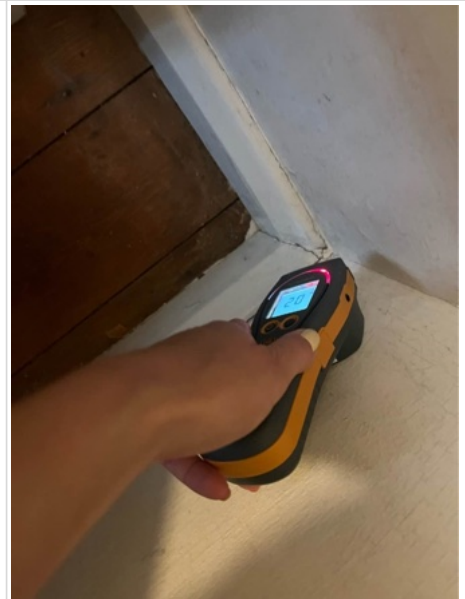
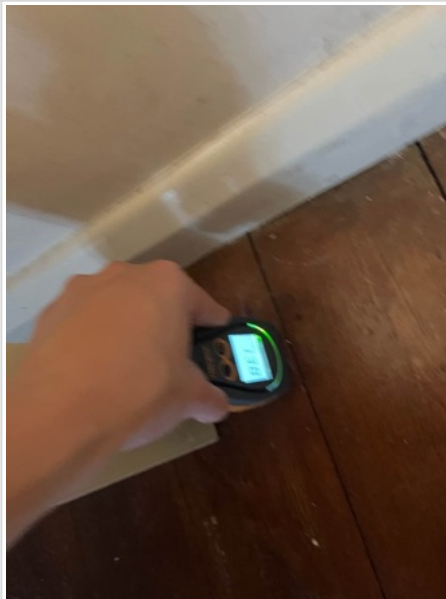
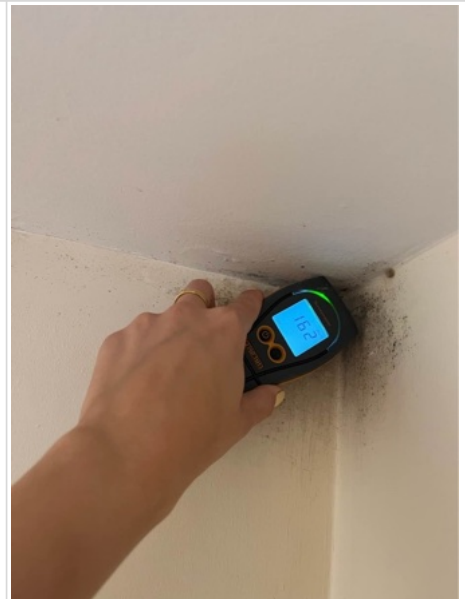
Number	1
Room(s)/ Area Affected	Front Bedroom
Signs Of Water Damage Observed	Mould Growth
Specifically:	2 ceiling-wall corners suffering from mould growth & the external front corner localised to low levels of the walls suffering from mould growth and elevated damp readings
Moisture Meter Readings	External front corner(low levels): 200RS-250RS; Ceiling-wall areas showing dry readings
Corresponding External Defects	-Suspected downpipe overflow issues due to blockages in the gutter outlet causing the ceiling wall junctions to suffer from condensation and mould growth. -Downpipe going directly into the ground and showing water around the base, likely causing the localised area showing elevated damp readings and mould, just above skirting boards at low levels of the wall, in the front bedroom corner.

<p>Corresponding Internal Defects: Condensation</p>	<p>Mould Growth Note:</p> <p>Mould is classified as a Category 1 health hazard under the Housing Health and Safety Rating System (HHSRS) and must be promptly addressed. This can severely impact people with an impaired immune system, particularly young children and adults with a predisposition to respiratory conditions.</p> <p>No In-depth Dry Readings Recorded Raising Concerns Relating To Condensation</p> <p>Acceptable dry readings obtained on areas where mould was noted, indicating the issues is condensation related rather than damp related.</p> <p>Signs of Condensation</p> <p>Definition: Condensation occurs when warm, moist air meets a cold surface, leading to water droplets forming. Inadequate ventilation exacerbates condensation, contributing to mould growth and deterioration of internal finishes.</p> <p>We believe the property to be suffering from condensation related issues and those condensation related issues are likely to be caused by a number of contributory factors including:</p> <ul style="list-style-type: none"> - Inadequate Heating Strategy <p>All doors to the bedrooms are fire doors and they all stay shut as a result. We understand that this specific bedroom is only used sporadically and that the heating would only come on when someone stays within the room.</p> <p>Therefore this room could have periods where no heating is on which will make it predisposed to condensation and mould forming, particularly on the inside of external elevations which get a lot colder but also at corners of the floor wall joint or wall ceiling joint where there is a lack of airflow to the area areas.</p> <p>This is particularly problematic during the colder months where temperatures in the room would get really cold. Recommended temperatures which should keep the risk of condensation and mould growth at bay should normally be no less than 18 to 20°C at any time.</p> <ul style="list-style-type: none"> -Lack of trickle vents on the windows which stop any passive air flow during periods when no one is in the property or the room. -Inadequate mechanical extraction, particularly in the nearby bathroom. <p>Please see Additional Observations section below describing the rate of extraction for the extractor fans in hoods in the property.</p>

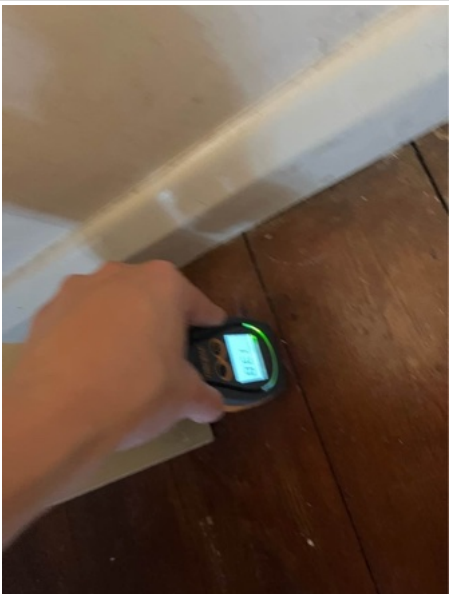
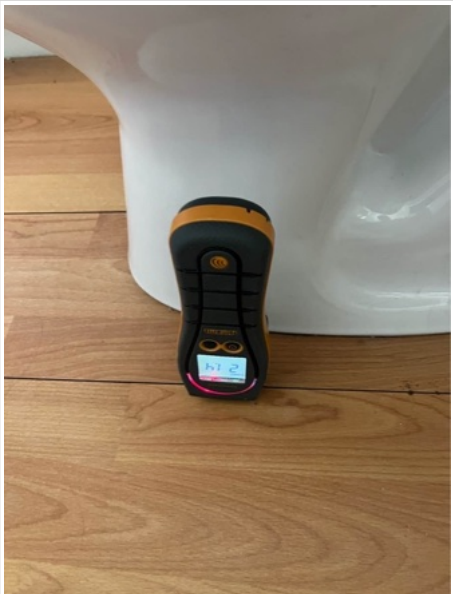
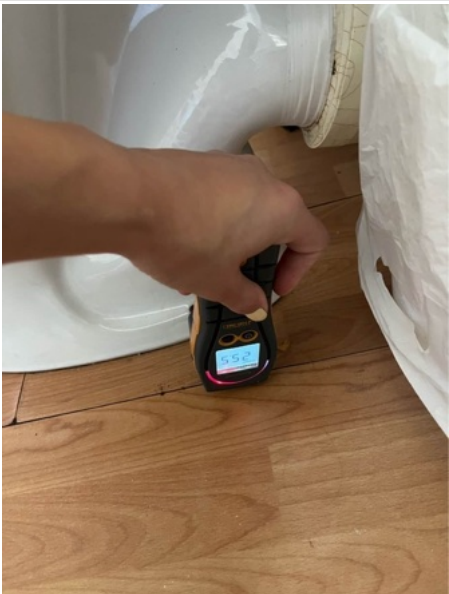
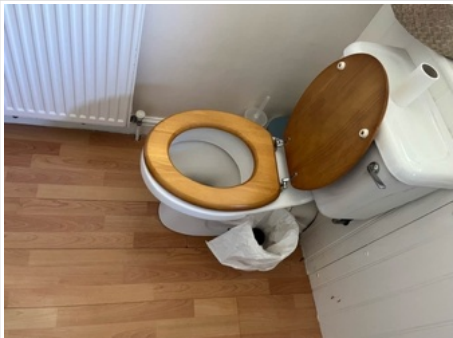
Number	2
Room(s)/ Area Affected	Bathroom
Specifically:	Around the WC, on the laminate floor
Moisture Meter Readings	20% WME-25.5% WME
Corresponding External Defects	N/A
Corresponding Internal Defects	There is a possibility of a hidden plumbing leak on the WC and this would need to be investigated during a leak detection.
Additional Notes	Readings obtained on the laminate flooring from the grooves between the boards showed elevated Wood Moisture Equivalent readings (WME) of above 20%, which could indicate a small leak originating from the WC. The floor has also bowed in this area.

Suspected Plumbing Leak	Yes
Further Leak Detection Recommended	Plumbing leaks beneath floors from heating systems, hot and cold-water services, or drainage runs can cause hidden underfloor dampness, timber decay, and contribute to elevated damp levels.
Additional Observations:

WC Suspected Leak Recommendations:	<p>WC & Bathroom Floor</p> <p>The bathroom floor should be monitored for any changes and if further deterioration of the floor is noted around the WC, you should instruct a qualified plumber or a leak detection company to check for the presence of any hidden plumbing leak and repair these as necessary.</p>

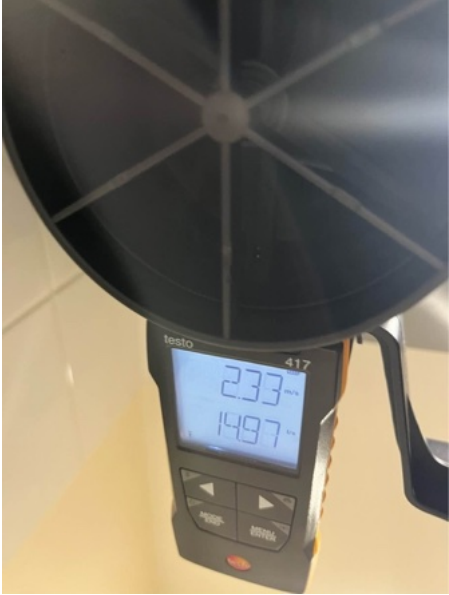
<p>Shower room extractor fan working at the recommended rate of extraction</p> </div> <div style="text-align: center;">

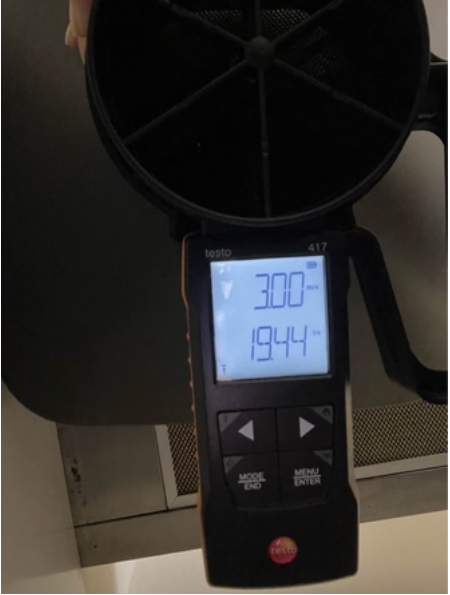
<p>Other Notes:</p>	<p>Inadequate Mechanical Extraction</p> <p>Mechanical extraction is essential in ensuring the humidity created in the property by showering, cooking, washing clothes etc. is being removed from the property effectively.</p> <p>The rate of extraction of the extractor fans and extractor hood has been tested using an anemometer and cross referenced against the recommended rise of extraction set out by Ventilation Document F.</p> <p>These were found to be as follows:</p> <p>-Kitchen extractor hood: Found to be working at 20 L per second, compared to the recommended 30 L per second.</p> <p>The recommendations here would involve cleaning out the filters which might be enough to restore the recommended rate of extraction.</p> <p>-Bathroom extractor fan found to be not working .</p> <p>-Shower room extractor fan: Found to be working at the recommended rate of extraction of 15 L per second .</p> <p>There is also a tumble drier which is not ducted outside and poses a risk for condensation in its current form.</p> <p>However, this does not appear to be used by the occupants, but rather the clothes appear to be dried in the conservatory by the occupants. And we would advise the tumble drier to only be used if it is ducted to the outside.</p>

<p>Kitchen extractor hood working at 2/3 the recommended rate of extraction</p> </div> </div>

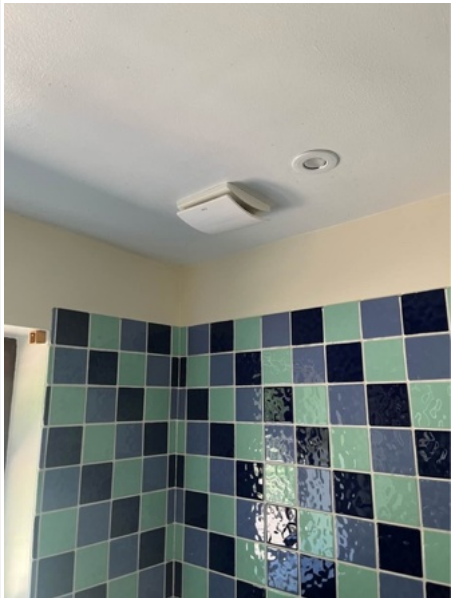
<p>Bathroom fan not working during our visit</p>

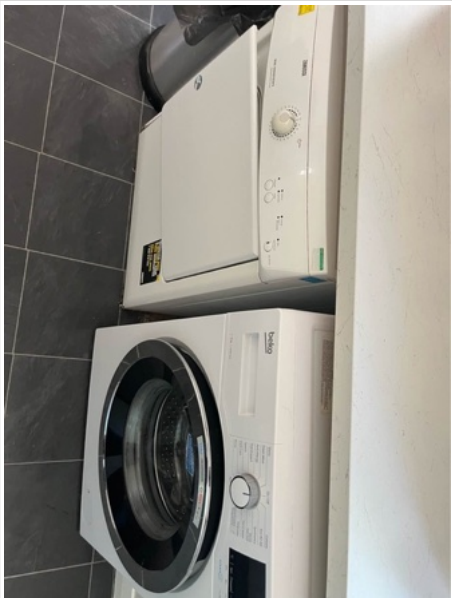
<p>Tumble drier</p>
