DAMP SURVEY REPORT

Survey Date and Time	03/09/2025
Occupied/ Unoccupied	Unoccupied
Surveyor Name	Bianca Hedesiu BSc(Hons) CSTDB WRT ASD

The property survey is a	Semi-detached
Assumed to have been constructed in the	Victorian Period (1837–1901)
Assumed floor construction comprising of	A combination of original timber suspended floors and solid concrete floors
Assumed wall construction comprising of	9-inch solid walls

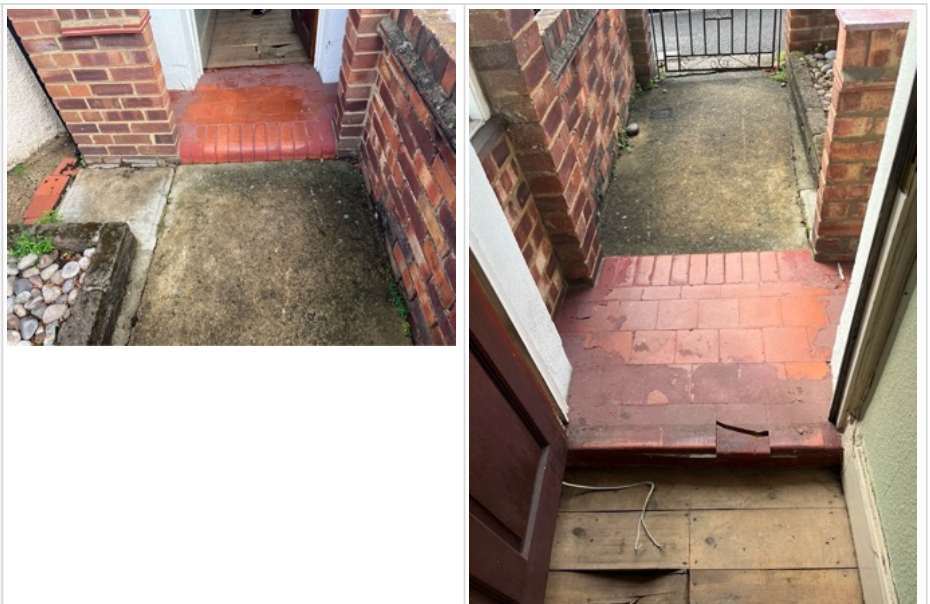
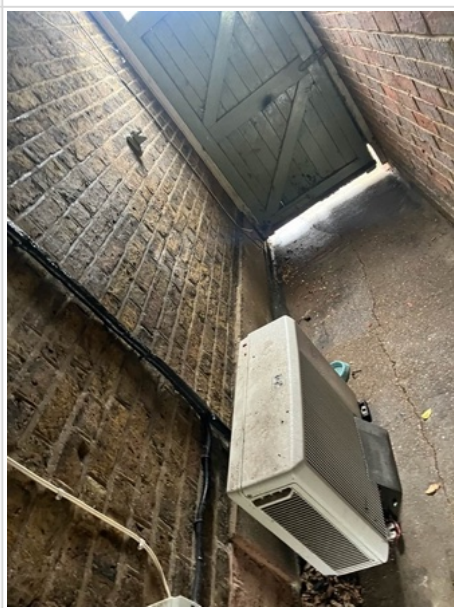
Bridged DPC by Rendered Plinth:

<p>The external renders and rendered plinth present at the base of the external walls are likely cement based and in the case of the renders, paint over using a non-breathable masonry paint, both conducive to trapping moisture in the wall due to their non-breathable nature.</p> <p>Given the render / rendered plinth extend down to ground level, it spans the wall below DPC and above, which can allow for the moisture to bypass the DPC via the plinth and cause internal damp at low levels of the walls.</p>

Render/ Rendered Plinth Bridging the DPC	Cut back the render /rendered plinth and stop 5-10mm above the DPC.
French Drain necessary to lower the high external ground levels	Install a French drain or dry gravel channel along the front elevation of the property, directly adjacent to the raised patio and external wall; This would create a lowered channel along the rear elevation (150mm-200mm wide) to ensure a minimum 150mm clearance from DPC to ground level, and 75mm clearance from ground to air bricks; The channel may be backfilled with a thin gravel layer with levels still kept in the recommended place compared to the DPC and air bricks. Reposition front step if necessary to facilitate lowering.
DPC Treatment (only if plaster deteriorates)	If plaster starts to deteriorate or salts become visible to the surface of the wall, a DPC treatment might be necessary. A PCA contractor should be instructed to hack off affected internal finishes back to brickwork up to 1.2m high, treat exposed masonry with salt neutralisers, and re-plaster with appropriate 3:1 sand/cement render mix incorporating waterproofing and additives. This will prevent further damage or spoiling to the internal decoration. Those works are best completed by a waterproofing contractor offering the necessary guarantees for the treatment. BS 6576:2005 gives recommendations for the chemical treatment of rising damp in existing buildings with solid walls, cavity walls (unfilled or filled) and random rubble-filled walls.

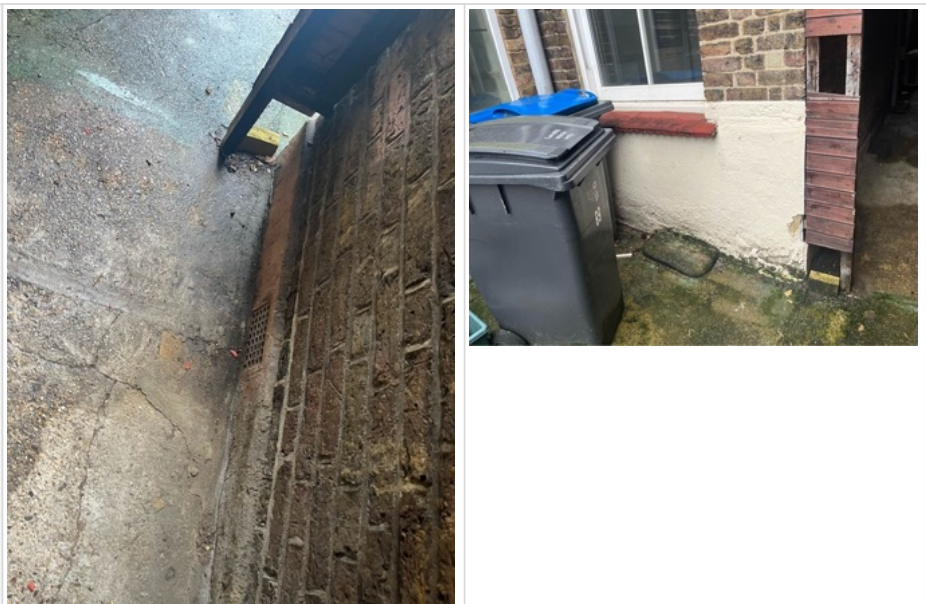
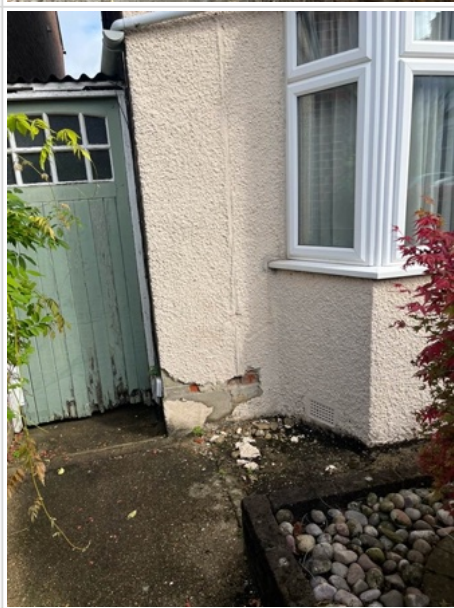
Bridged DPC by Raised Adjoining Structure:

<p>The poorly detailed front step being higher than the internal ground levels and DPC and is adjoining the external elevations directly.</p> <p>This is therefore allowing for lateral damp and restricting the subfloor ventilation in the area.</p>

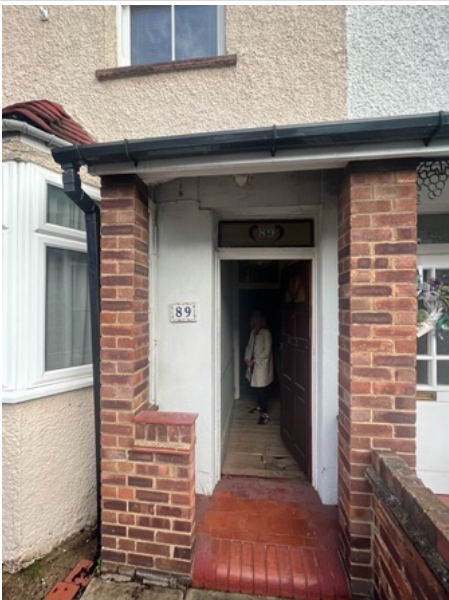
Contributory Issues	Hygroscopic Salt Contamination Due to Rising Damp	
Contributory Issue: Hygroscopic Salt Contamination Due to Rising Damp	Rising damp often carries salts from the ground into the masonry and plaster. These salts, once embedded, attract moisture from the air, creating ongoing damp issues even when the original source of moisture is no longer present.	
Defects Identified Relating To Inadequate Subfloor Ventilation	Cross Ventilation Not Achieved, Air Bricks Positioned Too Low	
'Cross flow' Ventilation Deficiencies	<p>One functioning air brick was noted at the front, several on the side elevation (side path) and one on the rear side bay.</p> <p>Despite this , crossflow ventilation is not achieved as there is no equivalent provision for ventilation to the suspended floor to the rear.</p> <p>Ventilation is therefore suboptimal to the suspended timber floors.</p> <p>The most effective type of ventilation type of ventilation to a timber suspended floor is the crossflow type, meaning from side to side or front to back. Poor ventilation within subfloor voids increases humidity levels, encouraging fungal decay (wet rot, dry rot) and timber infestation by wood-boring insects.</p>

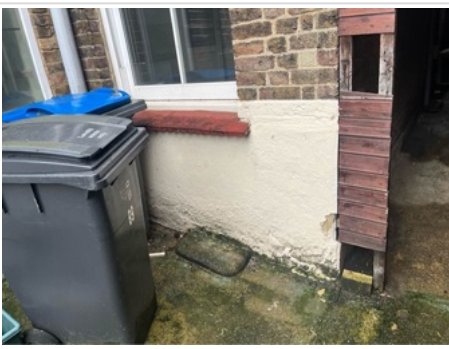
High External Ground Levels Near Suspended Floors	<p>Raised ground levels at the front can obscure or block underfloor air bricks, significantly impairing cross-ventilation.</p> <p>Where air bricks are not positioned at the recommended minimum separation from the ground levels, and are either in line or obstructed by the high external ground levels, risk of decay or infestation is increased due to the blockages to the ventilation but also due to the possibility of moisture entering the subfloor void from water splashing from the nearby surfaces.</p>

Subfloor Ventilation Deficiencies	
Subfloor Ventilation Improvements:	-Install additional air bricks to both front and rear walls of the suspended timber floors (serving both reception rooms and dining/kitchen areas), ensuring proper cross ventilation. - Lower ground levels adjacent to air bricks to maintain at least 75mm of clear airspace below air brick openings. -Ensure that subfloor ventilation meets current standards, with airbricks installed at no more than 1.8m centres and cross-ventilation achieved.

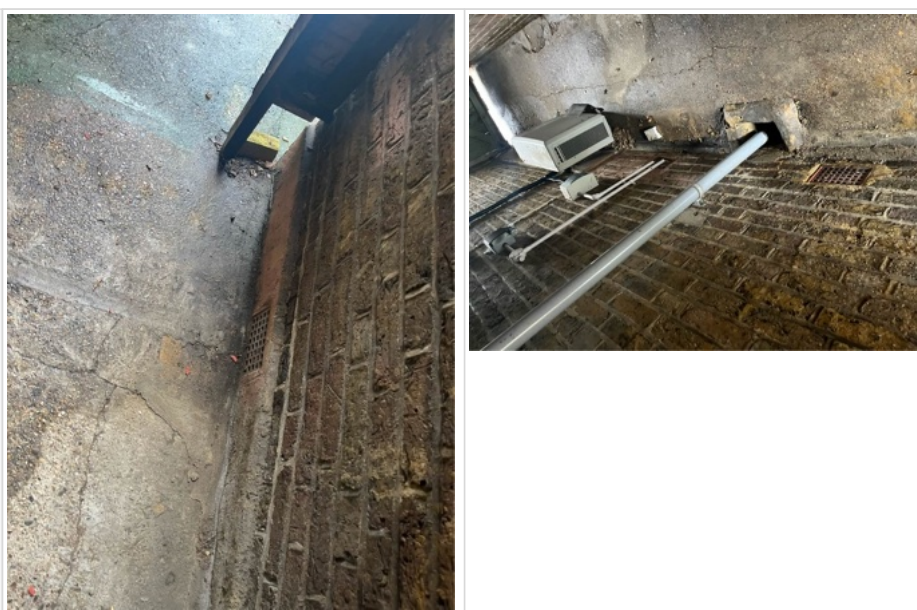
Risk of Decay/ Infestation to the Subfloor Timber	
Risk of Decay/ Infestation to the Subfloor Timber	<p>Rising Damp</p> <p>Moisture from rising damp can penetrate through walls into the ends of floor joists embedded directly into brickwork, causing timber decay, rot, and a weakened floor structure over time. Due to the non-invasive nature of our surveys and fixed floor coverings we were unable to inspect the subfloor timbers in the area.</p> <p>Air Bricks Positioned Too Low</p> <p>Where air bricks are not positioned at the recommended minimum separation from the ground levels, and are either in line or obstructed by the high external ground levels, risk of decay or infestation is increased due to the blockages to the ventilation but also due to the possibility of moisture entering the subfloor void from water splashing from the nearby surfaces.</p> <p>Lack of Cross Ventilation</p> <p>Poor 'cross flow' ventilation (front to back or side to side) within subfloor voids is conducive to humidity building up inside the void, encouraging fungal decay (wet rot, dry rot) and timber infestation by wood-boring insects.</p>

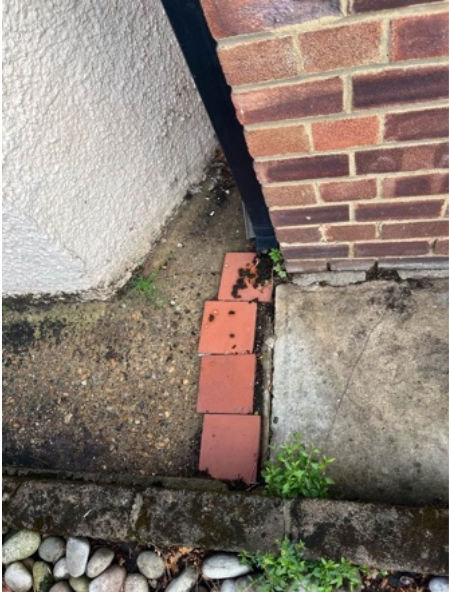
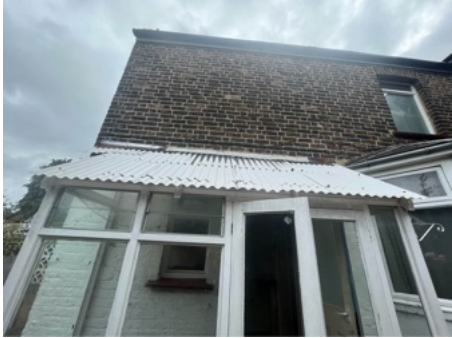
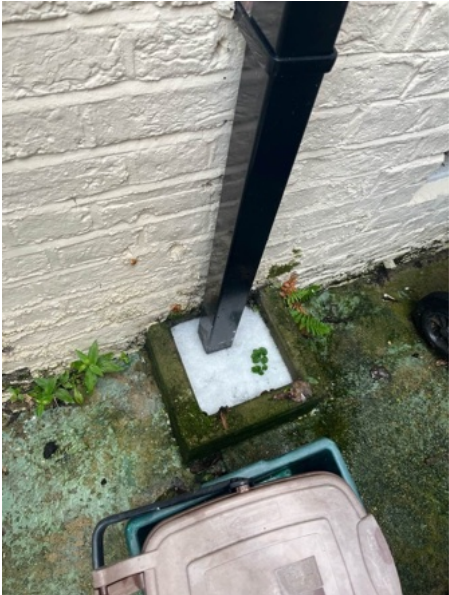
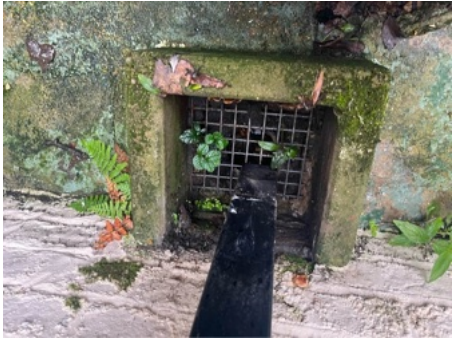
Rainwater Goods Defects Noted	<p>-A front downpipe discharges at the base of the front wall, between the front door and front bay with no visible connection to the drainage system. This is thought to be allowing for saturation at low levels.</p> <p>Internally, dampness was recorded in corresponding areas of the reception room.</p> <p>-The rear gully, located adjacent to the rear left-hand side bay, was found to be blocked and filling up quickly during testing indicating overflow issues are very likely to affected the surrounding wall area.</p> <p>This is therefore thought to be directing water against the wall and likely contributing to internal dampness in the dining room and adjoining hallway.</p>
Annotated Pictures

Penetrating Damp	Penetrating Damp was found to be present at the property due to the following external defects. In more detail:
Rainwater Goods:	<p>Redirect downpipe at front elevation to a proper gully or connect to storm water drains.</p> <p>Clear and unblock gullies, particularly the overflowing rear left-hand side gully.</p> <p>Repair defective joints to soil stack to stop leaks.</p> <p>Conduct a water test during heavy rainfall or simulated with a hose. Identify and repair all leaking joints, ensuring brackets are sound and joints are watertight. Where gutters are distorted or split, replacement with matching materials is required.</p>
Render Coverings:	<p>In the short term, repairs to the render can be undertaken by opening cracks to a sound substrate and repaired with a weather-resistant filler or mastic.</p> <p>Another option is using cement or mortar.</p> <p>For a long-term solution, consider replacing the render with a more flexible and modern render type, such as:</p> <ul style="list-style-type: none"> -Silicone-based render: Highly flexible, breathable, and water-resistant. -Monocouche render: A single-coat, breathable option with good flexibility. -Acrylic render: Durable, flexible, and resistant to cracking. These options will provide better protection against wind-driven rain and thermal movement.

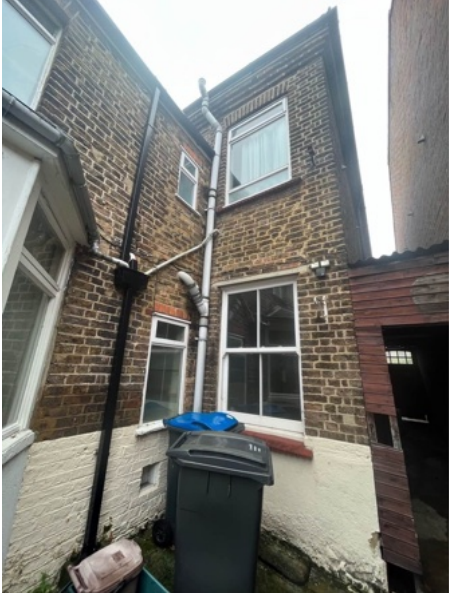
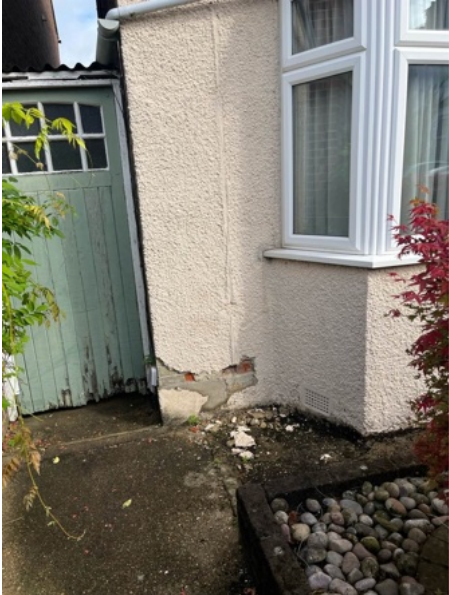
Render/ Coverings Defects Noted	Localised deterioration external render and external paint was noted, potentially contributing to moisture penetration.	
Annotated Pictures

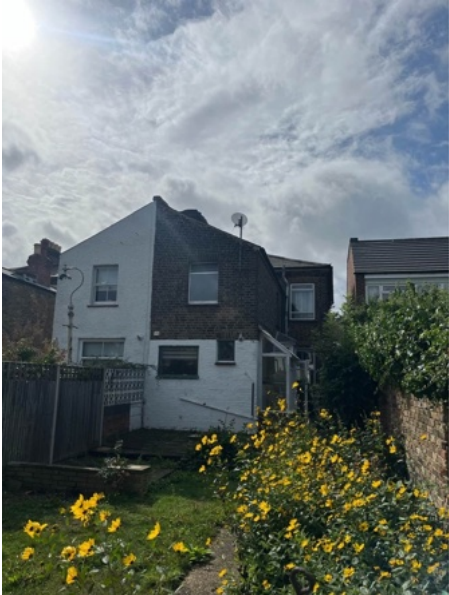
Chimney Stacks/ Flashings Defects Noted	Old Chimney Breast & Hygroscopic Salt Contamination, Pointing	
Pointing	<p>Rear Shared Chimney:</p> <p>The side chimney stack appears to have been removed above the roof line.</p> <p>The remaining chimney to the rear (shared with neighbour) could only be observed from ground level and our view of it was limited. Despite this, we were able to observe weathered pointing which makes the chimney stack vulnerable to water ingress.</p>

Old Chimney Breast & Hygroscopic Salt Contamination	<p>Note: Hygroscopic Salt Contamination to Chimney Breasts Chimney breasts and flues can absorb moisture from years of burning fossil fuels, which release hygroscopic salts. These salts remain in the masonry and plaster and absorb moisture from the air, leading to damp patches and staining around the chimney breast even when there is no active water penetration. Moisture can linger in the chimney structure due to the presence of these salts, leading to persistent damp issues.</p>
Roof Defects Noted	<p>Side Lean-to Roof: The corrugated plastic covering is poorly flashed against the wall and has no guttering provisions, therefore substandard in its design. Portico Roof: Deteriorated mortar flashing was noted to the portico roof. Covered Path Roof: The side path roof is also thought to be suboptimal and the covering is leaking, contributing to internal damp risk.</p>

Roofer Inspection Recommended	Yes
Further Roofer Inspection	<p>A further roofer drone inspection is recommended to observe any further defects to the chimney stack, as this could be contributing to moisture ingress in the chimney breasts below.</p> <p>In addition, the roofer should advise on new roof coverings for the lean to extension and side path, incorporating compatible membranes and rainwater goods disposal systems.</p>
Annotated Pictures

Chimney & Flashings	Old Chimneys & Hygroscopic Salt Contamination, Open Pots, Brickwork
Chimney: Open Pots Flashings: Portico Roof	Roofer drone inspection is recommended to the chimney stack for further defects. New lead flashing to be added to the portico roof at the junction with the front elevation. Install galvanised chimney cowls to all open chimney pots to stop moisture ingress.
Chimney: Brickwork	<p>Repoint brickwork of the stack with lime mortars.</p> <p>Apply a BBA-approved deep-penetrating water repellent such as Stormdry masonry cream to protect external masonry while allowing breathability.</p>
Hygroscopic Salt Contamination of the Chimney Stack/ Breast	<p>Plaster can be tested for the presence of those salts to confirm their presence.</p> <p>Where plaster/ decorations has deteriorated damp proofing specialist providing the necessary guarantees should be instructed to carry out the following works:</p> <ul style="list-style-type: none"> -Hack off the plaster back to chimney stack brickwork on the affected chimney breasts walls corner to corner around the chimney breast (whole length and height) and take down ceiling plasterboard to allow membrane to be inserted all the way up the wall. -Apply a vertical damp proof membrane as per the manufacturer's guidelines (such as Newton 503) to the affected interior walls. -Fix back plasterboard to the walls with no screws into the new membrane on the wall.

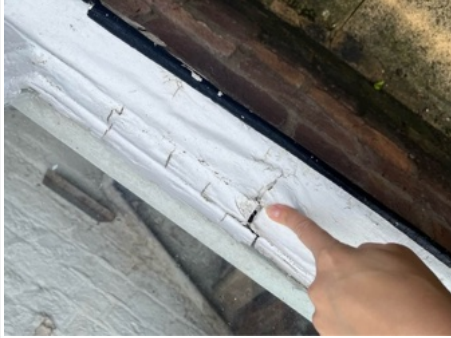
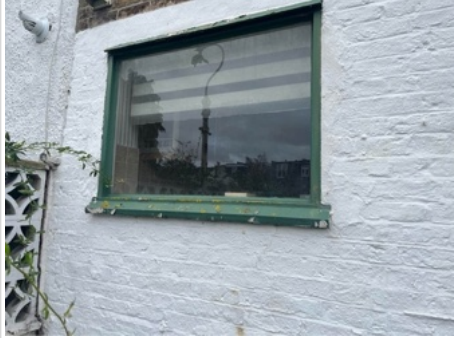
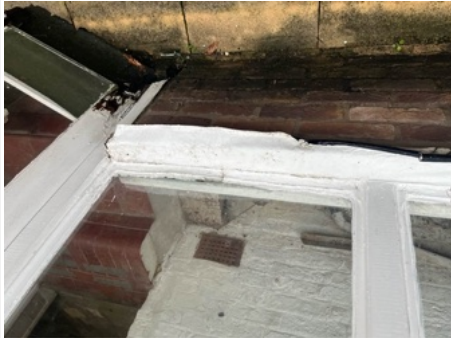
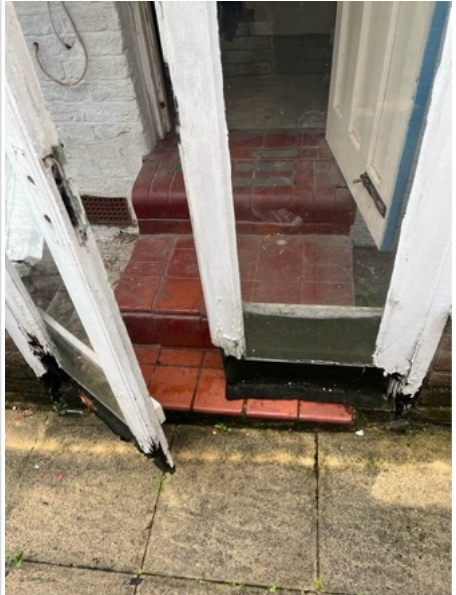
Windows & Doors	<p>Defective Timber Framed Windows/Doors</p> <p>The side lean to extension roof without any guttering has allowed the window sills and door frame to decay in the areas below.</p>
Annotated Pictures

Roof:	Replace the corrugated plastic side lean-to roof with a properly flashed and guttered structure to prevent ongoing ingress. Relay or reconstruct covered side path roof, installing proper drainage.
Other	Replace affected timber elements on the lean to extension. Repair leaking tap.
Natural Drying Note	The affected walls are likely to dry out naturally, however this will take several months of Spring/Summer weather (Masonry drying time is usually 25mm/month). If any salts or other contaminants appear then these must be neutralised before re-decoration. Any damp stains should be neutralised with a stain block such as Zinsser before redecoration. You can consider speeding up the drying the process of natural drying by the installation of dehumidifiers and air movers.

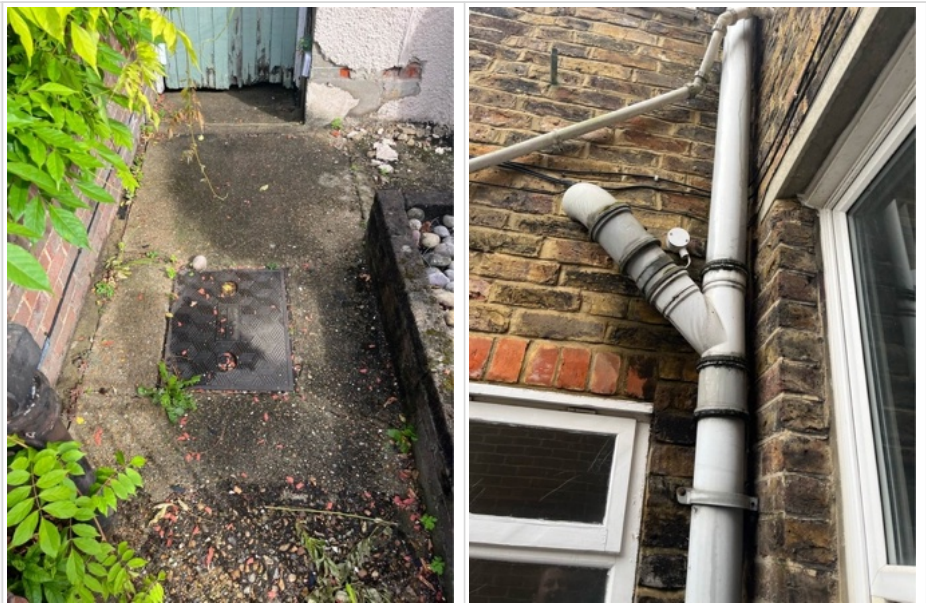
Defects Identified Relating To Other Types of Damp	Suspected Plumbing or Drains Leak, Other
Further CCTV Survey Recommended	<p>Evidence of leakage from joints, with moss growth noted on the soil stack on the left-hand side elevation. This may be allowing water ingress adjacent to the dining room wall and will need to be tested and checked in the areas below ground to confirm any issues/ leaks.</p> <p>Defective internal drainage pipes, such as waste pipes or soil stacks, leaking under floors or within walls, can create localised damp issues and foul odours.</p>

CCTV Drainage Survey	Carry out CCTV drain survey to check condition of underground drainage and identify defects or leaks. Arrange CCTV drainage surveys to assess the condition of internal drainage runs. Repair or replace defective sections, ensuring all new drainage works comply with Building Regulations Part H.
-----------------------------	---

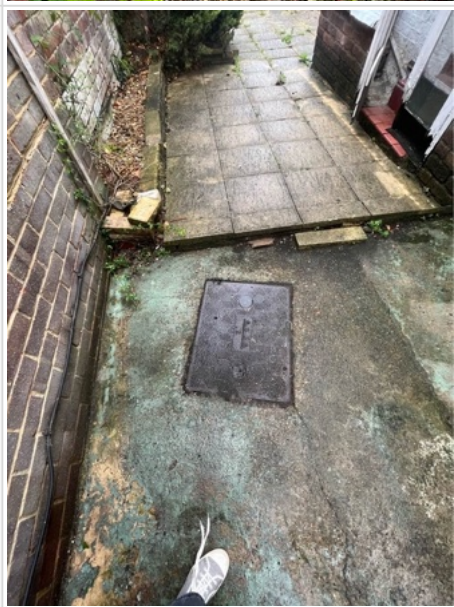
Other Defects

<p data-bbox="531 1568 1461 1612">A leaking tap was noted by the rear elevation corresponding to the kitchen.</p>

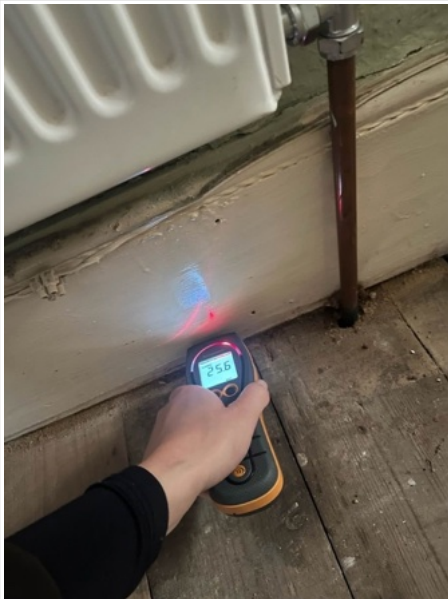
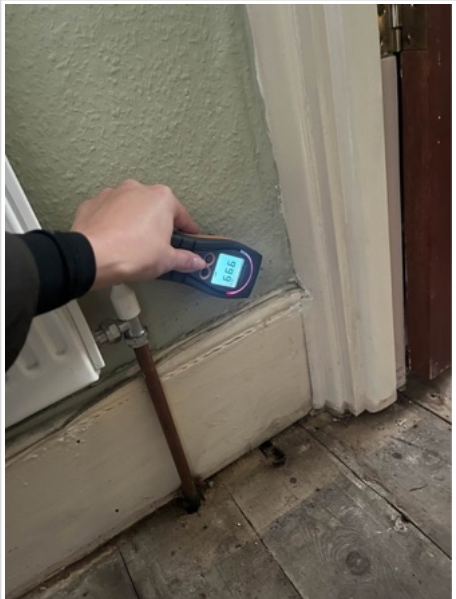
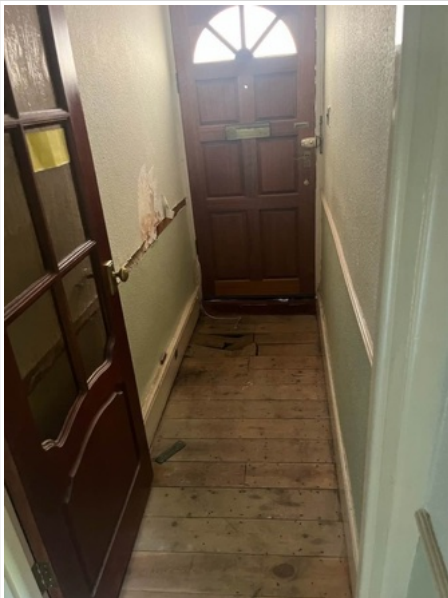
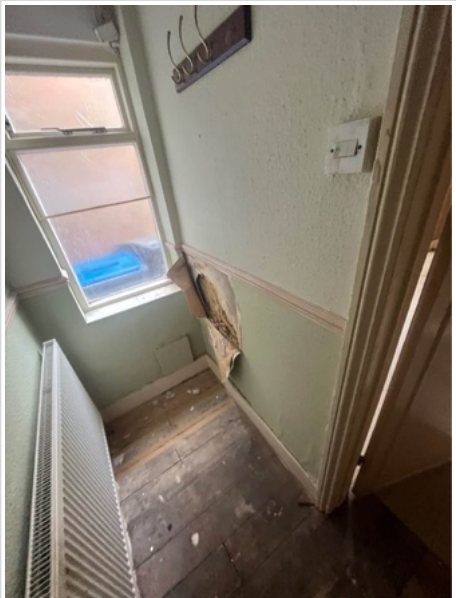
<p>Dampness noted on both sides of the front door at low levels, corresponding with raised levels and step and bridged DPC.</p> <p>Elevated damp readings were also noted by the bottom of the staircase, adjacent to a radiator pipe running into the floor, and dampness was recorded with evidence of skirting and floorboard deterioration.</p> <p>We suspect a small hidden plumbing leak is likely responsible for this.</p> <p>We also cannot rule out any issues originating from the party wall neighbour as this affected wall is a party wall.</p>
	<p>Elevated damp readings and deterioration of the plaster were also noted on the dividing wall between the hallway and dining room.</p> <p>Defects to the overflowing gully and leaks on the chimney stack are thought to be contributory factors for the damp.</p>
Annotated Pictures

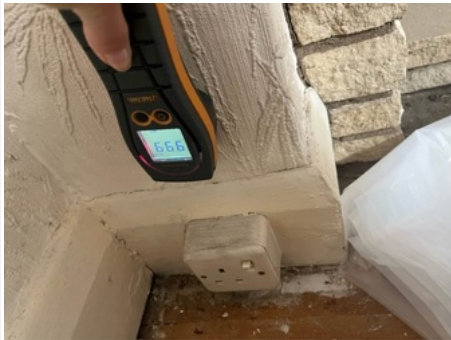
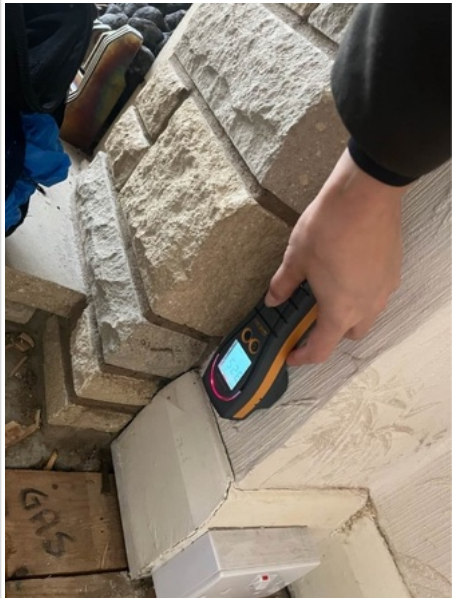
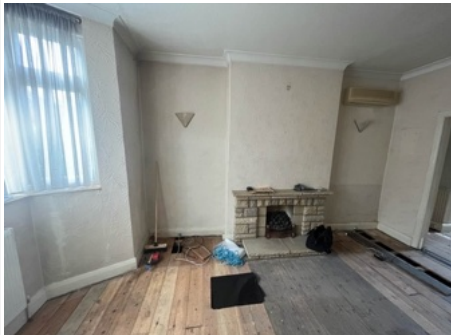
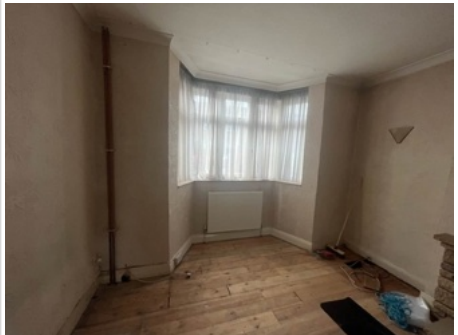
Number	2
Room(s)/ Area Affected	Reception room

Signs Of Water Damage Observed	Wallpaper damage
Specifically:	On the inside of the front bay, on the inside of the left-hand side elevation including chimney breasts (at low levels)
Moisture Meter Readings	200RS-999RS
	<p>Elevated damp readings were noted on the front elevation and bay, corresponding to the discharging downpipe and raised ground levels.</p> <p>The readings extend on the inside of the side flank wall, at low levels of the walls only and only sporadically. We believe the defects to the rendered plinth bridging the DPC and inadequate roof coverings over the side path are responsible for the those.</p>
	<p>Chimney breasts also showed high readings when tested.</p> <p>Given the stacks above have been removed we suspect the readings are a sign of salt contamination due to old soot contaminants in the plaster.</p> <p>Chimney stacks are believed to be scheduled for removal as part of refurbishment works.</p>

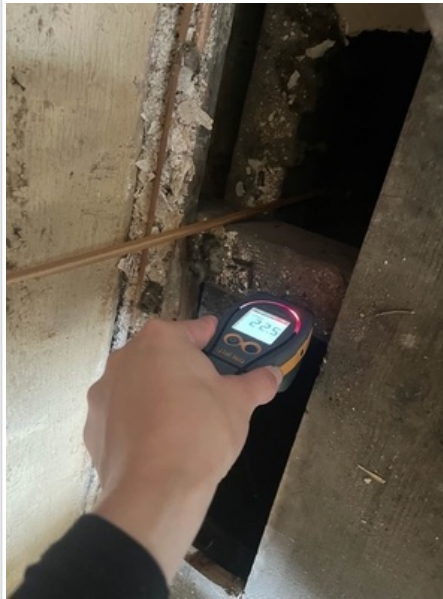
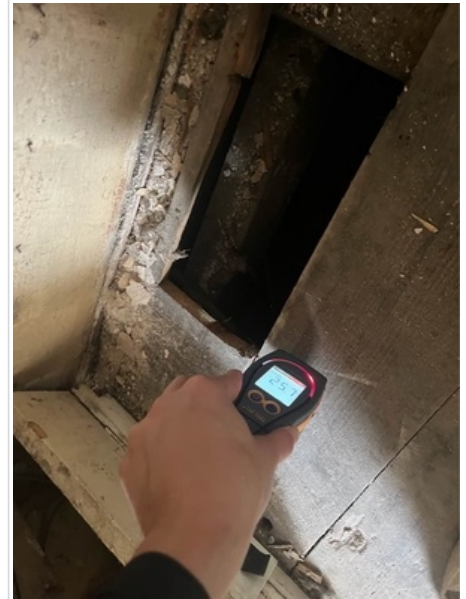
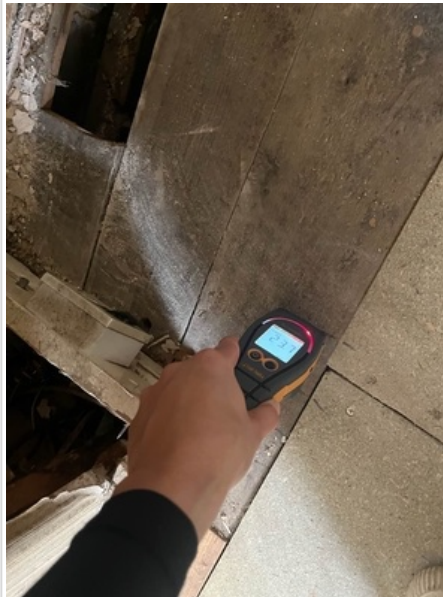
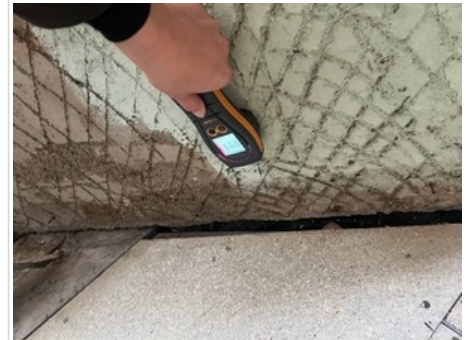
Number	3
Room(s)/ Area Affected	Dining Room & Kitchen
Signs Of Water Damage Observed	Blown Plaster, Water Stains
Specifically:	On the inside of the left-hand side flank elevation (at low levels of the walls), on the inside of the party wall including chimney breast (at low levels in the dining room)
Moisture Meter Readings	200RS-999RS
	<p>Dining Room:</p> <p>Dampness at low levels was noted to rear bay walls and adjacent internal partition wall between the dining room and hallway.</p> <p>This is thought to be corresponding with overflowing gully and defects to soil stack.</p> <p>The party wall including the chimney breast also records elevated moisture levels at low levels which could be related to the chimney stack defects, hygroscopic salt contamination of the chimney breast due to the old soot in the plaster or hidden leaks.</p> <p>We also cannot rule out any issues originating from the neighbouring property.</p> <p>Accesibile floorboards and joists by the party wall were also found to show elevated damp readings higher than the 20% Wood Moisture Equivalent (WME%) threshold, after which timbers become at risks for decay or infestation by wood boring insects.</p>

<p>Kitchen:</p> <p>Elevated damp readings were recorded on the left-hand side wall at low levels, likely associated with defective lean-to roof flashings and drainage.</p>

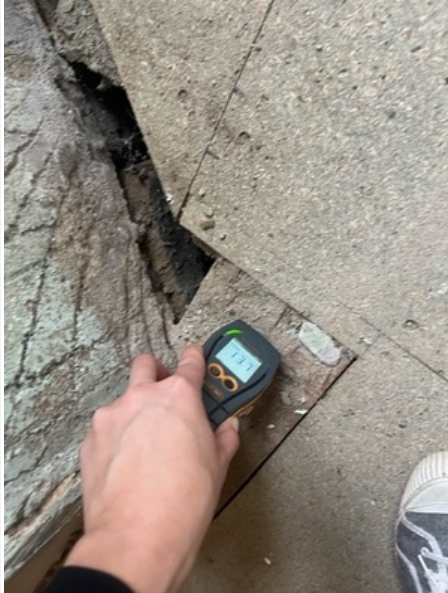
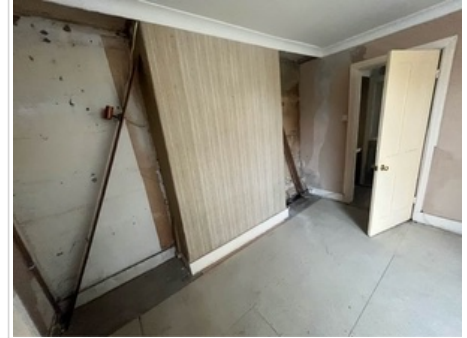
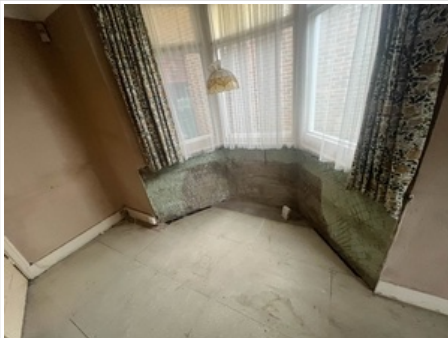
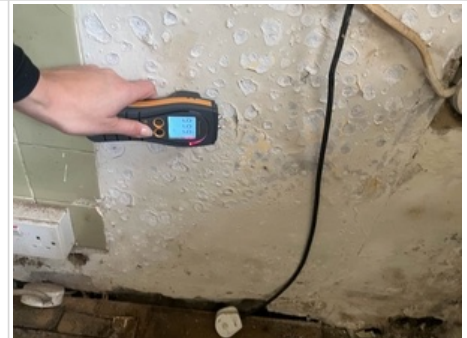
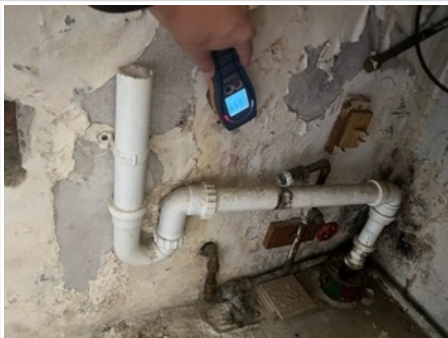
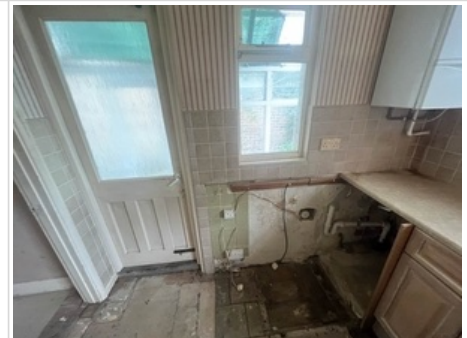
Suspected Plumbing Leak

Further Leak Detection Recommended	Plumbing leaks beneath floors from heating systems, hot and cold-water services, or drainage runs can cause hidden underfloor dampness, timber decay, and contribute to elevated damp levels.

Trace and Access/ Leak Detection	Engage a professional leak detection service to identify and rectify any present plumbing leaks. Initiate an insurance claim under "Trace & Access" and "Escape of Water" coverage on the Buildings Insurance.
Water damage drying and remediation	<p>Once leak has been fixed, appoint a water damage specialist to carry out strip-out, professional drying and reinstatement works. You are advise to carry those tests in the neighbouring property to ensure no defects originate from beyond the party wall. Professional drying regime using industrial dehumidifiers following IICRC S500 guidelines.</p> <p>Damp timber elements to be treated with a fungicidal treatment.</p> <p>Drying duration estimated at 3-4 weeks, monitored by moisture mapping.</p> <p>Once the readings have reached equilibrium, the reinstalments can begin.</p>
