DAMP SURVEY REPORT

Survey Date and Time	01/01/2025
Occupied/ Unoccupied	Occupied
Surveyor Name	Bianca Hedesiu BSc(Hons) CSTDB WRT ASD

The property survey is a	Detached
Assumed to have been constructed in the	Interwar Period (1918–1939)
Assumed floor construction comprising of	A combination of original timber suspended floors and solid concrete floors
Assumed wall construction comprising of	9-inch solid walls
Construction Type Note	Rear extension added

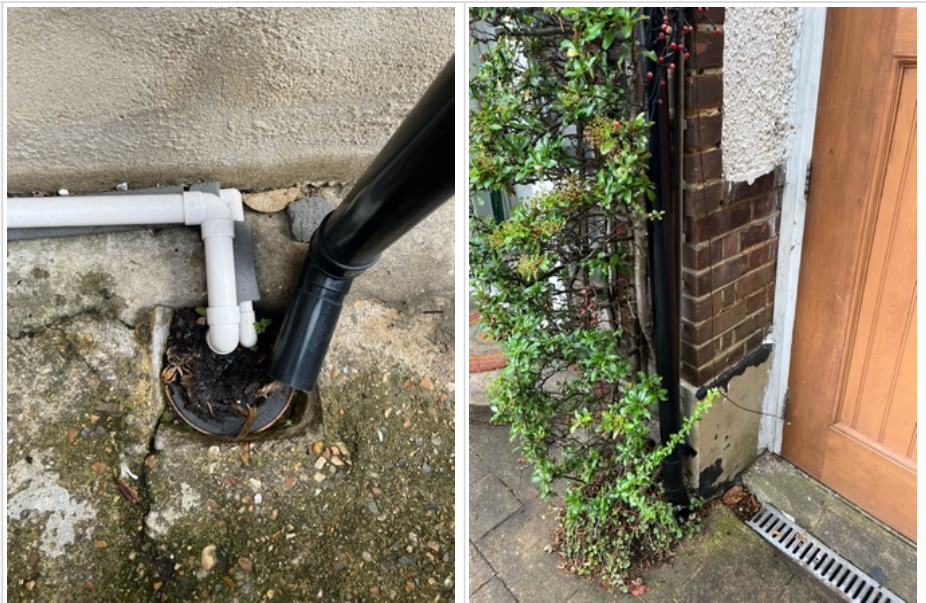
Penetrating Damp	Penetrating damp is a type of damp that occurs when water infiltrates a building horizontally from the outside, typically through walls, roofs, or windows. Unlike rising damp, which comes from the ground, penetrating damp is caused by external water sources, such as rain entering the structure through defects or porous materials.
Defects Identified Relating To Penetrating Damp	Rainwater Goods, Chimney Stacks, Render/ Coverings, Parapet Wall
Rainwater Goods Defects Noted	<p>The front downpipe to the right-hand side of the of the front door is discharging at the base of the walls and not toward the nearby gully, which is fully obstructed by debris.</p> <p>This is thought to be allowing for water to pool in the area and saturate the bottom of the wall, allowing for damp at low levels of the wall and mould growth, which is evidenced in the porch wall, on the other side of the downpipe in question.</p> <p>Another gully was noted to be partly blocked by debris.</p>

Penetrating Damp	Penetrating Damp was found to be present at the property due to the following external defects. Recommendations in more detail:
Rainwater Goods:	<ul style="list-style-type: none"> -The downpipe at the front to be extended into the nearby gully. Clear all gullies from debris or obstructions. -Conduct a water test during heavy rainfall or simulated with a hose. Identify and repair all leaking joints, ensuring brackets are sound and joints are watertight. -Clear moss, vegetation, or other debris from the gutters regularly.

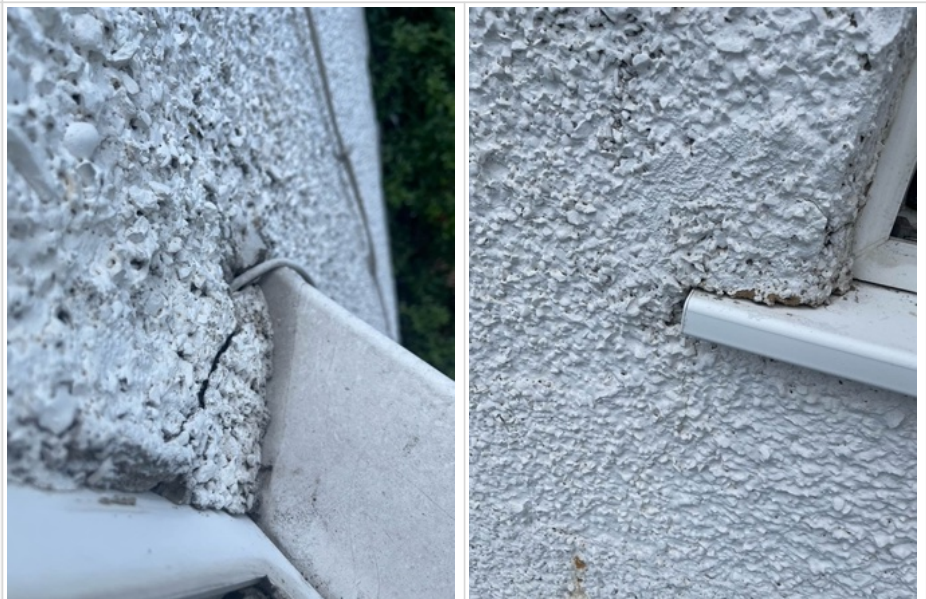
<p>Render/ Coverings Defects Noted</p>	<p>Pebble dash render was cracked in multiple places. Pebble dash renders tend to be cement-based renders, which act as moisture entry points when they become cracked or damaged.</p> <p>Those cementitious type renders are unsuitable for a solid wall construction, as they can trap moisture, preventing natural evaporation and contributing to internal damp via capillary absorption and wind-driven rain.</p> <p>The type of masonry paint usually used to paint those renders also tend to be non-breathable, which is exacerbating the issue.</p> <p>Localised damp spots were noted on the inside of the rear elevation in the top bedroom and bathroom and on the inside of the right-hand side elevation corresponding to the affected area in the front RHS bedroom.</p>
<p>Annotated Pictures</p>

Render Coverings:	<p>In the short term, repairs to the render can be undertaken by opening cracks to a sound substrate and repaired with a weather-resistant filler or mastic. Another option is using cement or mortar.</p> <p>For a long-term solution, consider replacing the render with a more flexible and modern render type, such as:</p> <ul style="list-style-type: none"> -Silicone-based render: Highly flexible, breathable, and water-resistant. -Monocouche render: A single-coat, breathable option with good flexibility. -Acrylic render: Durable, flexible, and resistant to cracking. These options will provide better protection against wind-driven rain and thermal movement.
Chimney	Flaunching & Brickwork, Old Chimneys & Hygroscopic Salt Contamination
Chimney: Flaunching & Brickwork	<p>Front Stack</p> <p>Apply a BBA-approved deep-penetrating water repellent such as Stormdry masonry cream to protect external masonry while allowing breathability.</p> <p>New flaunching to seal the area between the chimney pot.</p> <p>When up close, the roofer on site should look for any further defects which could be contributing to the damp.</p> <p>*Removal of the stack is also another option for future proofing the property, if fireplaces are no longer in use.</p>

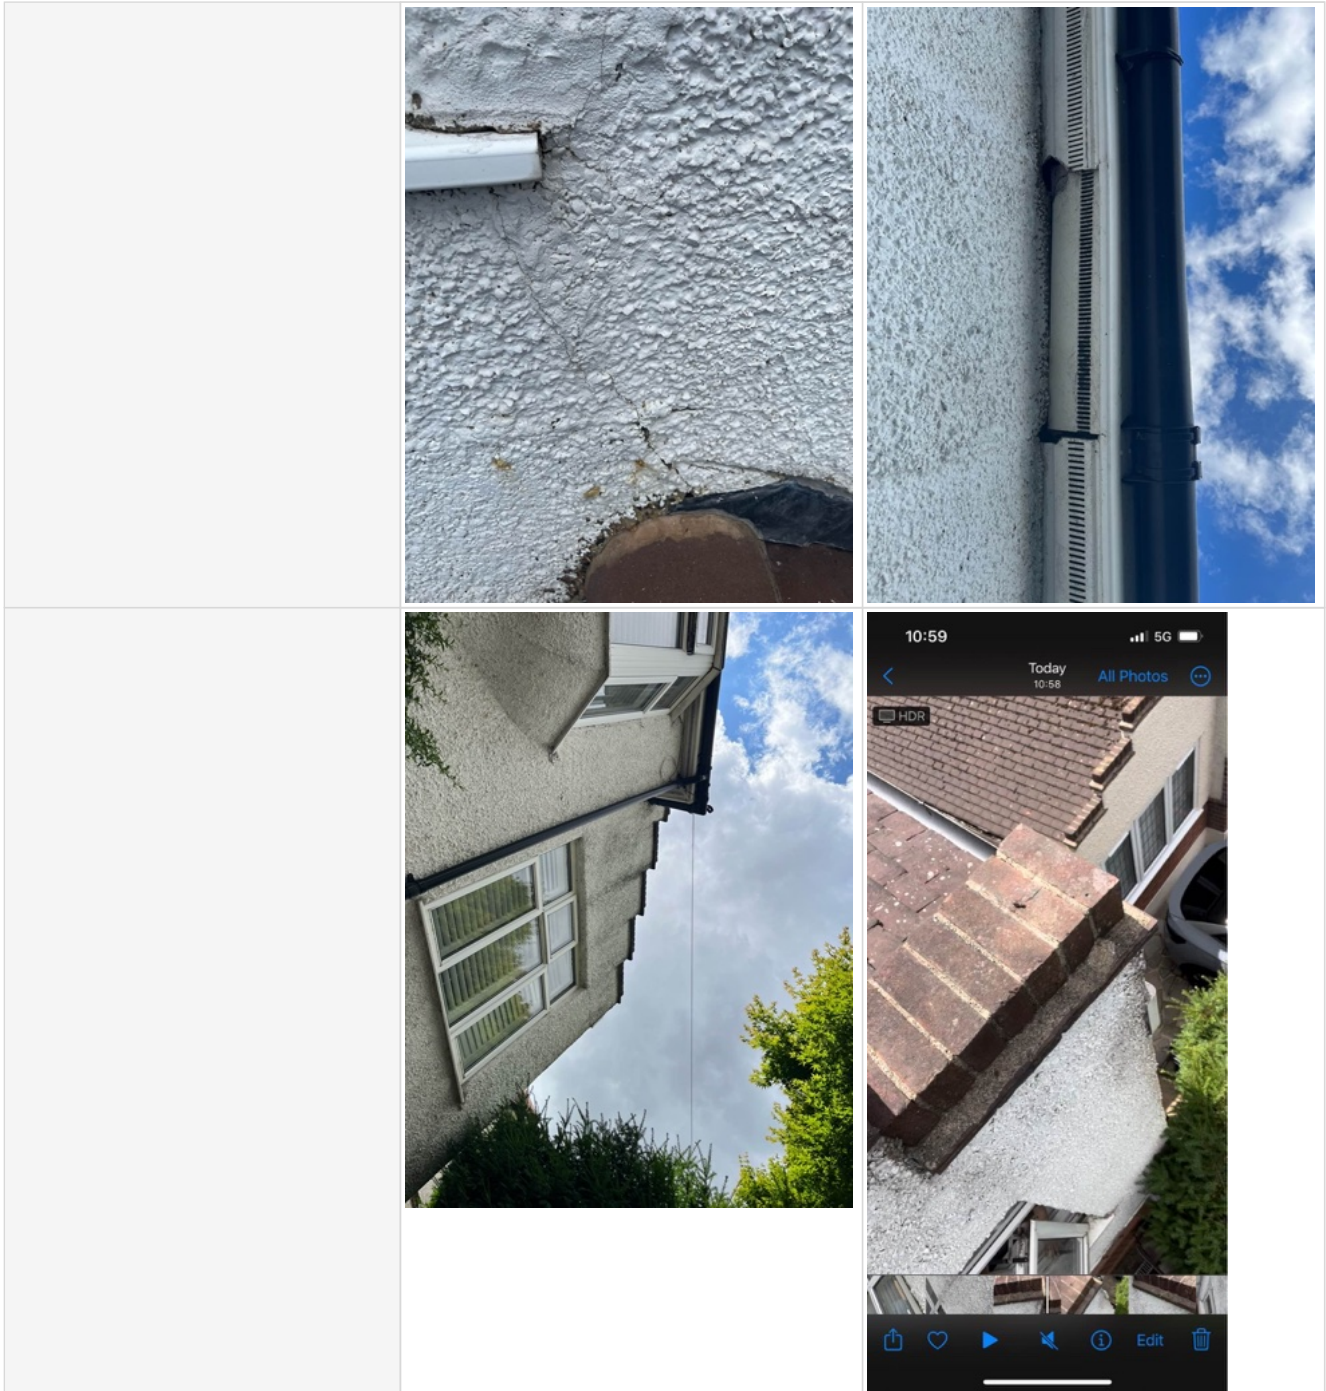
Parapet Wall Defects:

Defects were noted with the front parapet wall, which is showing red soft bricks at the very top of the wall, and water marks on the render below. No coping stones are present at the top to direct the water away from the external wall which is likely causing the penetrating damp in the bedroom below.

Parapet Wall:	<p>Coping Stones:</p> <p>Front stepped parapet wall to have twice weathered coping stones added and incorporate drip groove to help direct the water away from the parapet wall.</p>
Natural Drying Note	<p>Most of the affected walls, apart from the chimney breasts are likely to dry out naturally, however this will take several months of Spring/Summer weather (Masonry drying time is usually 25mm/month). If any salts or other contaminants appear then these must be neutralised before re-decoration. Any damp stains should be neutralised with a stain block such as Zinsser before redecoration. You can consider speeding up the drying the process of natural drying by the installation of dehumidifiers and air movers.</p>

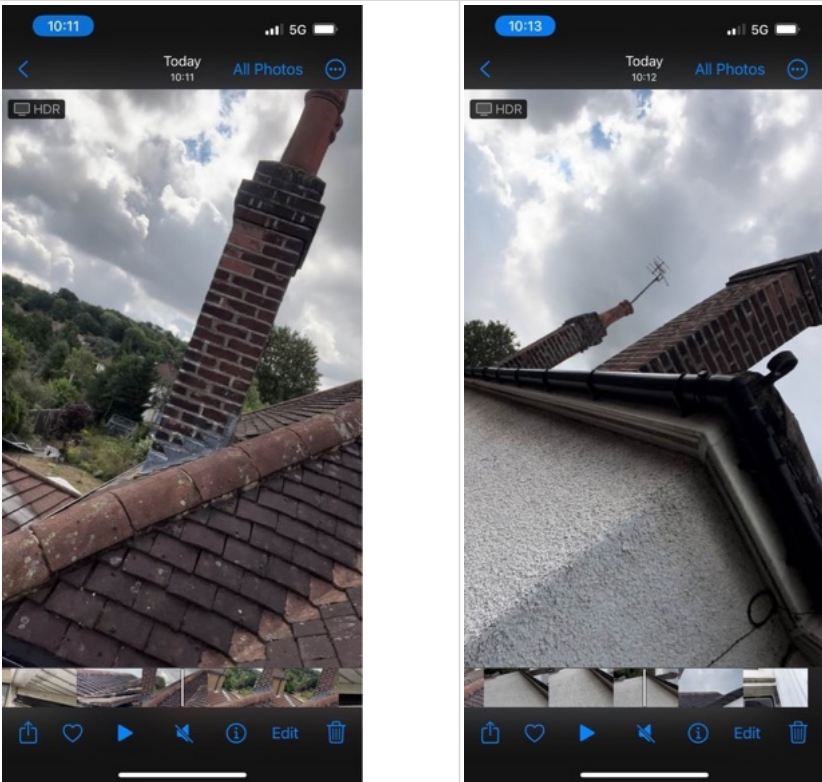
<p>Chimney Stacks Defects Noted</p>	<p>Flaunching & Brickwork defects, Old Chimney Breast & Hygroscopic Salt Contamination</p>
<p>Flaunching & Porous Bricks</p>	<p>Red soft bricks are present which are quite porous. Bricks become more porous overtime making them more susceptible to moisture retention.</p> <p>We've been able to observe some moss growing from the top of the flaunching on the front left-hand side stack, which could be concealing further cracking and defects to the flaunching, which is a concrete fillet holding the chimney pots together.</p> <p>Those defects could allow for moisture to get inside the flue and affect the chimney breast below and this is evidenced by the damp found in the front left hand side bedroom on the chimney breast and adjacent walls/ ceiling.</p>
<p>Annotated Pictures</p>

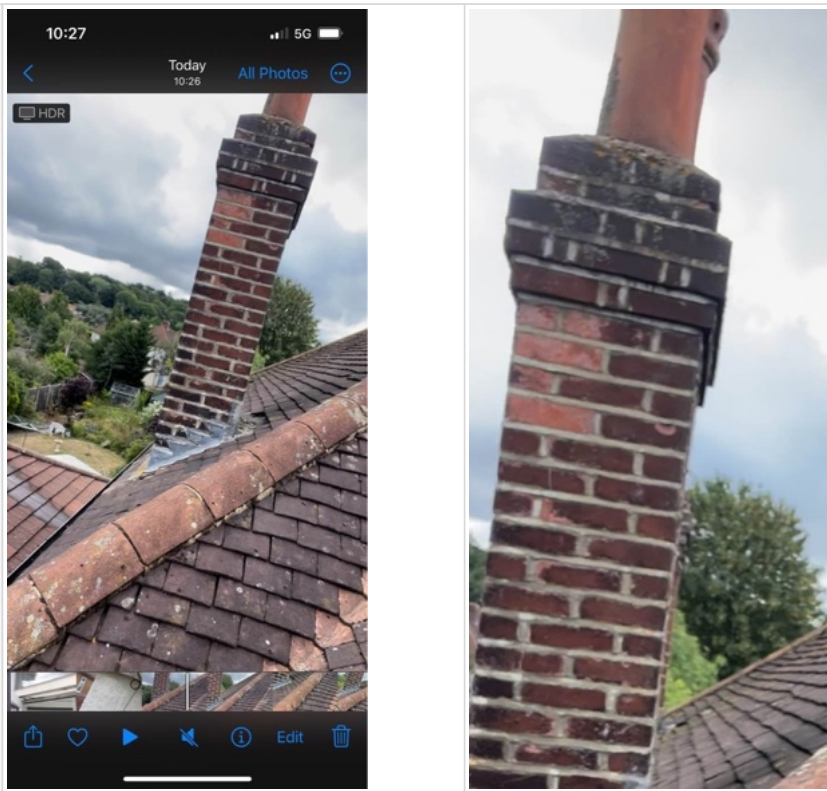
<p>Old Chimney Breast & Hygroscopic Salt Contamination</p>	<p>Note: Hygroscopic Salt Contamination to Chimney Breasts: Chimney breasts can absorb moisture from the air and release hygroscopic salts. These salts remain in the masonry and plaster and absorb moisture from the air, leading to damp patches and staining around the chimney breast even when there is no active water penetration. Moisture can linger in the chimney structure due to the presence of these salts, leading to persistent damp issues.</p>

Hygroscopic Salt Contamination of the Chimney Stack/ Breast	<p>In the loft space, the debris around the chimney stack, above the affected bedroom ceiling to be cleared, as this could be hygroscopic and causing the ceiling wet patch.</p> <p>Where plaster/ decorations has deteriorated damp proofing specialist providing the necessary guarantees should be instructed to carry out the following works:</p> <ul style="list-style-type: none"> -Hack off the plaster back to chimney stack brickwork on the affected rear bedroom walls corner to corner around the chimney breast (whole length and height) and take down ceiling plasterboard to allow membrane to be inserted all the way up the wall. -Apply a vertical damp proof membrane as per the manufacturer's guidelines (such as Newton 503) to the affected interior walls. -Fix back plasterboard to the walls with no screws into the new membrane on the wall. <p>The rear elevation where the old stack and breast was removed should also be treated as effloresce was noted in the area, which signifies their presence.</p>

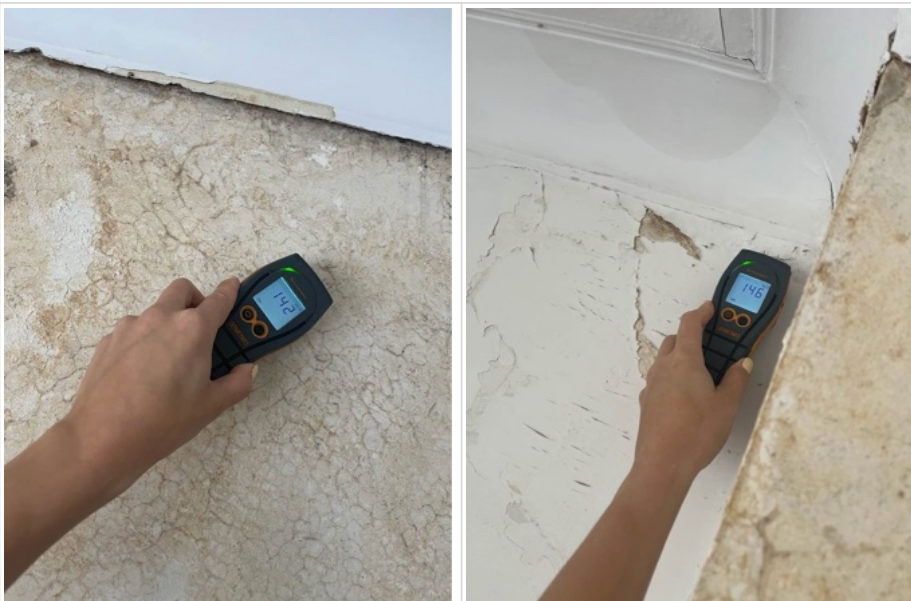
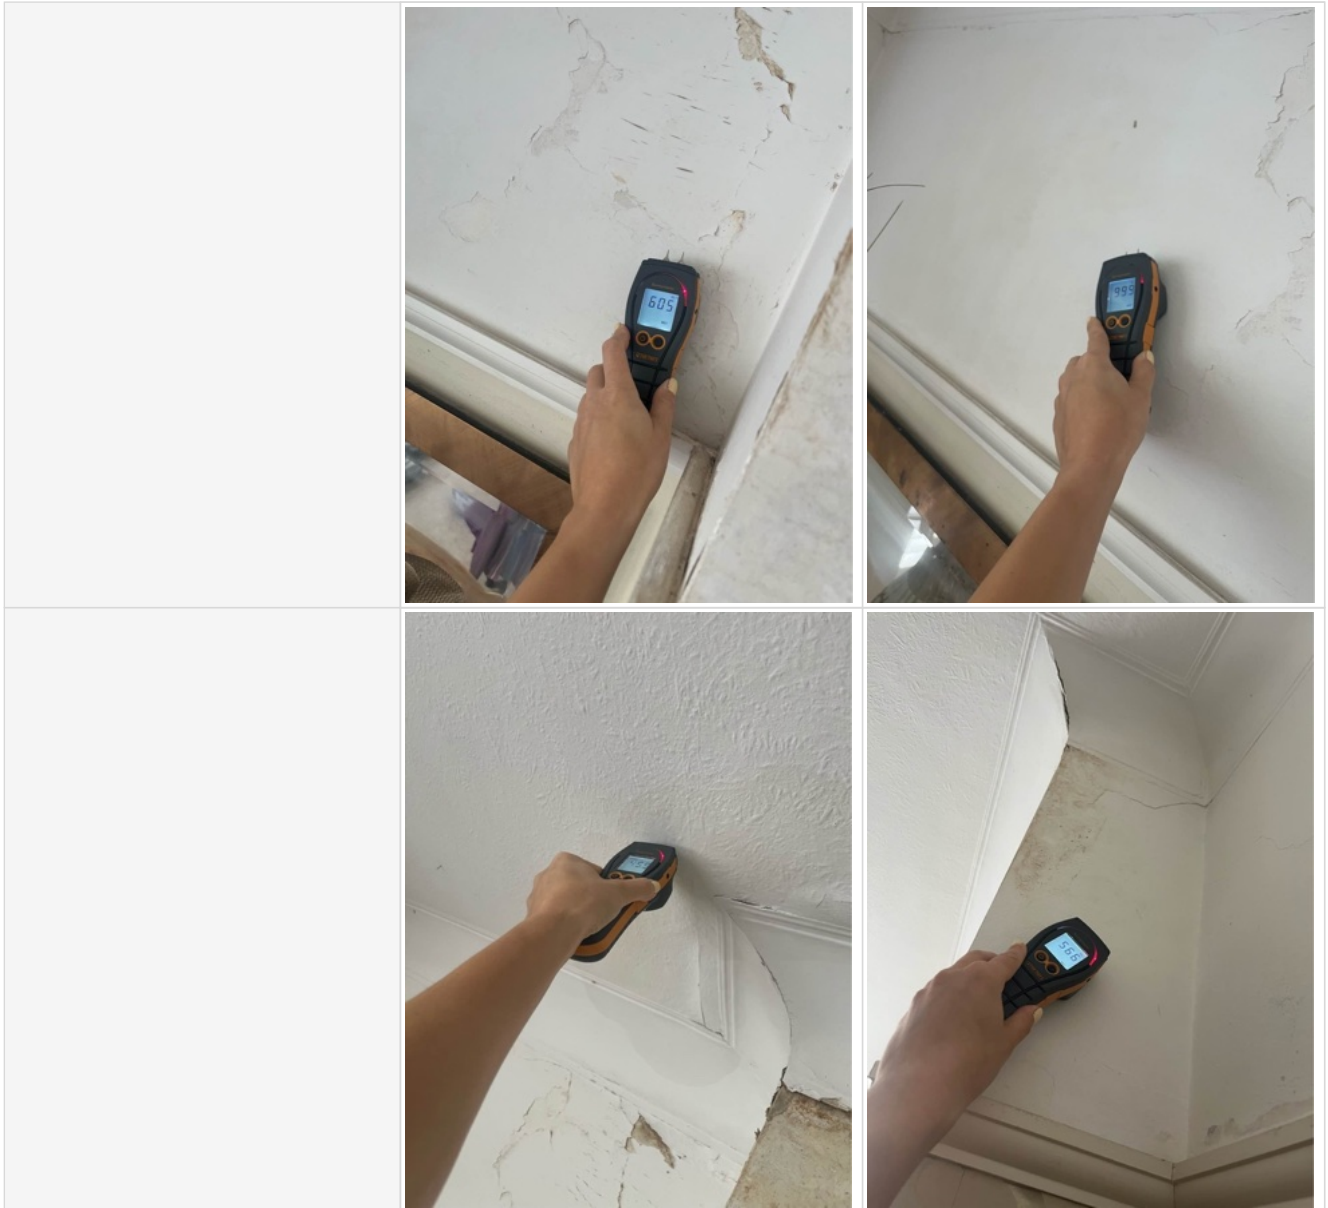
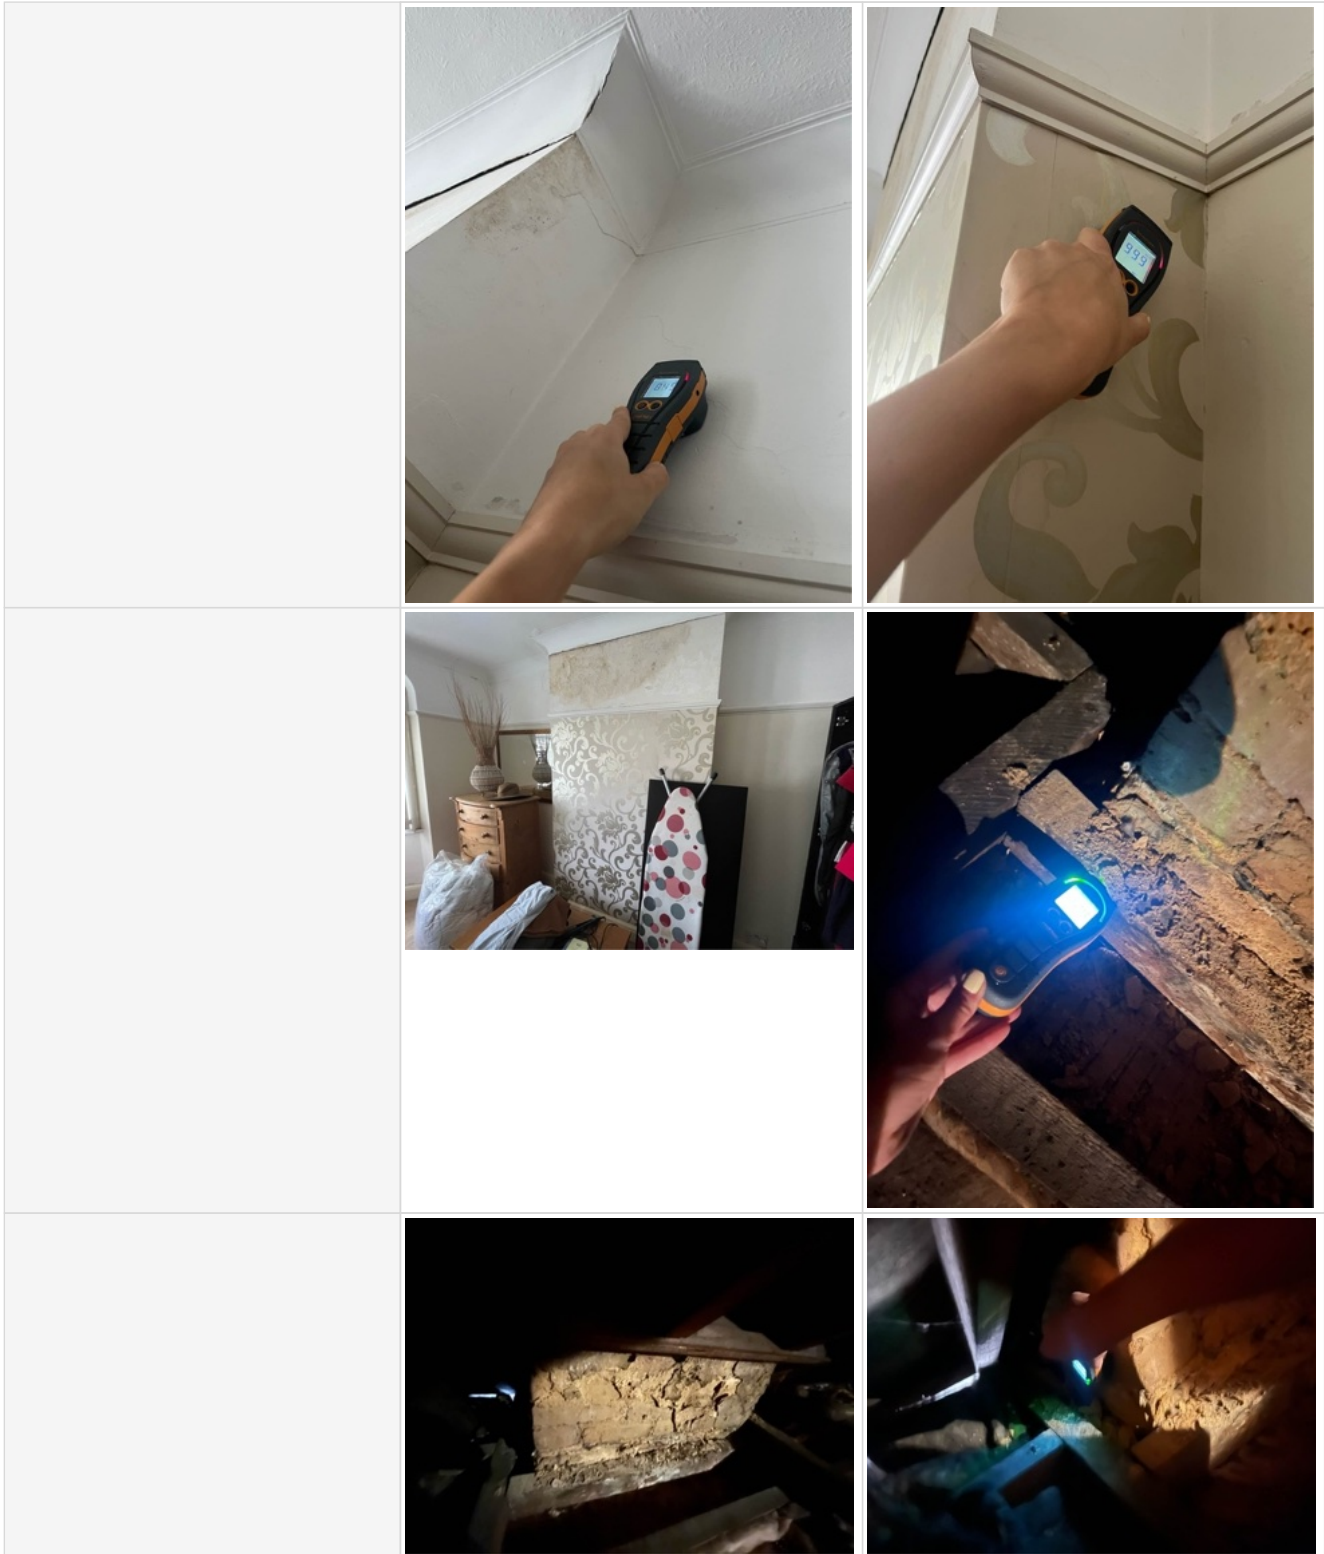
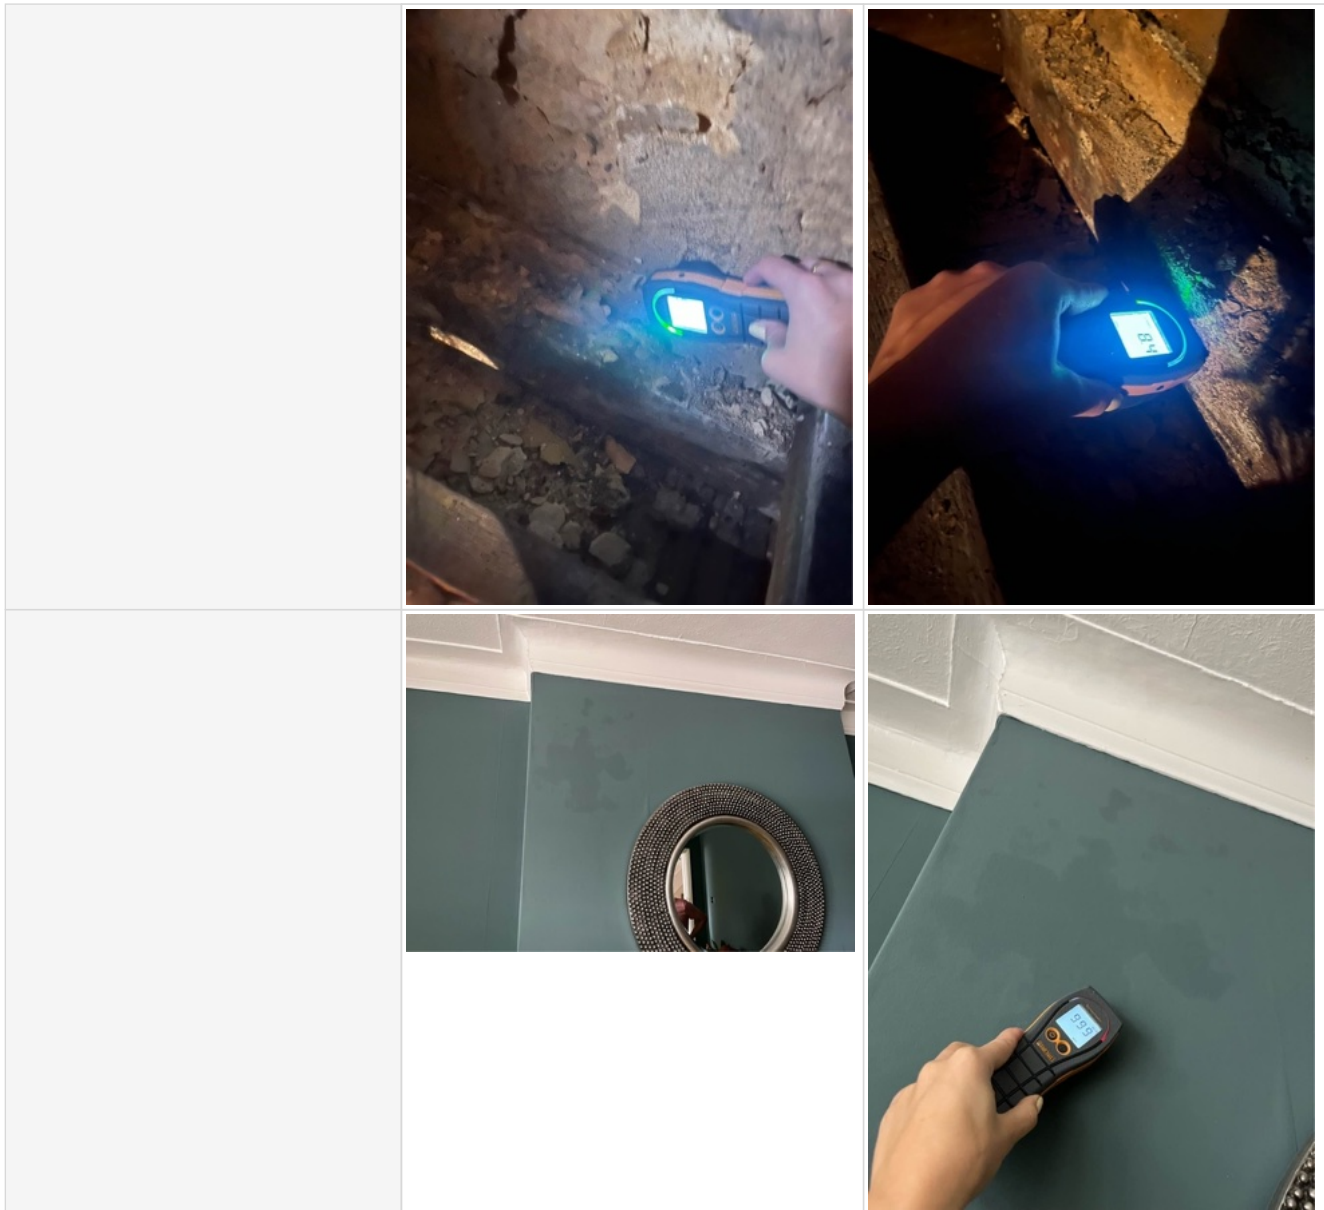
Number	1
Room(s)/ Area Affected	Front left-hand side bedroom and Living Room below
Signs Of Water Damage Observed	Water Marks, Water Stains
Specifically:	Front LHS bedroom: on the chimney breast at the top and adjacent ceiling and wall areas, to the corners of the bay window sill & Living Room: chimney breast only
Moisture Meter Readings	200RS-999RS
Corresponding External Defects	<p>Front LHS bedroom:</p> <p>Suspected issues with the flaunching and porous bricks and possible historical gutter overflow issues likely affecting the chimney breast and adjacent wall/ ceiling areas.</p> <p>Render defects affected either side of the bay below the window sill.</p>
Corresponding Internal Defects	<p>Both chimney breasts which are one on positioned on top of the other are thought to be suffering from hygroscopic salt contamination due to the old soot. We note that the chimneys are no longer in use.</p> <p>Hygroscopic salt contamination is know to manifest on chimney breasts as persistent wet patches, due to those salts/ contaminants which attract moisture from the ambient.</p> <p>Lack of adequate airflow inside the flue leading condensation.</p> <p>We note that the opening for the vents on both chimney breast is not large enough and is this is likely limiting the airflow inside the flue.</p>

Additional Notes	<p>The chimney stack was also checked in the loft and this was found to be primarily dry. We know that works have been attempted in the past couple of years part of which might've helped the moisture ingress however we've also had good weather which could've allowed for some of the damage to have dried out.</p> <p>Debris was visible around the chimney stack in the loft just above the affected ceiling area below. This debris should be cleared to clear the area of any contaminated debris.</p>
Annotated Pictures

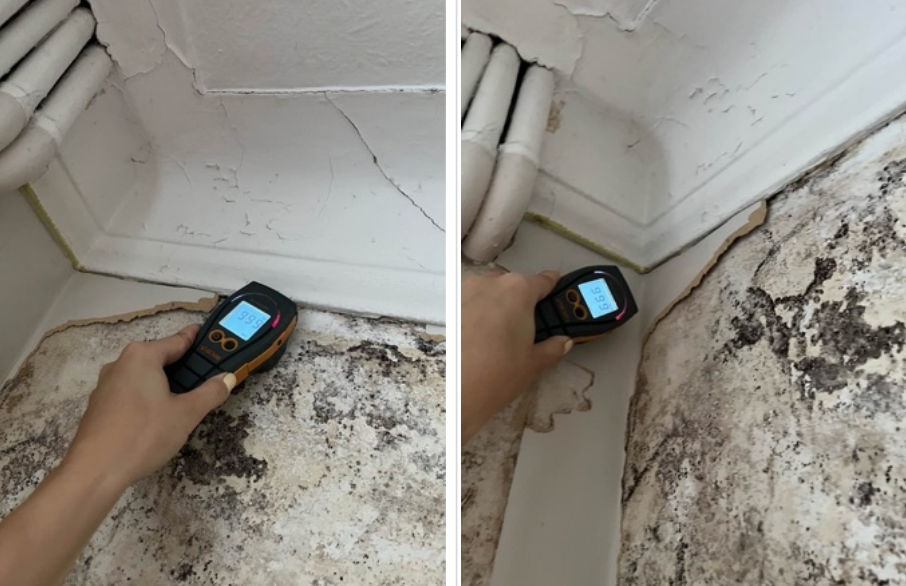
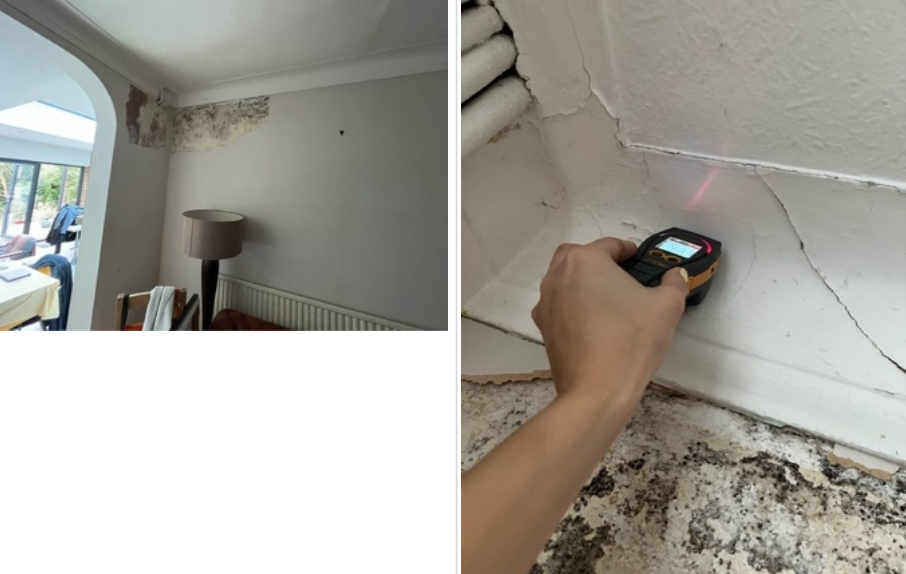
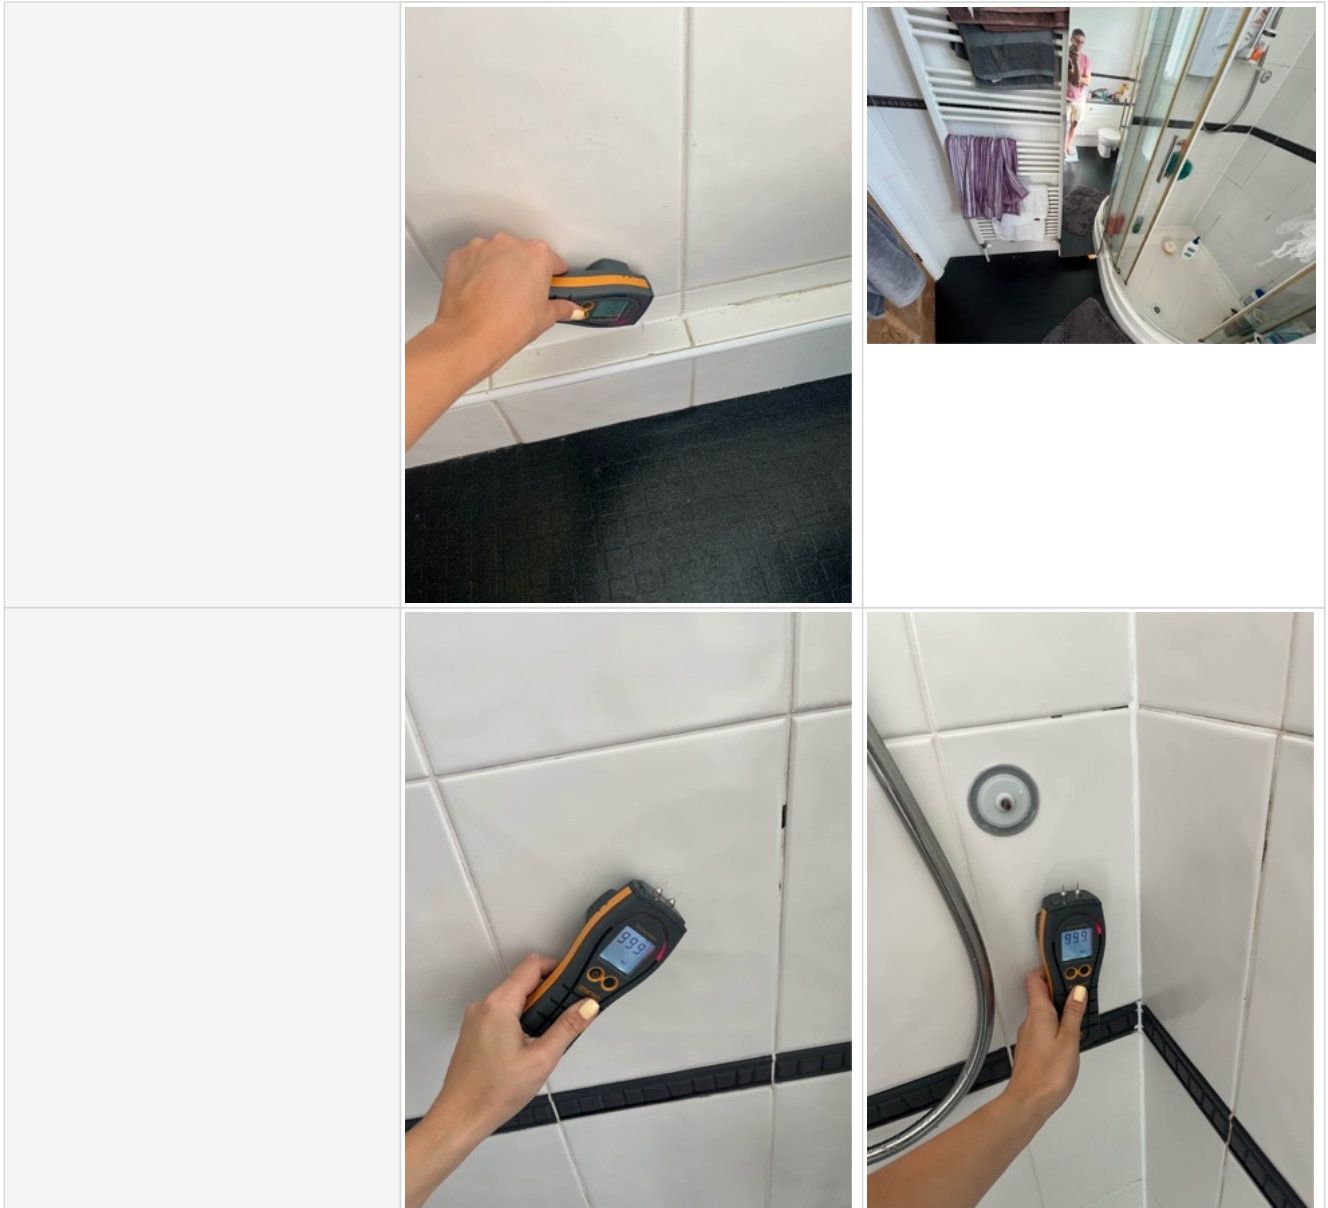
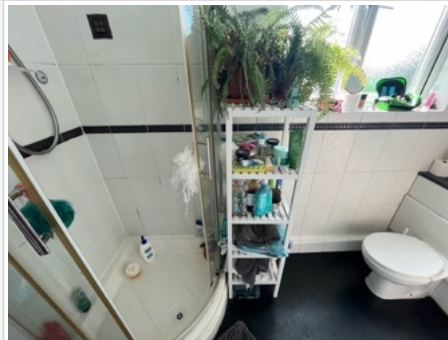
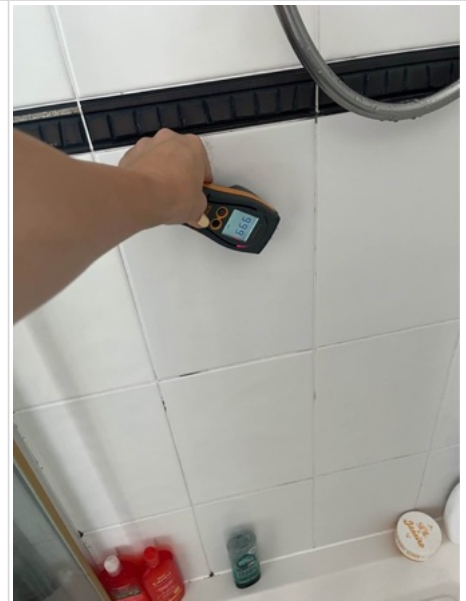
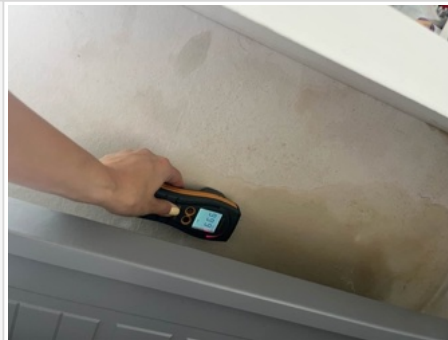
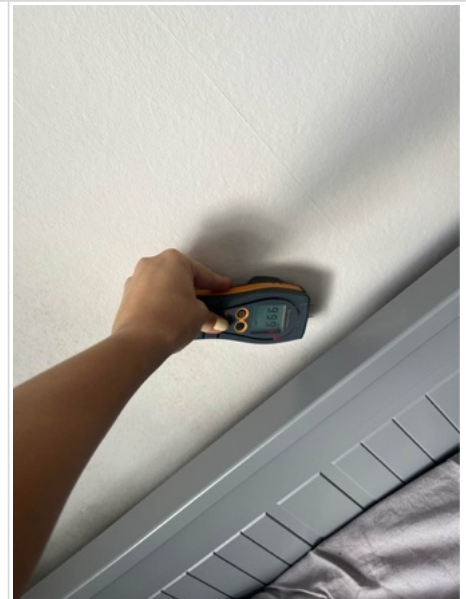
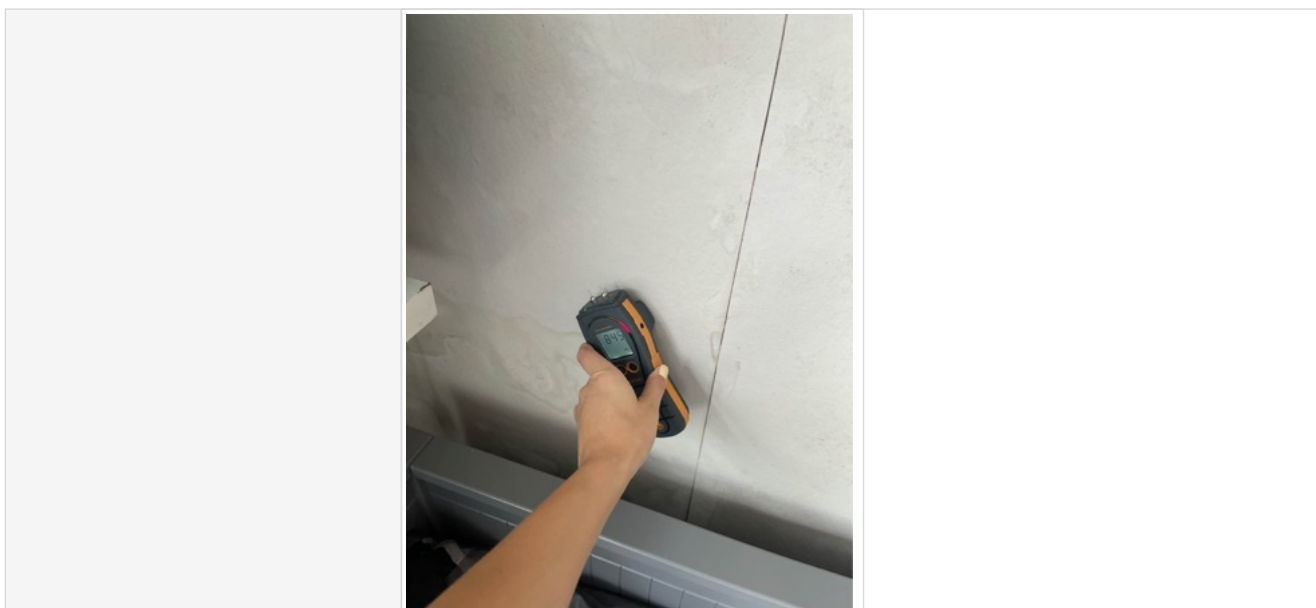
Number	2
Room(s)/ Area Affected	Rear left-hand side bedroom, Bathroom & Study below
Signs Of Water Damage Observed	Water Stains, Mould Growth, Blown Plaster
Specifically:	On the inside of the rear elevation and diving wall between the rear bedroom and bathroom stretching the shower enclosure only, primarily at low levels of the wall, and wall area below in the study
Moisture Meter Readings	200RS-999RS
Corresponding External Defects	Localised issues with the pebble dash render, however, this is not thought to be the main culprit for the damp, on the inside of the rear elevation on the top floor.

Corresponding Internal Defects	<p>Grouting defects on the wall tiles</p> <p>The grouting between the wall tiles in the shower enclosure has perished in multiple places and is likely allowing for moisture to get behind the tiles during showering and get trapped behind them, in time pushing the moisture into the adjacent bedroom walls and study walls below.</p> <p>Loose shower seals could also be contributing to the damp.</p> <p>Chimney stack above this area was removed, which could mean hygroscopic slat contamination due to the old soot is a possible contributory factor to the damp recorded on parts of the old stack in both the bathroom and bedroom.</p>
Additional Notes	<p>Study below is showing extensive mould growth and damp coming from top down.</p>
Annotated Pictures

Other Recommendations:	<p>Bathroom & Adjacent Bedroom</p> <p>We understand the client has plans to redo the bathroom upstairs fully at some point in the near future which will solve the underlying issues.</p> <p>Depending on when that is planned for, the grouting in the tiles could be temporarily repaired along with the seals around the shower tray.</p> <p>Alternatively, at the time of the bathroom works, we would advise a couple of weeks of drying of the wall structure before retiling.</p> <p>Study & Porch</p> <p>Mould can be washed off with soapy water and wall lining paper in the Study repaired post drying.</p>
-------------------------------	--

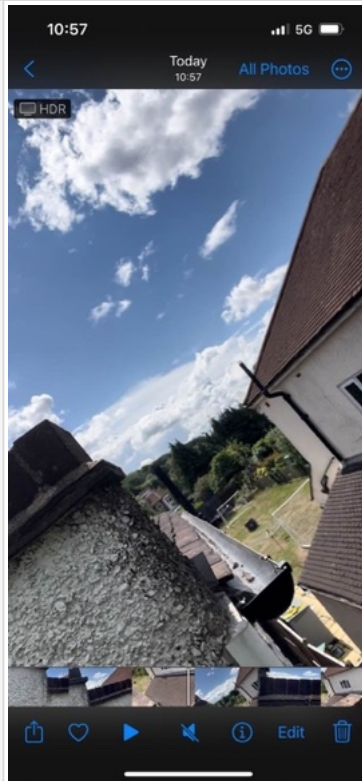
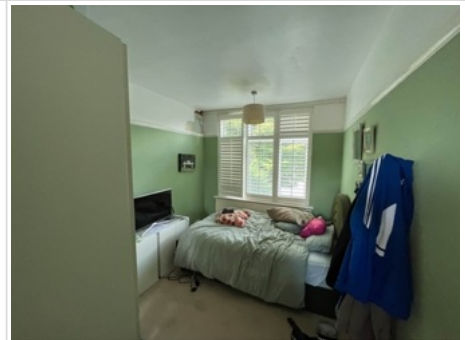
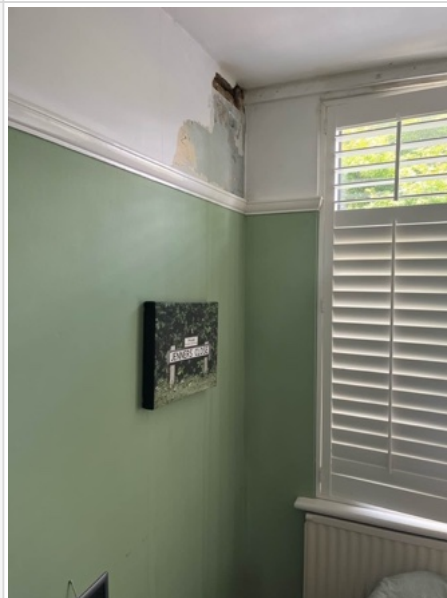
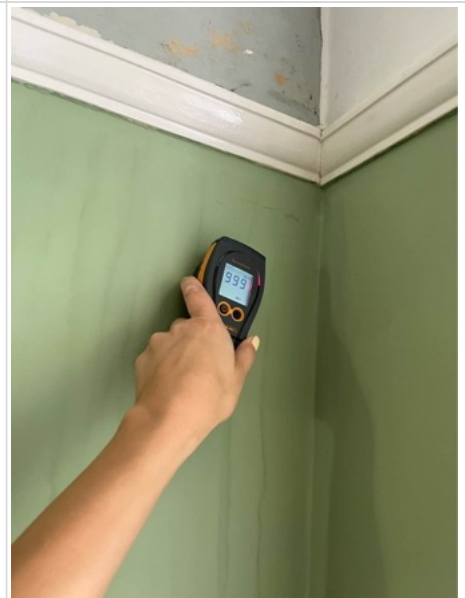
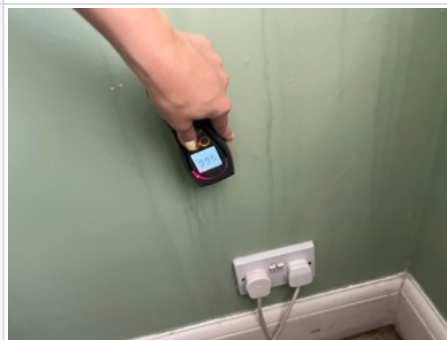
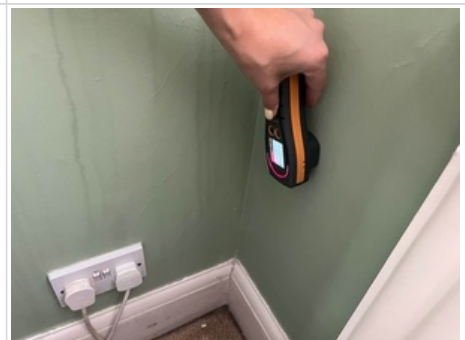
Number	3
Room(s)/ Area Affected	Front right-hand side bedroom
Signs Of Water Damage Observed	Water Stains, Mould Growth
Specifically:	Front right-hand side corner of the room (coming from top down)
Moisture Meter Readings	200RS-999RS
Corresponding External Defects	<p>Porous bricks and lack of coping stones on parapet wall are allowing for rainwater to run down the parapet wall and affect the front right-hand side corner of the wall.</p> <p>Cracking of the pebble dash render can be noted externally, along with watermarks on the pebble dash render steaming form the top of the parapet wall.</p>
Corresponding Internal Defects	N/A

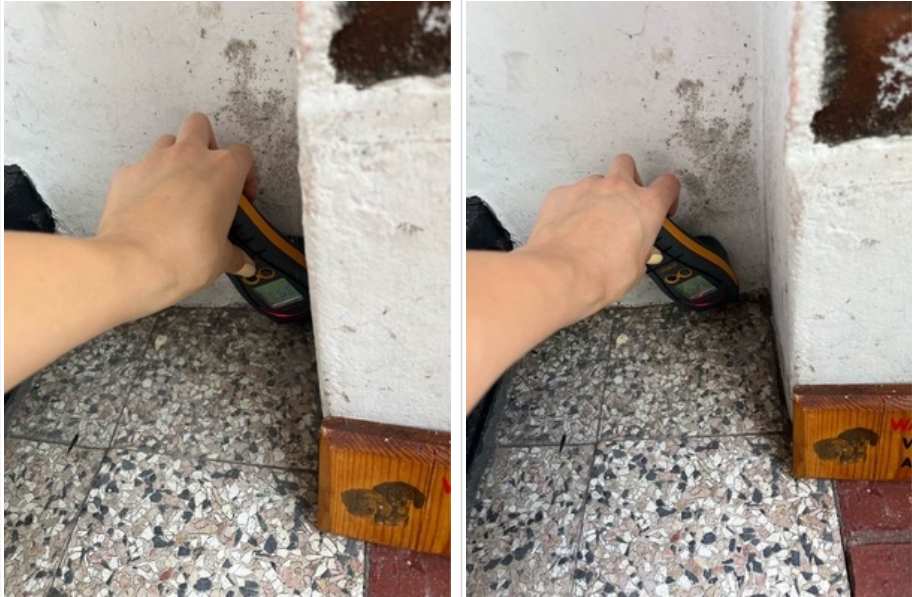
Number	4
Room(s)/ Area Affected	Porch
Signs Of Water Damage Observed	Mould Growth
Specifically:	On the level at low levels, to the right-hand side of the front door in a small localised area
Moisture Meter Readings	200RS-999RS
Corresponding External Defects	Downpipe discharging inadequately at the base of the wall, while the gully nearby is blocked by debris
Corresponding Internal Defects	Colder wall areas in unheated porch which can make the affected wall more susceptible to condensation and subsequently, mould growth.
Annotated Pictures
