DAMP & TIMBER SURVEY REPORT

Timber Survey Report

Scope of Survey	Specific Areas Of Concern
Instructions Received Specific Area	We have received instructions from the client to complete a Timber Survey aimed at documenting the presence of timber decay within the subfloor timbers.
Specific Areas Surveyed:	Cloakroom & Dining Room
How?	In Written Form

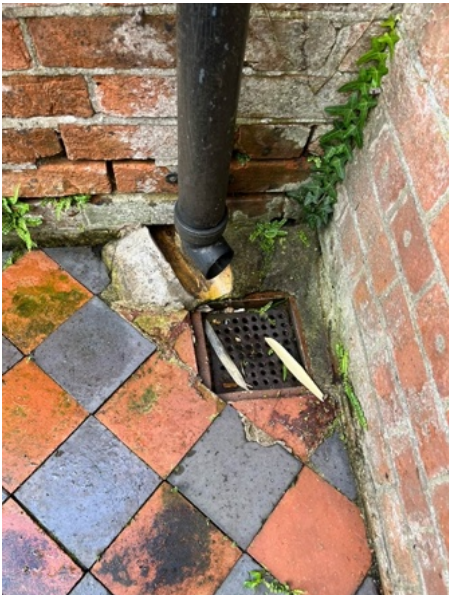
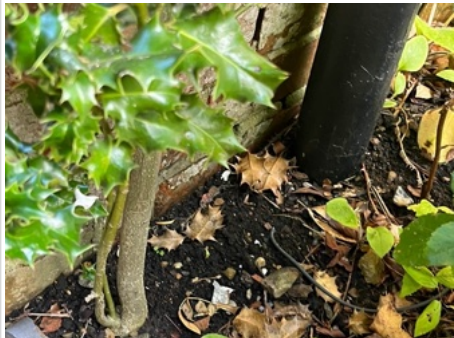
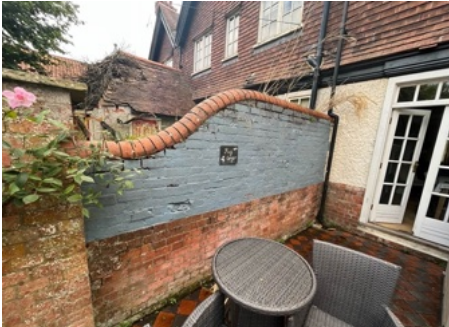
Defects Identified Relating To	Suspected Plumbing or Drains Leak
--------------------------------	-----------------------------------

Further CCTV Survey Recommended	<p>Suspected Faults to The Drainage Systems</p> <p>We suspect issue with the underground drains and gullies should be responsible for the damp in the subfloor underside which has allowed for the Dry Rot outbreak which we have identified in both the Dining Room but also in the Cloakroom.</p> <p>A gully is located by the rear patio door and party line and on the other side of the boundary wall between the property and party wall neighbouring the neighbouring property's soil stack was noted to be entering the ground. The gully and soil stack could be related to the dry rot outbreak.</p> <p>Further investigation will be needed to assess the presence of any defects to those elements but also more widely with the drainage around the perimeter of the two properties.</p> <p>Being adjoined though a party wall, the dry rot could have spread into the neighbouring property from the surveyed property or the other way around.</p> <p>Defective internal drainage pipes, such as waste pipes or soil stacks, leaking under floors or within walls, can create localised damp issues and allow for moisture to raise into the subfloor void, later leading to fungal decay and even a Dry Rot outbreak.</p> <p>The client has also confirmed previous blockages to the drains, which may have contributed to elevated moisture levels.</p>

CCTV Drainage Survey	<p>Arrange CCTV drainage surveys to assess the condition of internal drainage runs. Repair or replace defective sections, ensuring all new drainage works comply with Building Regulations Part H.</p> <p>A CCTV drainage survey is strongly recommended to investigate the drainage system of the property and the neighbouring property, particularly the gully and soil stack adjacent to the party wall.</p> <p>Given the history of blockages, defective drainage is likely to be a major contributory factor.</p>
Trace and Access/ Leak Detection	<p>Engage a professional leak detection service to identify and rectify any present plumbing leaks in both properties.</p> <p>Initiate an insurance claim under "Trace & Access" and "Escape of Water" coverage on the Buildings Insurance.</p>

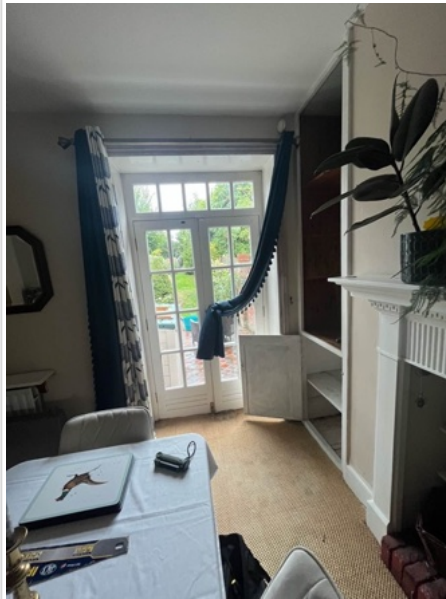
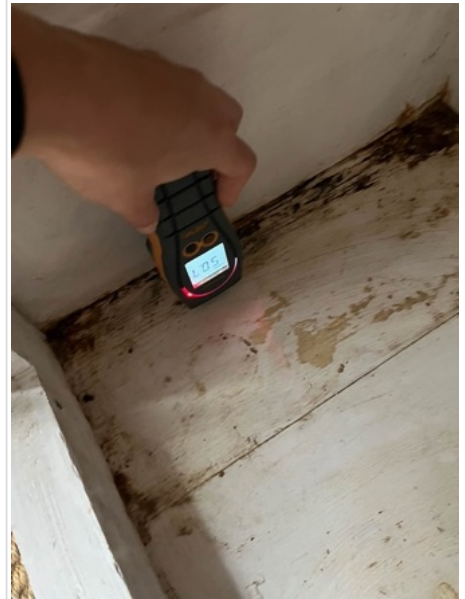
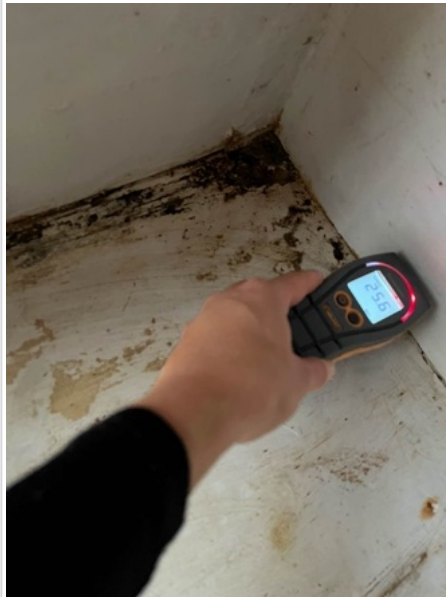
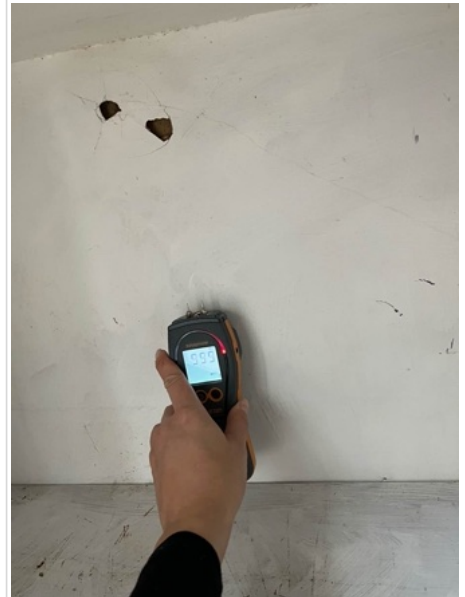
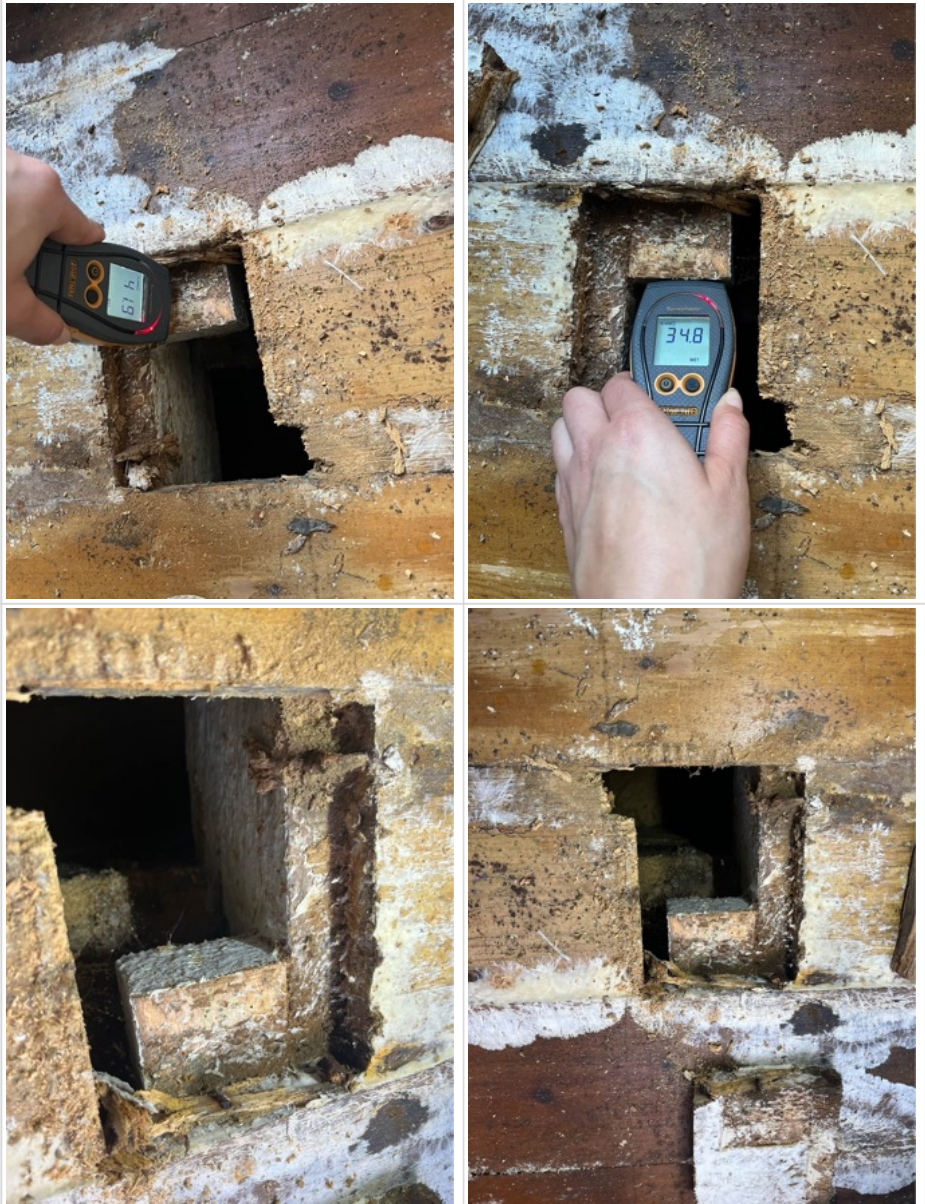
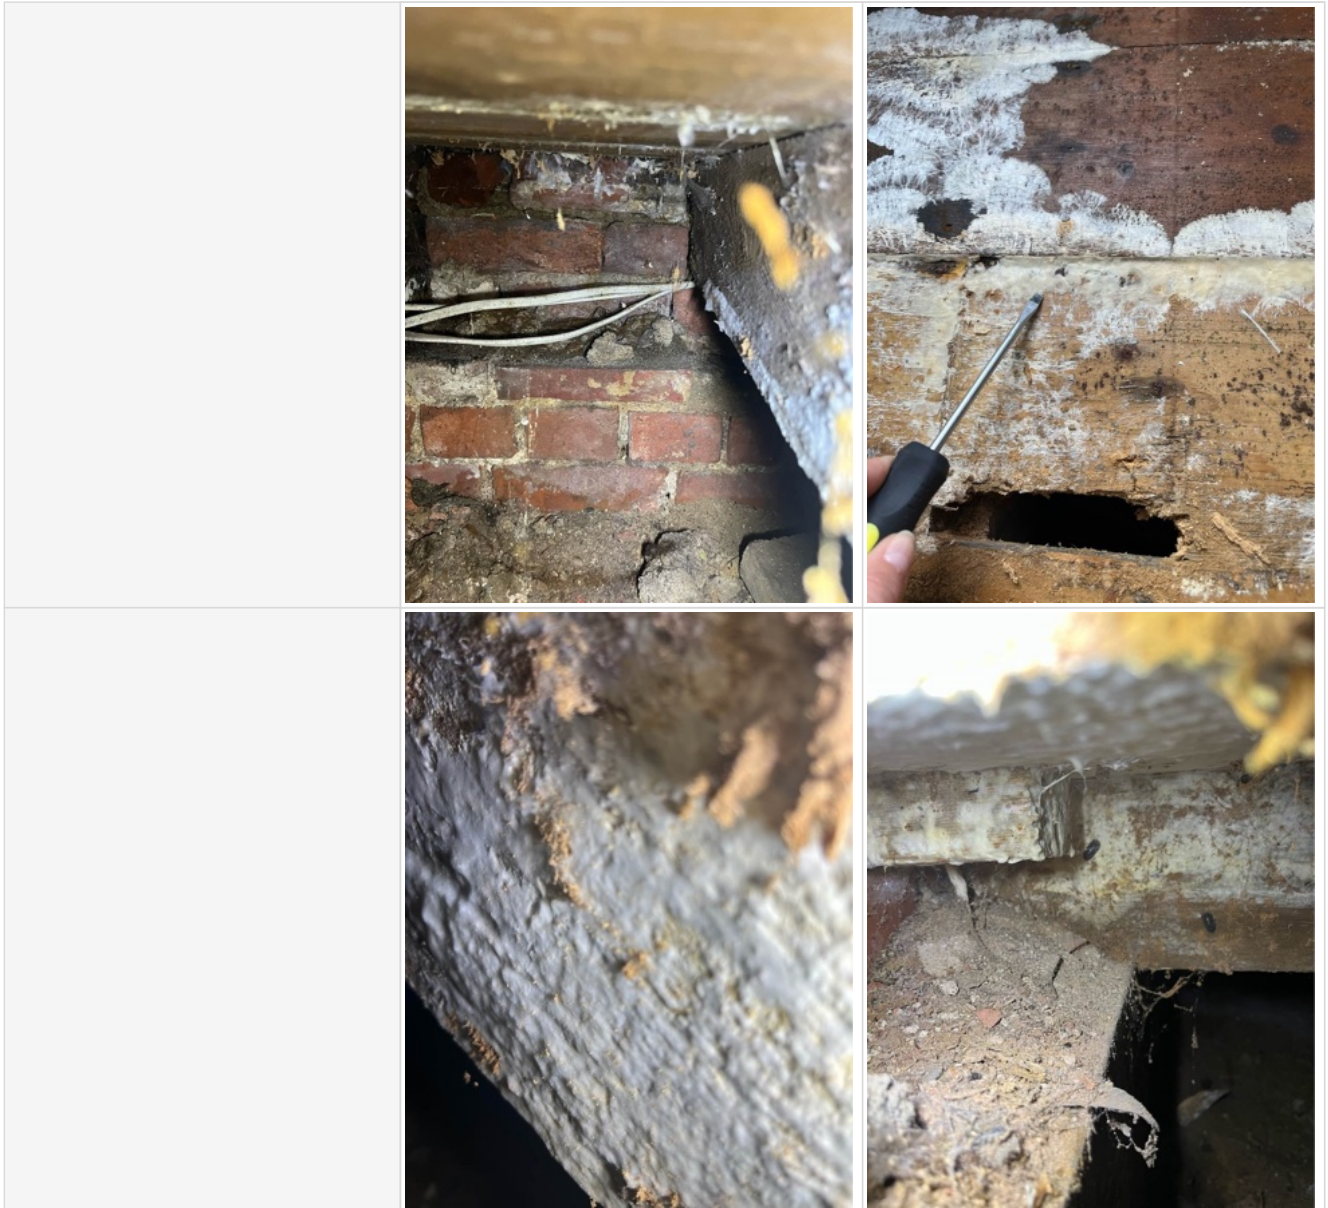
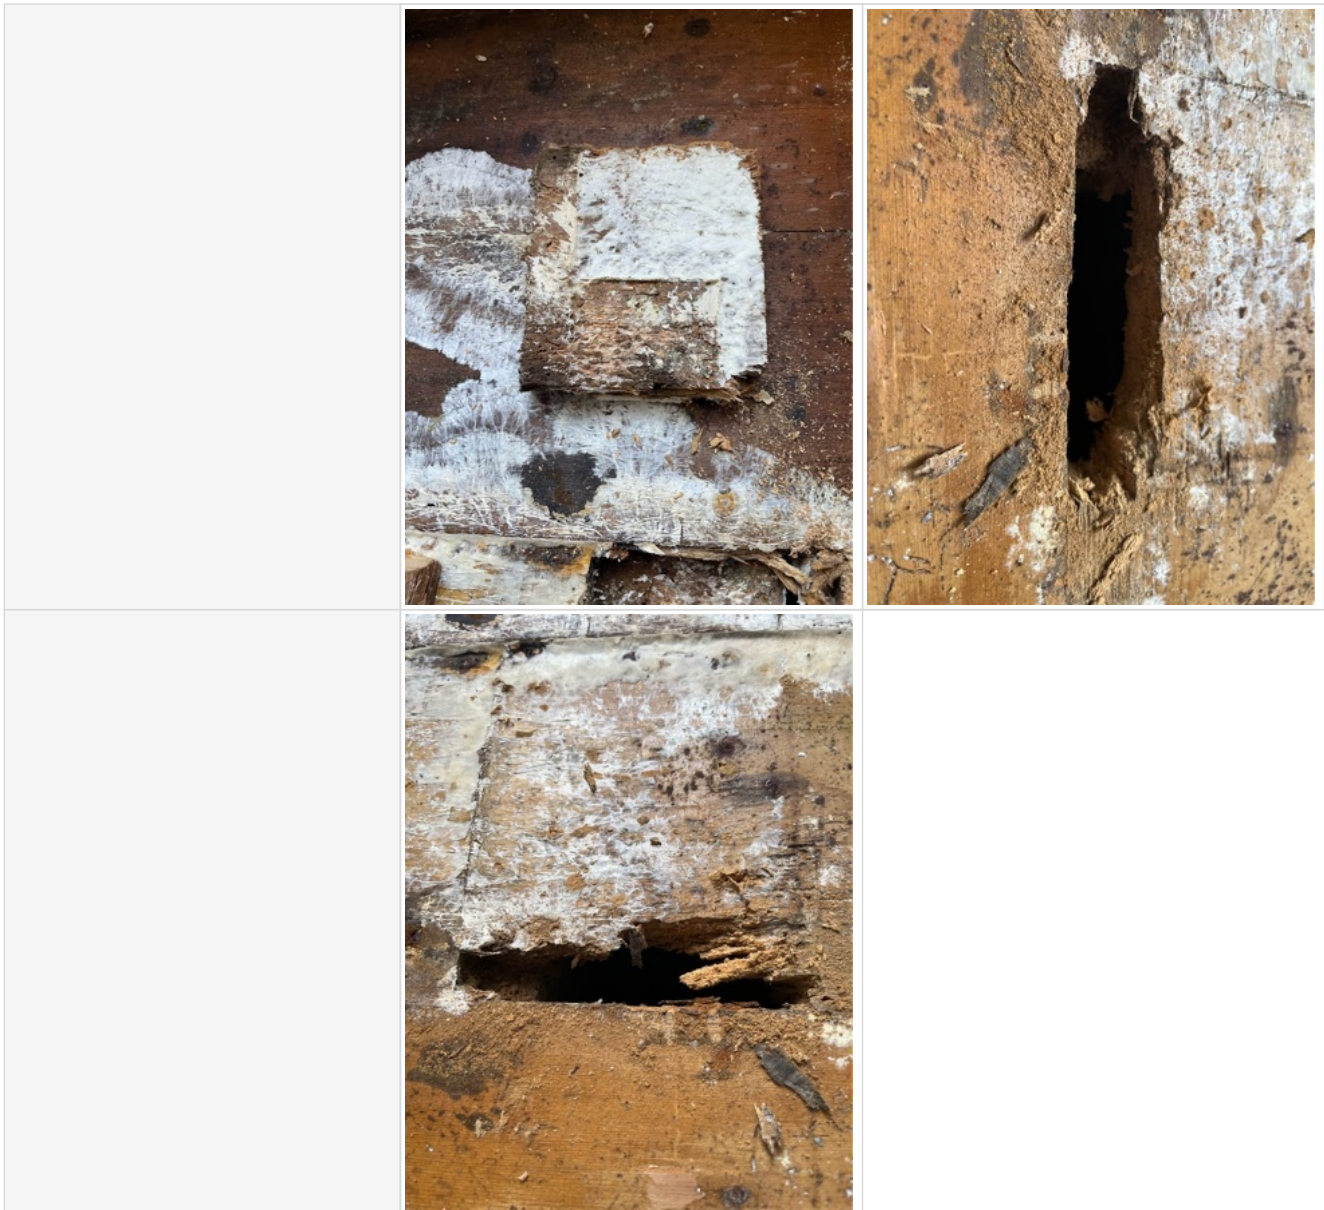
Number	1
Room(s)/ Area Affected	Dining Room
Specifically:	On the floor and party wall section adjoining the rear elevation, at low levels of the walls
Moisture Meter Readings	Walls: 200RS-999RS; Floors: 41% WME (Wood Moisture Equivalent) readings
	<p>Evidence of fungal growth located on the party wall cupboard adjoining the rear elevation had previously been cleaned by the client.</p> <p>Lifting a small section of the carpet adjoining the rear elevation, we were able to observe the signs of fungal decay by dry rot which extended into the subfloor void.</p> <p>Dry rot typical mycelium growth (white, cotton-like growth) was present to the underside of floorboards and associated joists.</p> <p>Decay is consistent with <i>Serpula lacrymans</i> (dry rot fungus). Common Furniture Beetle (<i>Anobium punctatum</i>) attack is also present alongside the dry rot attack. Floorboards and joists exhibited signs of softness and structural weakening, as well as signs of common furniture beetle attack. Readings were very high, up to 41%WME, well above the 20% WME threshold after which the risk of fungal decay/ infestation sets in.</p>

Water damage drying and remediation	<p>Once leak has been fixed, appoint a water damage specialist to carry out strip-out, professional drying and reinstatement works.</p> <p>Dry Rot & Common Furniture Beetle Treatment: Once the source of the leak has been found a full strip-out of the floor finished on the ground floor should be carried out as dry rot can spread in relatively dry condition and in places where signs of growth inside the ground floor rooms might not be readily visible.</p> <p>The strip-out should also be carried out to the neighbouring party wall property as failure to treat the whole outbreak adequately could lead to recurrence.</p> <p>Remedial works are required to remove affected and structurally compromised timbers up to 300-400mm from the last signs of fungal attack.</p> <p>Thereafter, replace with pre-treated timber. Any new cut ends to be treated with a 2 brush coat application of fungicidal treatment.</p> <p>All new and old timbers should be installed or reinstalled using wall plates into the masonry or protected by polythene membranes wherever they are in direct contact with masonry.</p> <p>All visible fungal growth and mycelium should be carefully removed and affected masonry and plaster on the wet or affected walls to be stripped back to brickwork.</p> <p>The exposed brickwork to be treated using appropriate biocide treatment.</p> <p>Professional drying regime using industrial dehumidifiers following IICRC S500 guidelines.</p> <p>Drying duration estimated at 4–6 weeks, monitored by moisture mapping.</p> <p>Once the readings have reached equilibrium, the reinstalments can begin.</p>

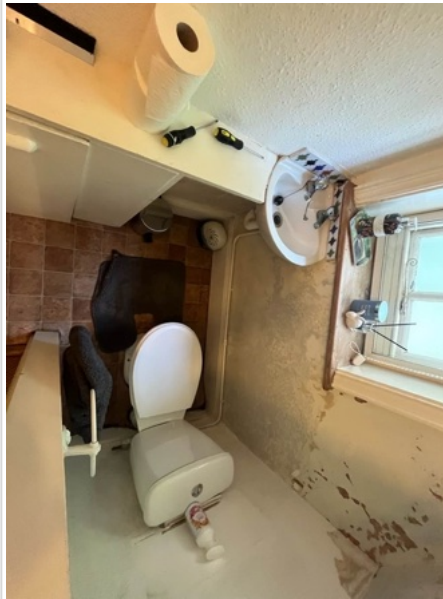
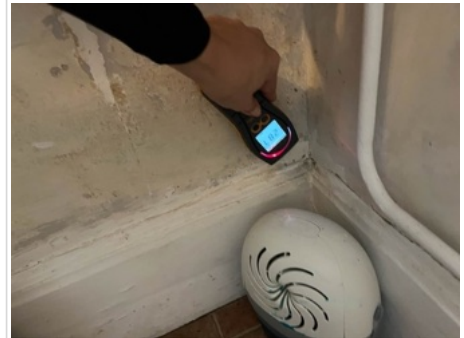
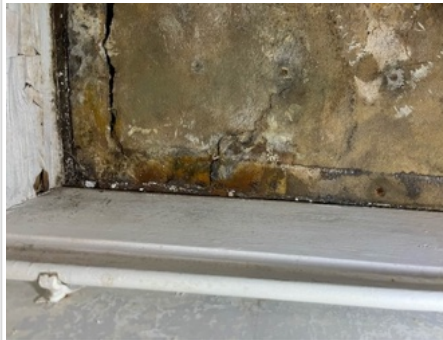
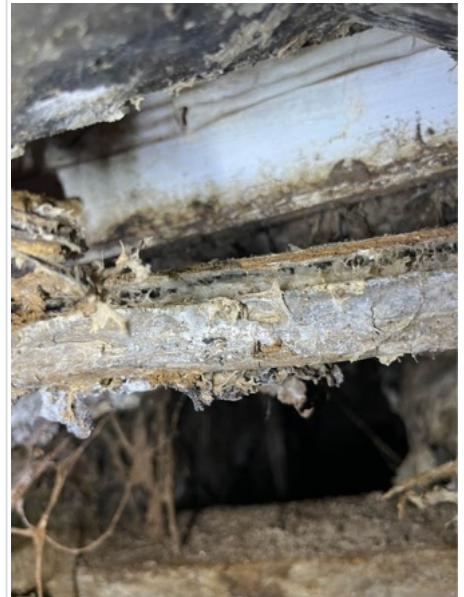
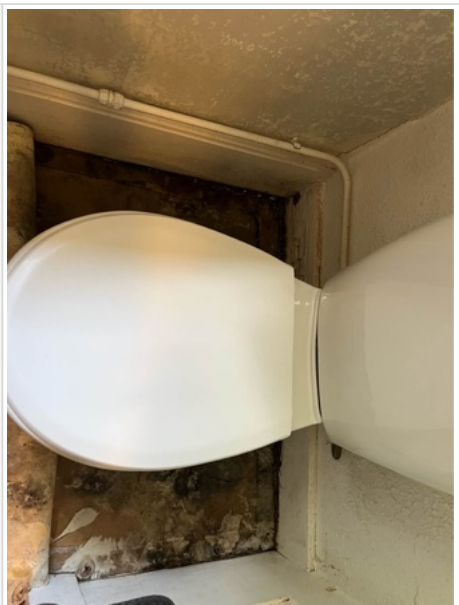
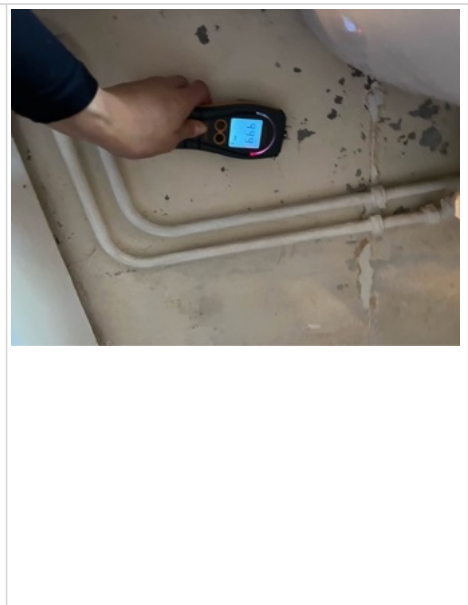
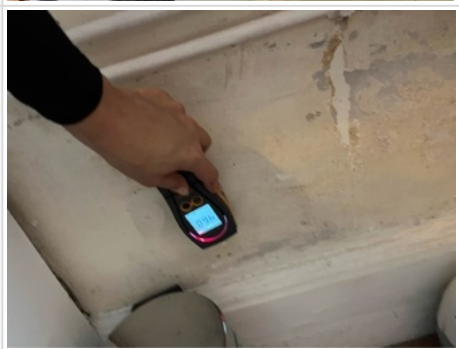
Number	2
Room(s)/ Area Affected	Cloakroom
	<p>The vinyl floor finish was lifted to reveal dry rot fungus growth.</p> <p>Floorboards in this area exhibited advanced decay and were found to be collapsing under limited tension from above, due to the structural integrity loss.</p> <p>Fine white strands and rusty spore dust were present too, which are all indicative of the same dry rot fungus.</p>

Suspected Plumbing Leak	Yes	
Further Leak Detection Recommended	<p>Given the extent of the damage, as a belt and braces approach, checks are recommended for any hidden plumbing leaks beneath floors.</p> <p>Leaks from heating systems, hot and cold-water services, or drainage runs can cause hidden underfloor dampness, timber decay, and contribute to elevated damp levels.</p>	
Additional Observations:		
Other Notes:	Concrete floor adjacent to the boiler showed elevated damp readings.
