DAMP & TIMBER SURVEY REPORT

Scope of Survey	Full Property
Instructions Received Full Property	We have received instructions from the client to complete a Damp & Timber Survey aimed at documenting the presence of damp within the property including any accessible structural timbers.
How?	In Written Form
Additional Notes	We were instructed to carry out a damp and timber survey, with a particular focus on both original and extended areas of the dwelling and subsequent structural timbers.

The property survey is a	Detached
Assumed to have been constructed in the	Late 16th century
Assumed floor construction comprising of	Solid concrete floors
Assumed wall construction comprising of	A combination of solid walls on the original parts of the property and cavity walls on the more recent extension(s)
Construction Type Note	<p>The subject property is a Grade II listed detached dwelling, with original elements understood to date back to the late 16th century (1600s). The original structure is of timber frame construction with exposed beams to walls and ceilings, and several later extensions, including a conservatory to the left-hand side elevation and rear additions.</p> <p>The floors comprise

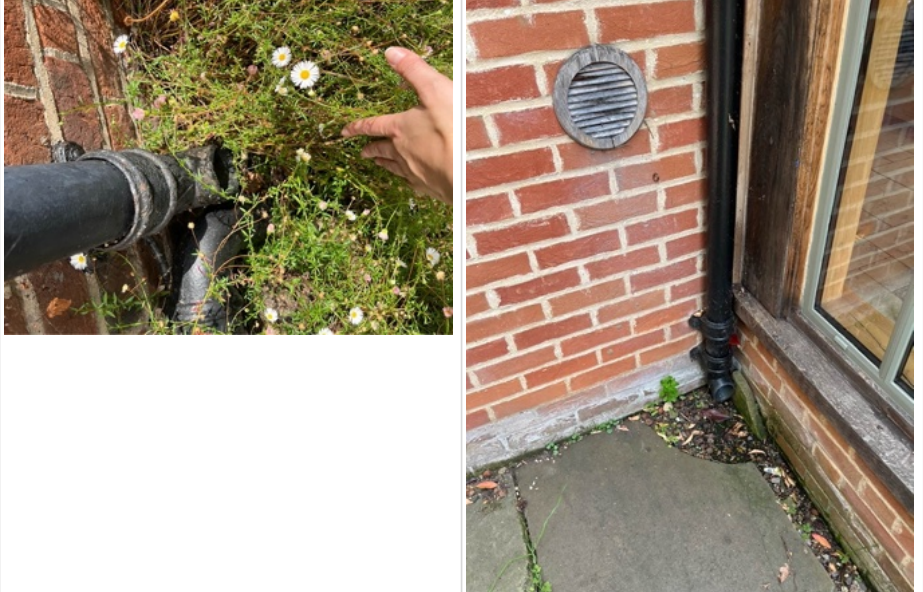
Penetrating Damp	Penetrating damp is a type of damp that occurs when water infiltrates a building horizontally from the outside, typically through walls, roofs, or windows. Unlike rising damp, which comes from the ground, penetrating damp is caused by external water sources, such as rain entering the structure through defects or porous materials.
Defects Identified Relating To Penetrating Damp	Rainwater Goods, Brickwork
Rainwater Goods Defects Noted	<p>-Wire mesh/cappings have been fitted to gutters on the right hand side elevation; however, these appear to have become partially obstructed, potentially causing overflow and moisture tracking down the masonry, above the areas corresponding to the cloak room external wall, where higher elevated damp readings were noted internally.</p> <p>-Several downpipes were observed to be discharging directly at the base of the walls, which may be contributing to elevated damp readings internally.</p>

Rainwater Goods:	<p>Clear obstructions from hopper heads and wire mesh/cappings to restore proper discharge.</p> <p>Redirect or extend the downpipes currently discharging at the wall base into an appropriate drainage gully.</p> <p>Conduct a water test during heavy rainfall or simulated with a hose. Identify and repair all leaking joints, ensuring brackets are sound and joints are watertight. Where gutters are distorted or split, replacement with matching materials is required.</p>
Brickwork	Porous Brickwork, Pointing, Spalled Bricks
Brickwork: Pointing	Rake out defective mortar to a minimum depth of 20mm and repoint using a breathable lime mortar no harder than the surrounding bricks to allow moisture movement and breathability. Cement-based mortars are not recommended for heritage or solid wall structures.
Brickwork: Porous Brickwork	For the long term protection of the bricks, apply a BBA-approved deep-penetrating water repellent such as Stormdry masonry cream to protect external masonry while allowing breathability.

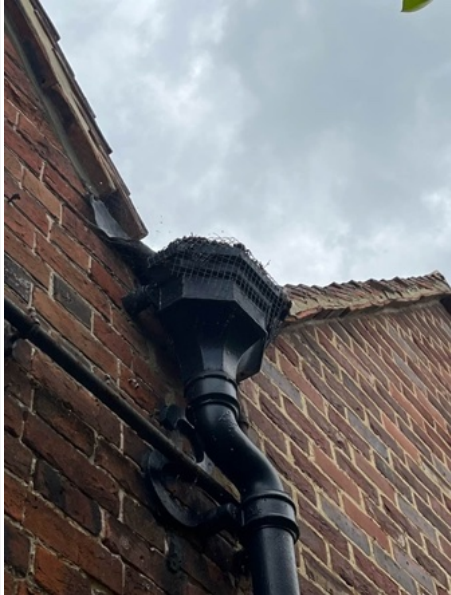
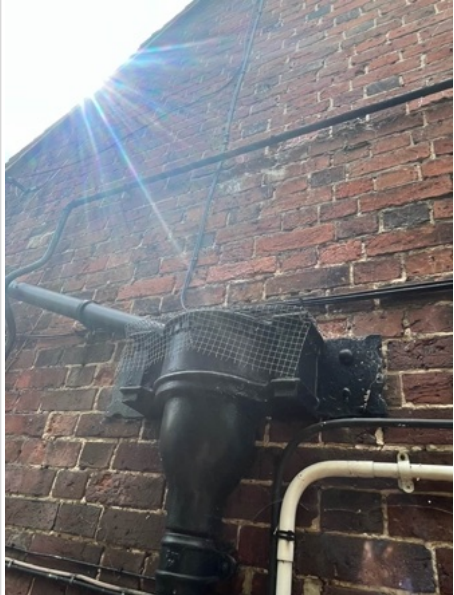
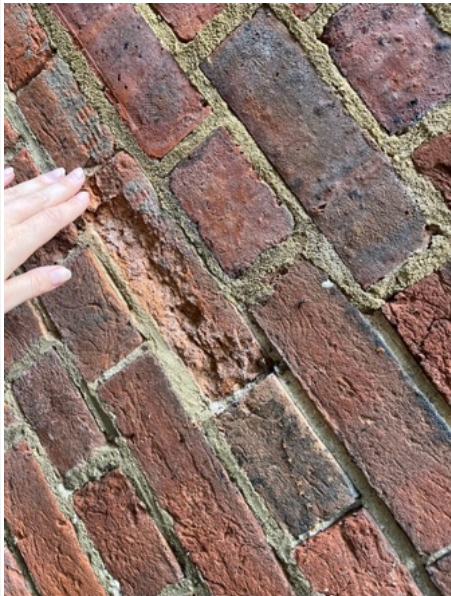
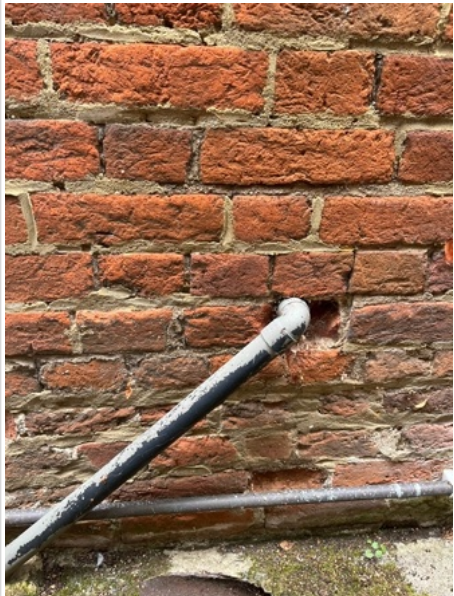
Brickwork Defects	Porous Brickwork or Stone, Perished or Defective Pointing, Spalled Brick Faces
Perished or Defective Pointing & Window Fillets	Some localised perished pointing areas were noted on the right-hand side elevation, including perished window fillets around the bathroom window. Weathered, cracked, or missing mortar joints allow rainwater to penetrate the external skin of the building and saturate masonry.
Porous Brickwork or Stone	Brickwork loses surface integrity over time, becoming more absorbent and leading to rain penetration during driving rain conditions.
Spalled Brick Faces	<p>Spalled bricks faces were note primarily on the left-hand side flank elevation, corresponding to the areas on the cloak room, where elevated damp readings were recorded.</p> <p>Some of the brick faces were repaired using incorrect materials such as cement type mortars, which can lead to further moisture ingress, given they are a lot harder than the bricks and trap moisture rather than allowing the bricks to breathe, as originally designed.</p> <p>Freeze-thaw cycles and prolonged saturation cause brick faces to spall (break off), exposing weaker core material.</p>

Brickwork: Spalled Bricks	Carefully cut out and replace severely spalled bricks with matching materials. Minor damage can be patched using brick dust mortar repairs. All work should match original brick type, size, and colour where possible.
Natural Drying Note	The affected walls are likely to dry out naturally, however this will take several months of Spring/Summer weather (Masonry drying time is usually 25mm/month). If any salts or other contaminants appear then these must be neutralised before re-decoration. Any damp stains should be neutralised with a stain block such as Zinsser before redecoration. You can consider speeding up the drying the process of natural drying by the installation of dehumidifiers and air movers.

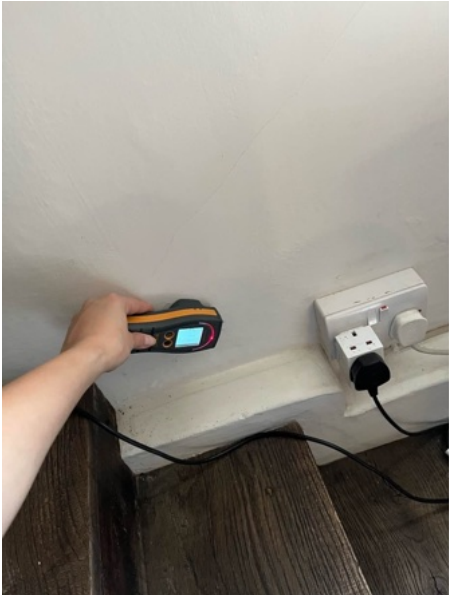
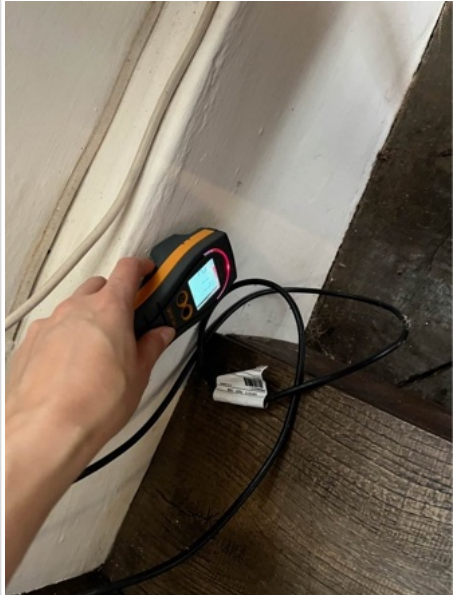
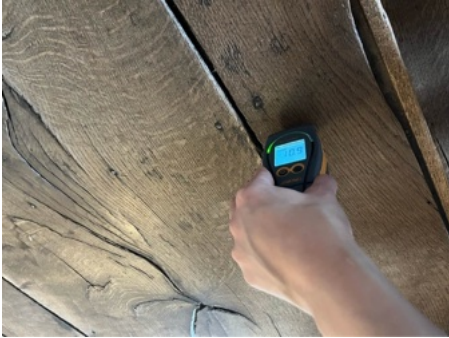
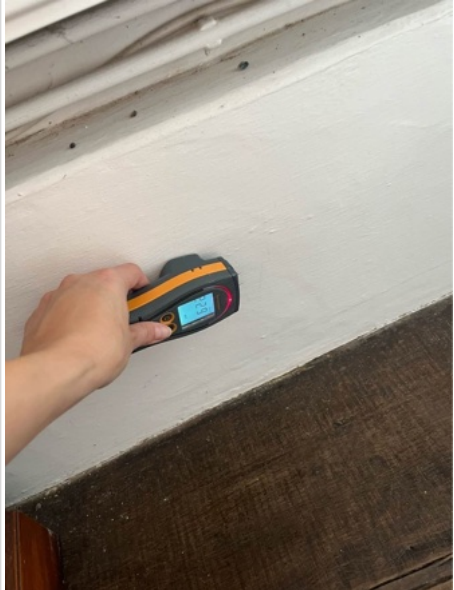
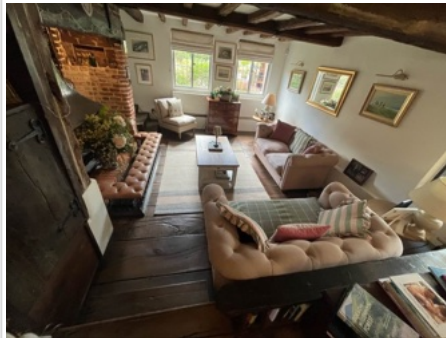
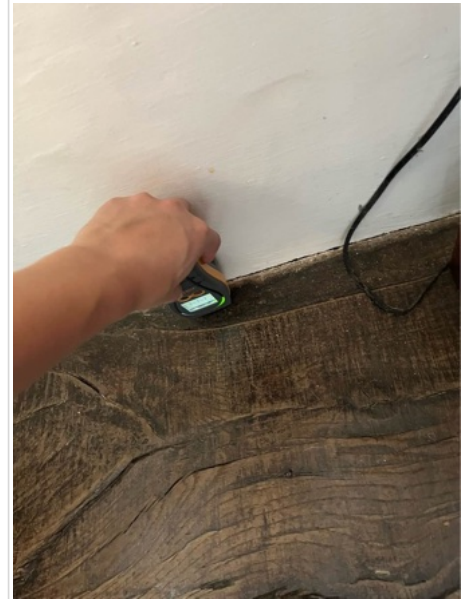
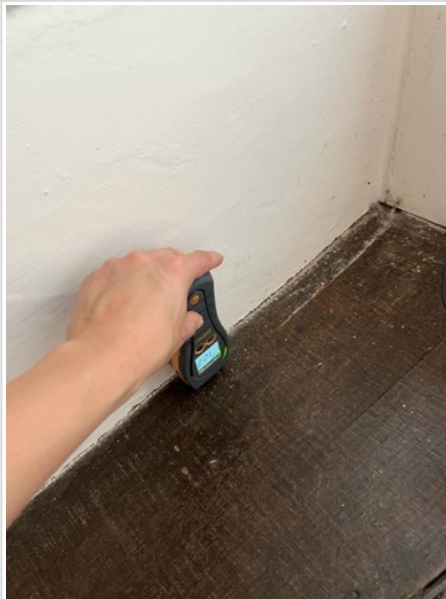
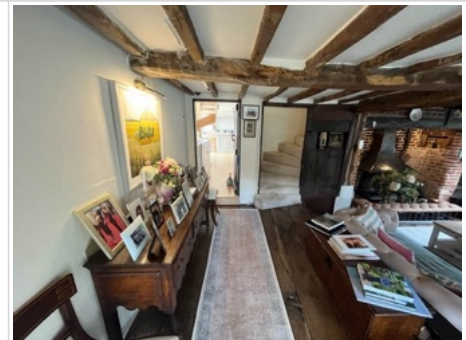
Number	1
Room(s)/ Area Affected	Lobby & Sitting Room
Specifically:	On the inside of the external elevations, sporadically
Moisture Meter Readings	200RS-999RS

Corresponding External Defects	<p>High brick porosity and lack of an original DPC are likely to be the main contributory factors for the sporadic damp readings obtained on localised sections of the external front wall in those rooms.</p> <p>The external brickwork looks in serviceable condition on the front elevation.</p>
Corresponding Internal Defects	<p>We noted that a section of the bottom of the front sitting room front wall is earth retaining (slightly below ground) due to the levels which step down from the rest of the floor levels on the ground floor.</p> <p>Some lateral damp is to be expected.</p>
Additional Notes	<p>Floorboard</p> <p>Floorboard were tested using the WME (Wood Moisture Equivalent) setting and readings were found to be acceptably dry.</p> <p>We were unable to access the subfloor void in the sitting room, where we believed the floor could be timber suspended and we cannot comment on how the subfloor is ventilated, due to the non-invasive nature of the survey.</p>

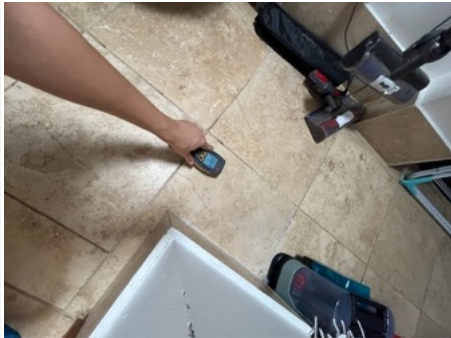
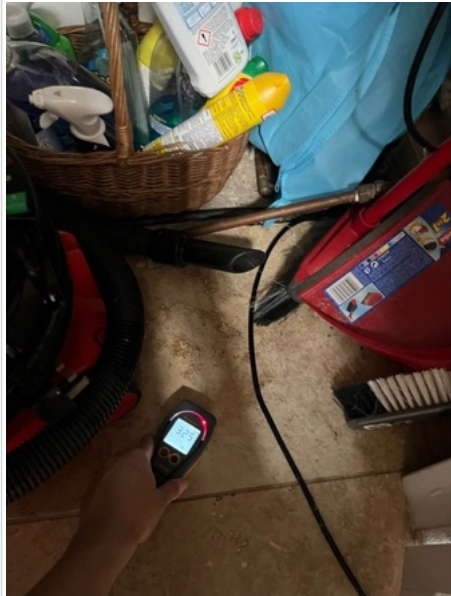
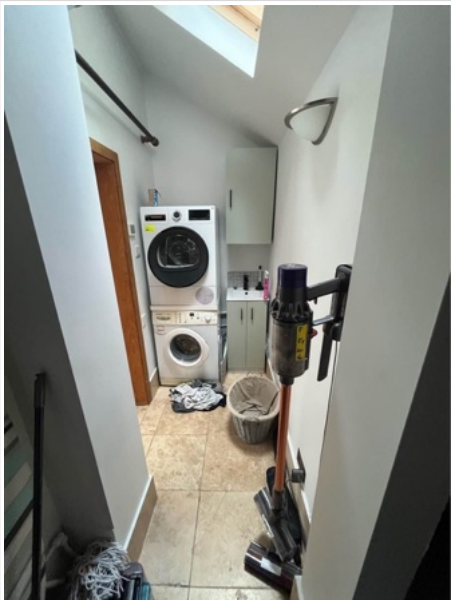
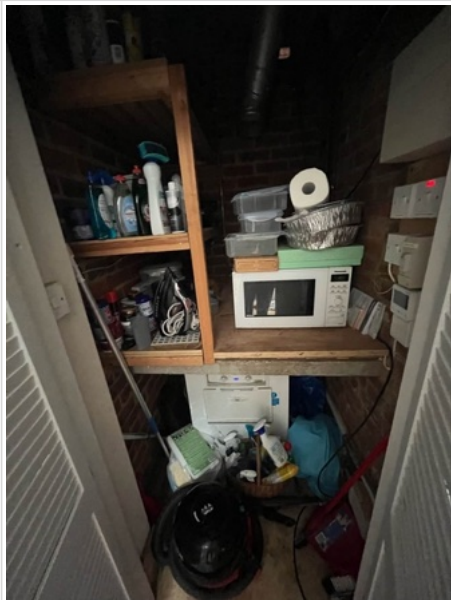
Number	3
Room(s)/ Area Affected	Utility Room

Specifically:	Tiled floor
Moisture Meter Readings	200RS-999RS
Corresponding Internal Defects	In the utility room, elevated readings were recorded over the solid floor, likely due to the absence of an effective/ modern DPM in the possibly older concrete slab.
Annotated Pictures

Other Recommendations:	<p>Cloakroom:</p> <p>Avoid the use of non-breathable wall finishes such as wallpapers to allow for the underlying structure to stay 'breathable' as originally designed.</p> <p>Utility room:</p> <p>Monitor the floor. If deterioration becomes visible, we would advise carrying out a leak detection to rule out any plumbing leaks.</p> <p>Structural Timbers:</p> <p>No immediate timber treatment is recommended, as all readings are below risk thresholds.</p> <p>However, we recommended a programme of periodic monitoring.</p>
-------------------------------	--

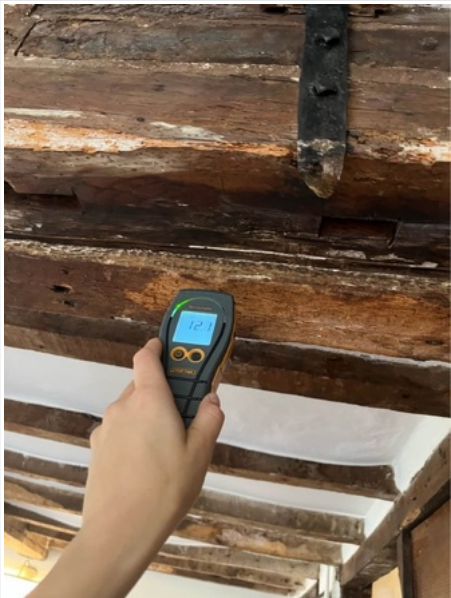
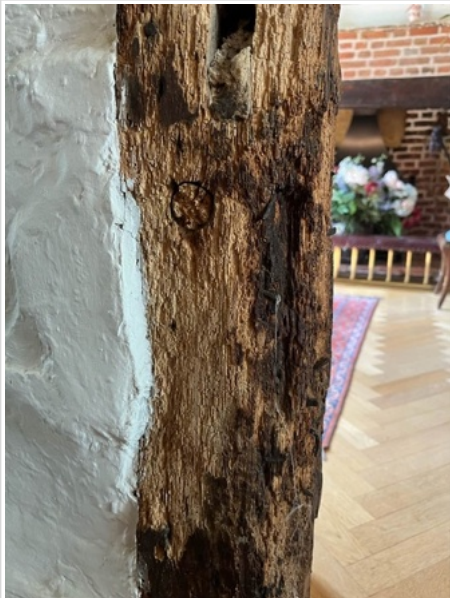
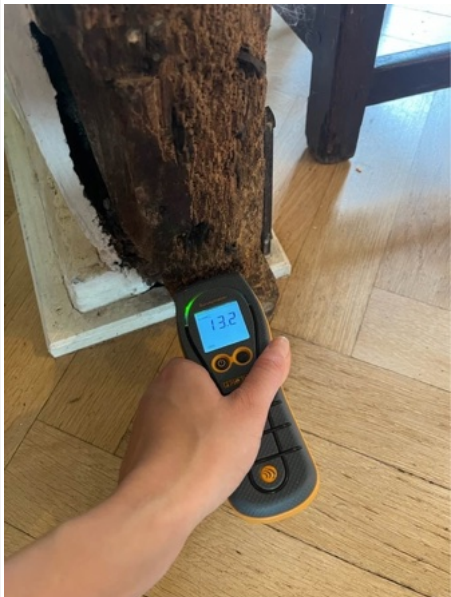
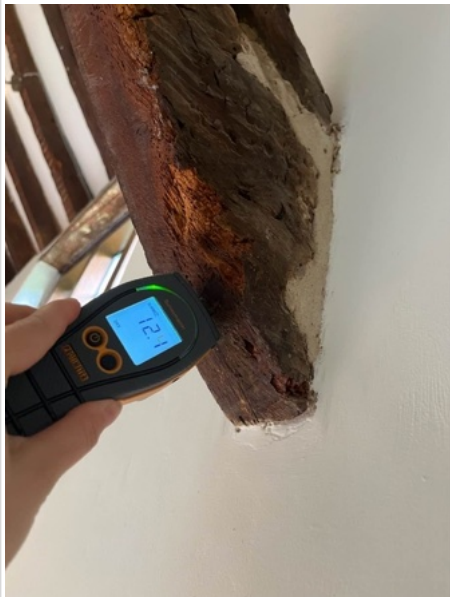
Structural Timbers:	No Active Issues Found
Structural Timbers:	<p>A thorough inspection of the accessible structural beams was carried out.</p> <p>Observations: Exposed beams and timbers across walls and ceilings were moisture-tested at intervals and consistently recorded below 20% WME, well within safe parameters for decay or infestation risk.</p> <p>Historical Fungal Decay: No signs of active wet rot or dry rot were detected.</p> <p>Some cuboidal cracking typical of historic brown rot was noted but appears long inactive.</p> <p>Historical Wood-boring Insects: Historical evidence of common furniture beetle (<i>Anobium punctatum</i>) were noted throughout the original parts of the property. In addition, reports of a previous attack of deathwatch beetle (<i>Xestobium rufovillosum</i>) activity was noted in a previous survey in the master bedroom. Our inspection revealed no fresh frass, or other signs of active infestation.</p>
