DAMP & CONDENSATION SURVEY REPORT

Damp & Condensation Survey Report

The property survey is a	Detached
Assumed to have been constructed in the	Interwar Period (1918–1939)
Assumed floor construction comprising of	Timber suspended floors
Assumed wall construction comprising of	Early cavity walls

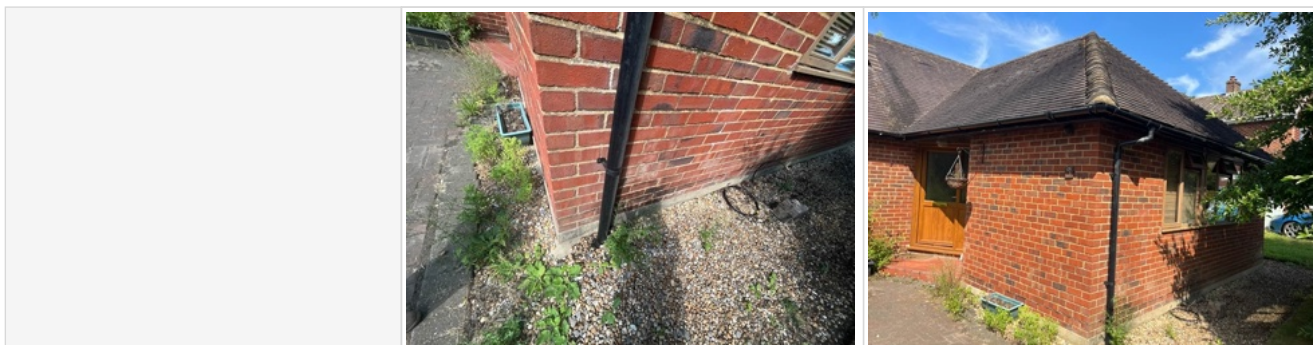
Defects Identified Relating To Other Types of Damp	Rainwater Goods
Other Defects	Front Elevation Downpipe & Guttering defects noted:
In more detail:	<p>Upon inspecting the guttering and down pipe more closely, we have observed that the outlet of the guttering is blocked by debris and vegetation.</p> <p>This is almost certainly allowing for water to overflow the gutter during heavy rain due to the obstructions in the downpipe. This in turn is likely allowing for moisture to get into the cavity wall and cause excess humidity to build up inside the cavity wall, contributing to the condensation and mould growth noted in the front bedroom.</p> <p>Water was visible around the same downpipe, at its base, which is going directly into the ground with no visible connection to the draining system. This could also mean, that water could be discharging improperly and causing saturation at low levels of the wall.</p> <p>A small internal area, at low levels of the wall was noted to show elevated damp readings and localised mould growth, on the other side of the downpipe entering the ground, which could be related.</p>

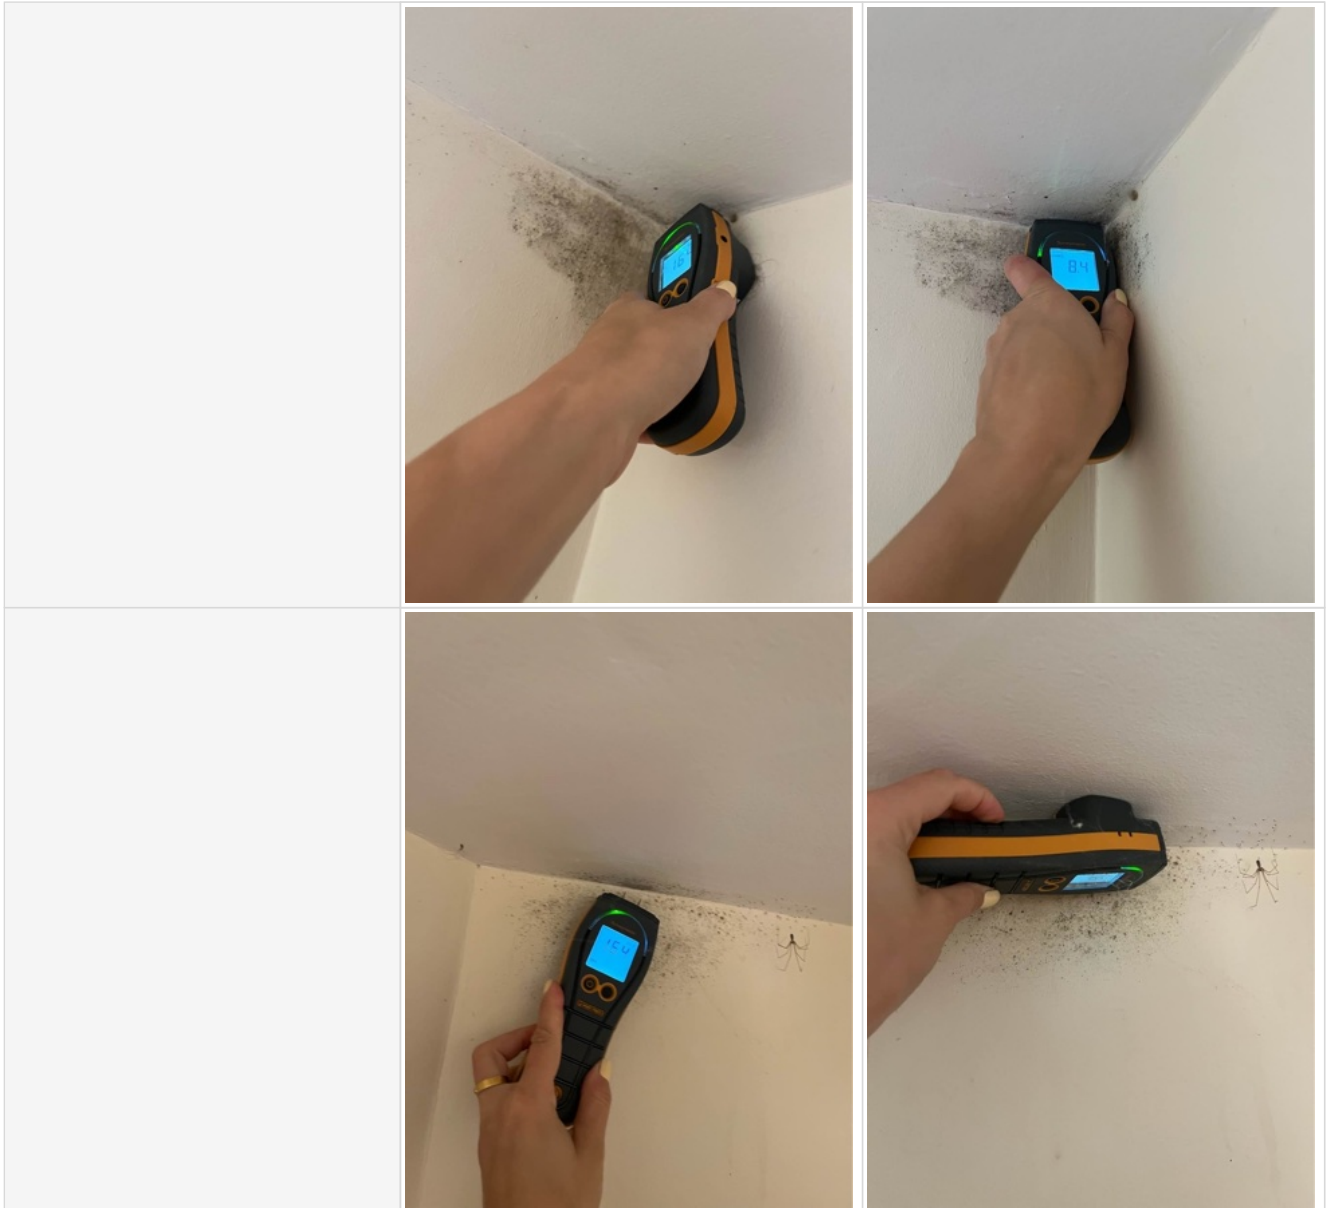
Number	1
Room(s)/ Area Affected	Front Bedroom
Signs Of Water Damage Observed	Mould Growth
Specifically:	2 ceiling-wall corners suffering from mould growth & the external front corner localised to low levels of the walls suffering from mould growth and elevated damp readings
Moisture Meter Readings	External front corner(low levels): 200RS-250RS; Ceiling-wall areas showing dry readings
Corresponding External Defects	-Suspected downpipe overflow issues due to blockages in the gutter outlet causing the ceiling wall junctions to suffer from condensation and mould growth. -Downpipe going directly into the ground and showing water around the base, likely causing the localised area showing elevated damp readings and mould, just above skirting boards at low levels of the wall, in the front bedroom corner.

<p>Corresponding Internal Defects: Condensation</p>	<p>Mould Growth Note:</p> <p>Mould is classified as a Category 1 health hazard under the Housing Health and Safety Rating System (HHSRS) and must be promptly addressed. This can severely impact people with an impaired immune system, particularly young children and adults with a predisposition to respiratory conditions.</p> <p>No In-depth Dry Readings Recorded Raising Concerns Relating To Condensation</p> <p>Acceptable dry readings obtained on areas where mould was noted, indicating the issues is condensation related rather than damp related.</p> <p>Signs of Condensation</p> <p>Definition: Condensation occurs when warm, moist air meets a cold surface, leading to water droplets forming. Inadequate ventilation exacerbates condensation, contributing to mould growth and deterioration of internal finishes.</p> <p>We believe the property to be suffering from condensation related issues and those condensation related issues are likely to be caused by a number of contributory factors including:</p> <ul style="list-style-type: none"> - Inadequate Heating Strategy <p>All doors to the bedrooms are fire doors and they all stay shut as a result. We understand that this specific bedroom is only used sporadically and that the heating would only come on when someone stays within the room.</p> <p>Therefore this room could have periods where no heating is on which will make it predisposed to condensation and mould forming, particularly on the inside of external elevations which get a lot colder but also at corners of the floor wall joint or wall ceiling joint where there is a lack of airflow to the area areas.</p> <p>This is particularly problematic during the colder months where temperatures in the room would get really cold. Recommended temperatures which should keep the risk of condensation and mould growth at bay should normally be no less than 18 to 20°C at any time.</p> <ul style="list-style-type: none"> -Lack of trickle vents on the windows which stop any passive air flow during periods when no one is in the property or the room. -Inadequate mechanical extraction, particularly in the nearby bathroom. <p>Please see Additional Observations section below describing the rate of extraction for the extractor fans in hoods in the property.</p>

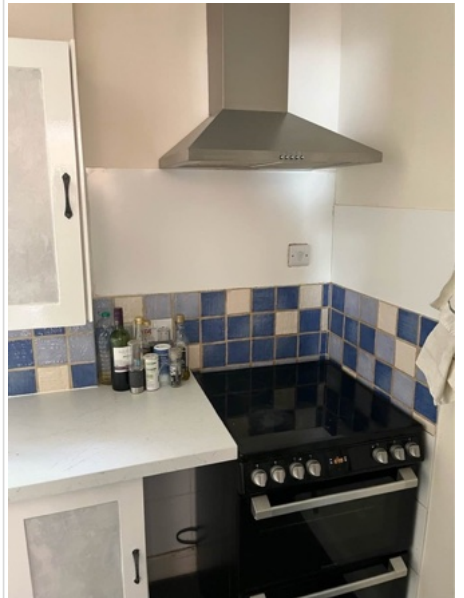
<p>Bathroom fan not working during our visit</p>

<p>Other Notes:</p>	<p>Inadequate Mechanical Extraction</p> <p>Mechanical extraction is essential in ensuring the humidity created in the property by showering, cooking, washing clothes etc. is being removed from the property effectively.</p> <p>The rate of extraction of the extractor fans and extractor hood has been tested using an anemometer and cross referenced against the recommended rise of extraction set out by Ventilation Document F.</p> <p>These were found to be as follows:</p> <p>-Kitchen extractor hood: Found to be working at 20 L per second, compared to the recommended 30 L per second.</p> <p>The recommendations here would involve cleaning out the filters which might be enough to restore the recommended rate of extraction.</p> <p>-Bathroom extractor fan found to be not working .</p> <p>-Shower room extractor fan: Found to be working at the recommended rate of extraction of 15 L per second .</p> <p>There is also a tumble drier which is not ducted outside and poses a risk for condensation in its current form.</p> <p>However, this does not appear to be used by the occupants, but rather the clothes appear to be dried in the conservatory by the occupants. And we would advise the tumble drier to only be used if it is ducted to the outside.</p>
