DAMP SURVEY REPORT

Survey Date and Time	03/09/2025
Occupied/ Unoccupied	Unoccupied
Surveyor Name	Bianca Hedesiu BSc(Hons) CSTDB WRT ASD

The property survey is a	Semi-detached
Assumed to have been constructed in the	Victorian Period (1837–1901)
Assumed floor construction comprising of	A combination of original timber suspended floors and solid concrete floors
Assumed wall construction comprising of	9-inch solid walls

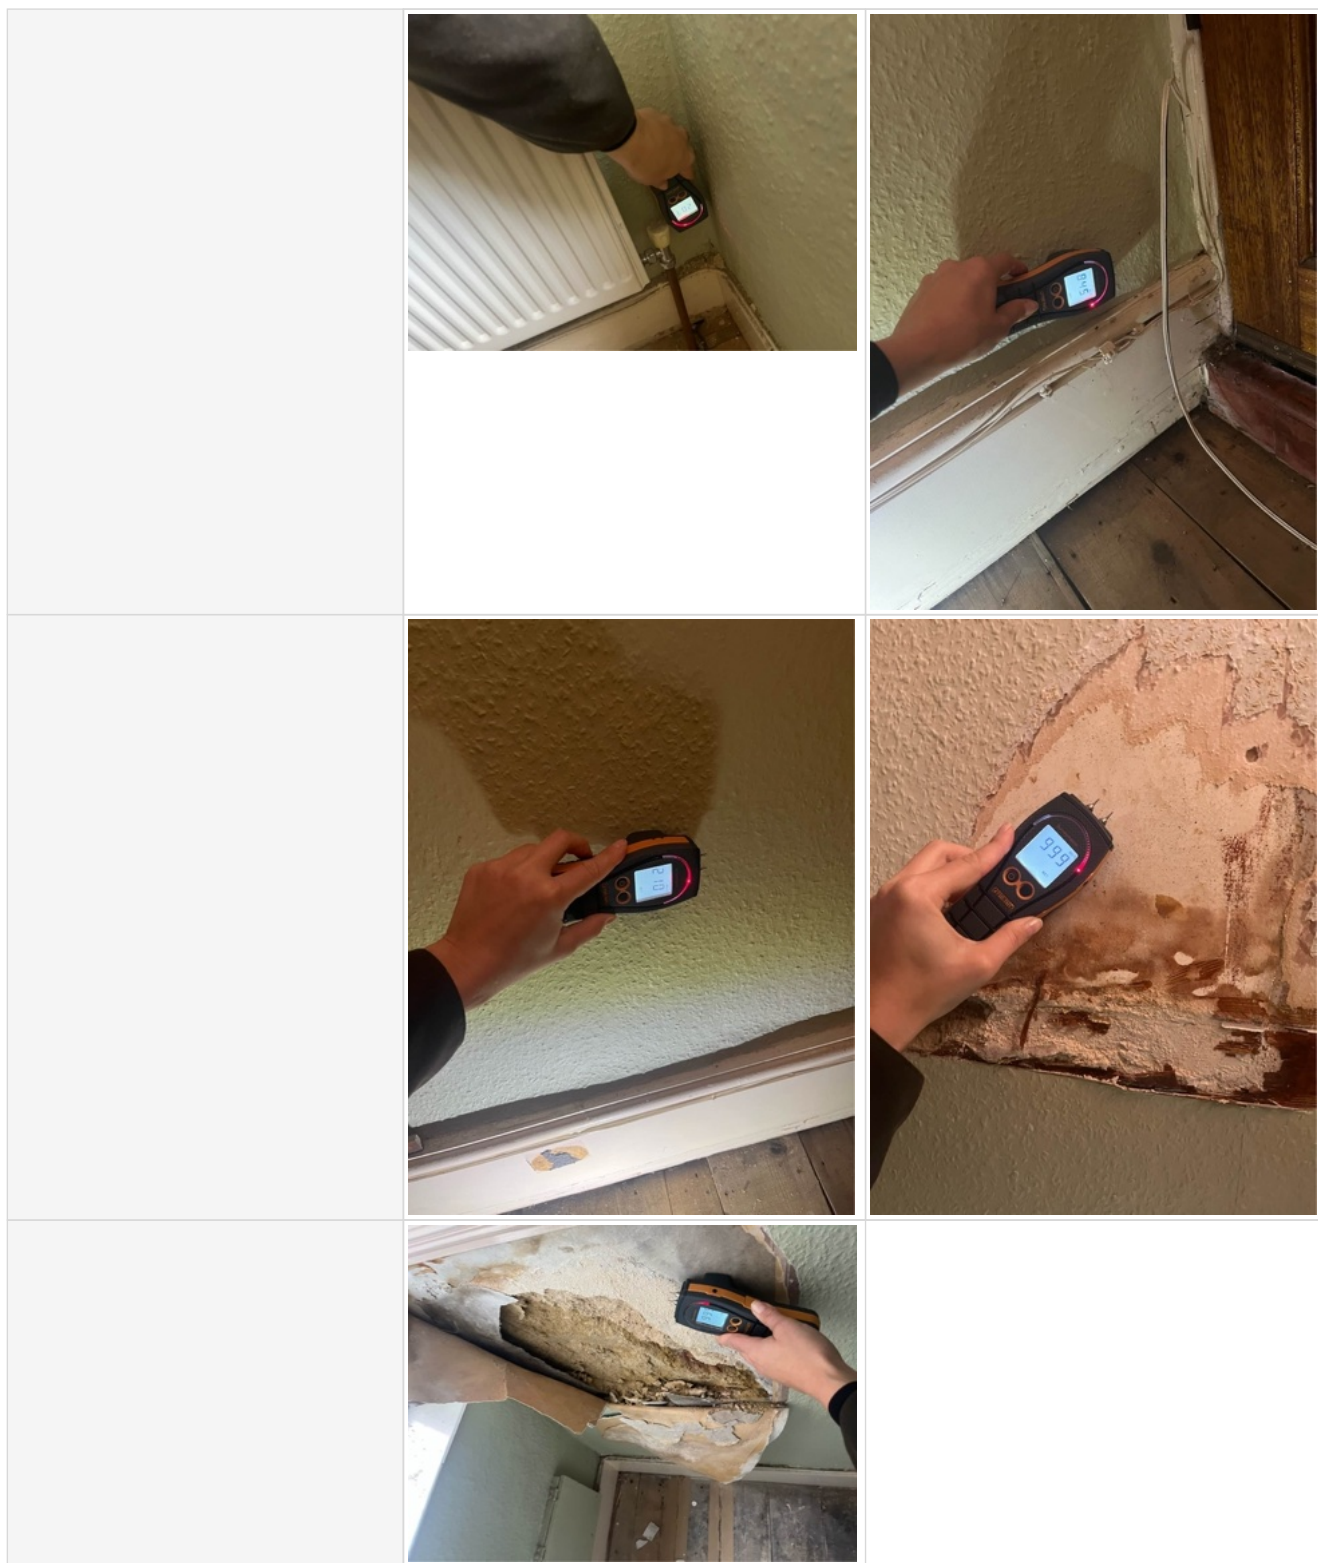
Room Affected (1)

Number	2
Room(s)/ Area Affected	Reception room

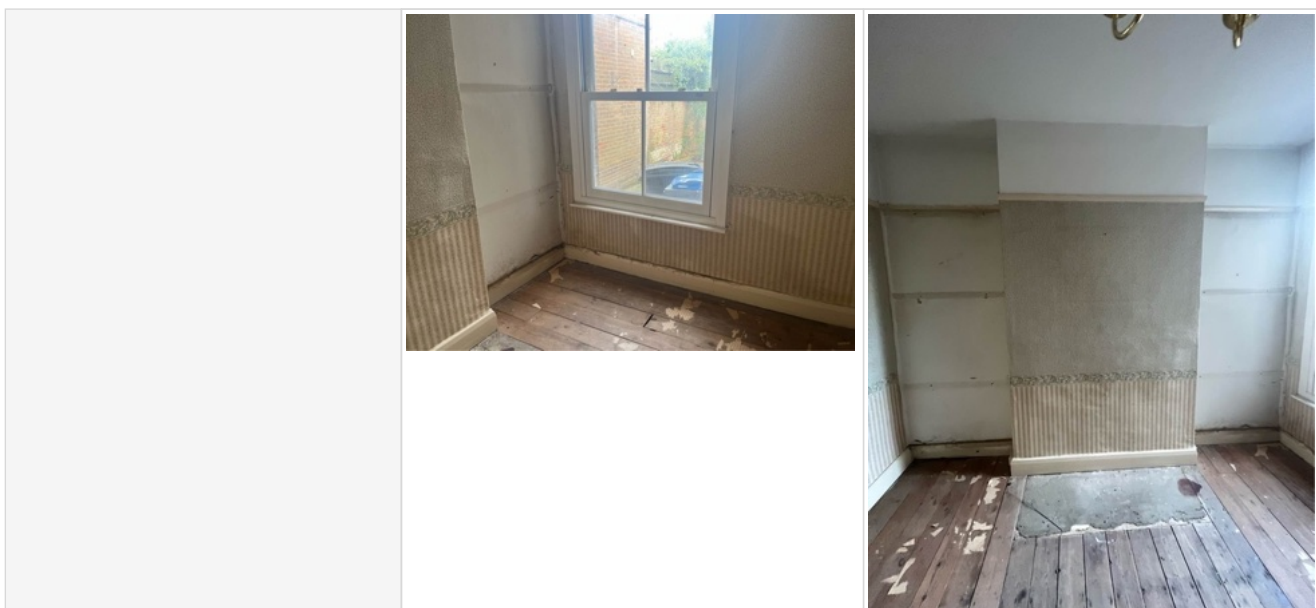
Room Affected (2)

Number	3
Room(s)/ Area Affected	Dining Room & Kitchen
Signs Of Water Damage Observed	Blown Plaster, Water Stains
Specifically:	On the inside of the left-hand side flank elevation (at low levels of the walls), on the inside of the party wall including chimney breast (at low levels in the dining room)
Moisture Meter Readings	200RS-999RS
	<p>Dining Room:</p> <p>Dampness at low levels was noted to rear bay walls and adjacent internal partition wall between the dining room and hallway.</p> <p>This is thought to be corresponding with overflowing gully and defects to soil stack.</p> <p>The party wall including the chimney breast also records elevated moisture levels at low levels which could be related to the chimney stack defects, hygroscopic salt contamination of the chimney breast due to the old soot in the plaster or hidden leaks.</p> <p>We also cannot rule out any issues originating from the neighbouring property.</p> <p>Accesibile floorboards and joists by the party wall were also found to show elevated damp readings higher than the 20% Wood Moisture Equivalent (WME%) threshold, after which timbers become at risks for decay or infestation by wood boring insects.</p>

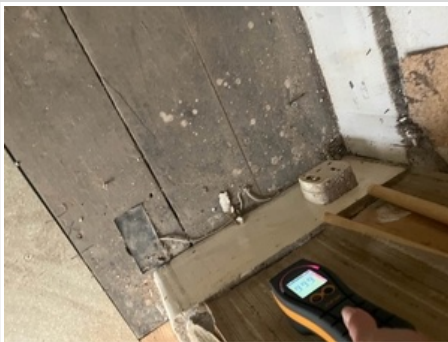
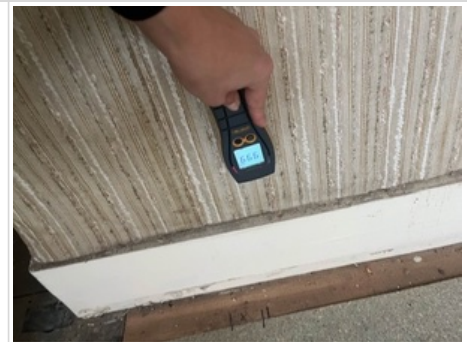
Suspected Plumbing Leak
