DAMP SURVEY REPORT

Survey Date and Time	01/01/2025
Occupied/ Unoccupied	Occupied
Surveyor Name	Bianca Hedesiu BSc(Hons) CSTDB WRT ASD

The property survey is a	Detached
Assumed to have been constructed in the	Interwar Period (1918–1939)
Assumed floor construction comprising of	A combination of original timber suspended floors and solid concrete floors
Assumed wall construction comprising of	9-inch solid walls
Construction Type Note	Rear extension added

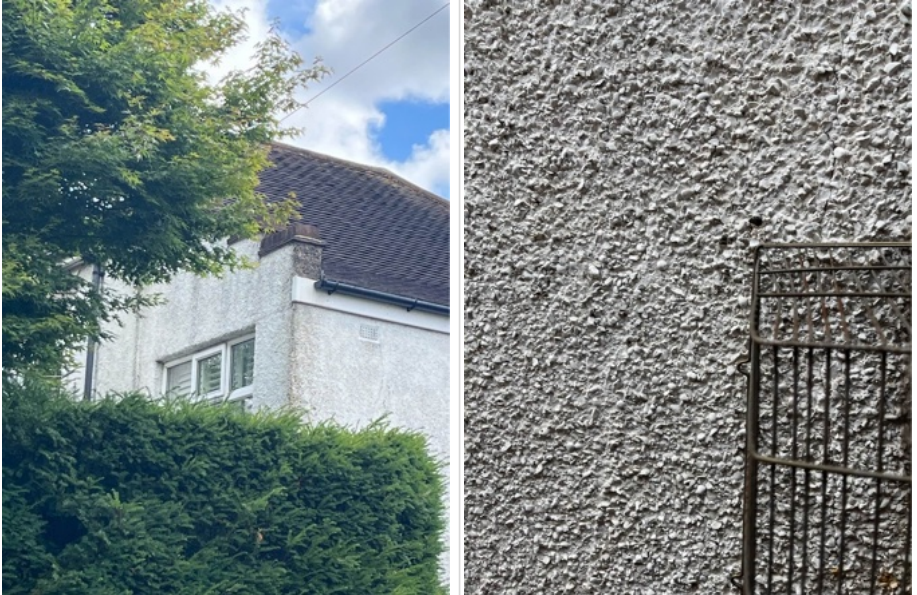
<p>Chimney Stacks Defects Noted</p>	<p>Flaunching & Brickwork defects, Old Chimney Breast & Hygroscopic Salt Contamination</p>
<p>Flaunching & Porous Bricks</p>	<p>Red soft bricks are present which are quite porous. Bricks become more porous overtime making them more susceptible to moisture retention.</p> <p>We've been able to observe some moss growing from the top of the flaunching on the front left-hand side stack, which could be concealing further cracking and defects to the flaunching, which is a concrete fillet holding the chimney pots together.</p> <p>Those defects could allow for moisture to get inside the flue and affect the chimney breast below and this is evidenced by the damp found in the front left hand side bedroom on the chimney breast and adjacent walls/ ceiling.</p>
<p>Annotated Pictures</p>
