DAMP & TIMBER SURVEY REPORT

Scope of Survey	Full Property
Instructions Received Full Property	We have received instructions from the client to complete a Damp & Timber Survey aimed at documenting the presence of damp within the property including any accessible structural timbers.
How?	In Written Form
Additional Notes	We were instructed to carry out a damp and timber survey, with a particular focus on both original and extended areas of the dwelling and subsequent structural timbers.

The property survey is a	Detached
Assumed to have been constructed in the	Late 16th century
Assumed floor construction comprising of	Solid concrete floors
Assumed wall construction comprising of	A combination of solid walls on the original parts of the property and cavity walls on the more recent extension(s)
Construction Type Note	<p>The subject property is a Grade II listed detached dwelling, with original elements understood to date back to the late 16th century (1600s). The original structure is of timber frame construction with exposed beams to walls and ceilings, and several later extensions, including a conservatory to the left-hand side elevation and rear additions.</p> <p>The floors comprise

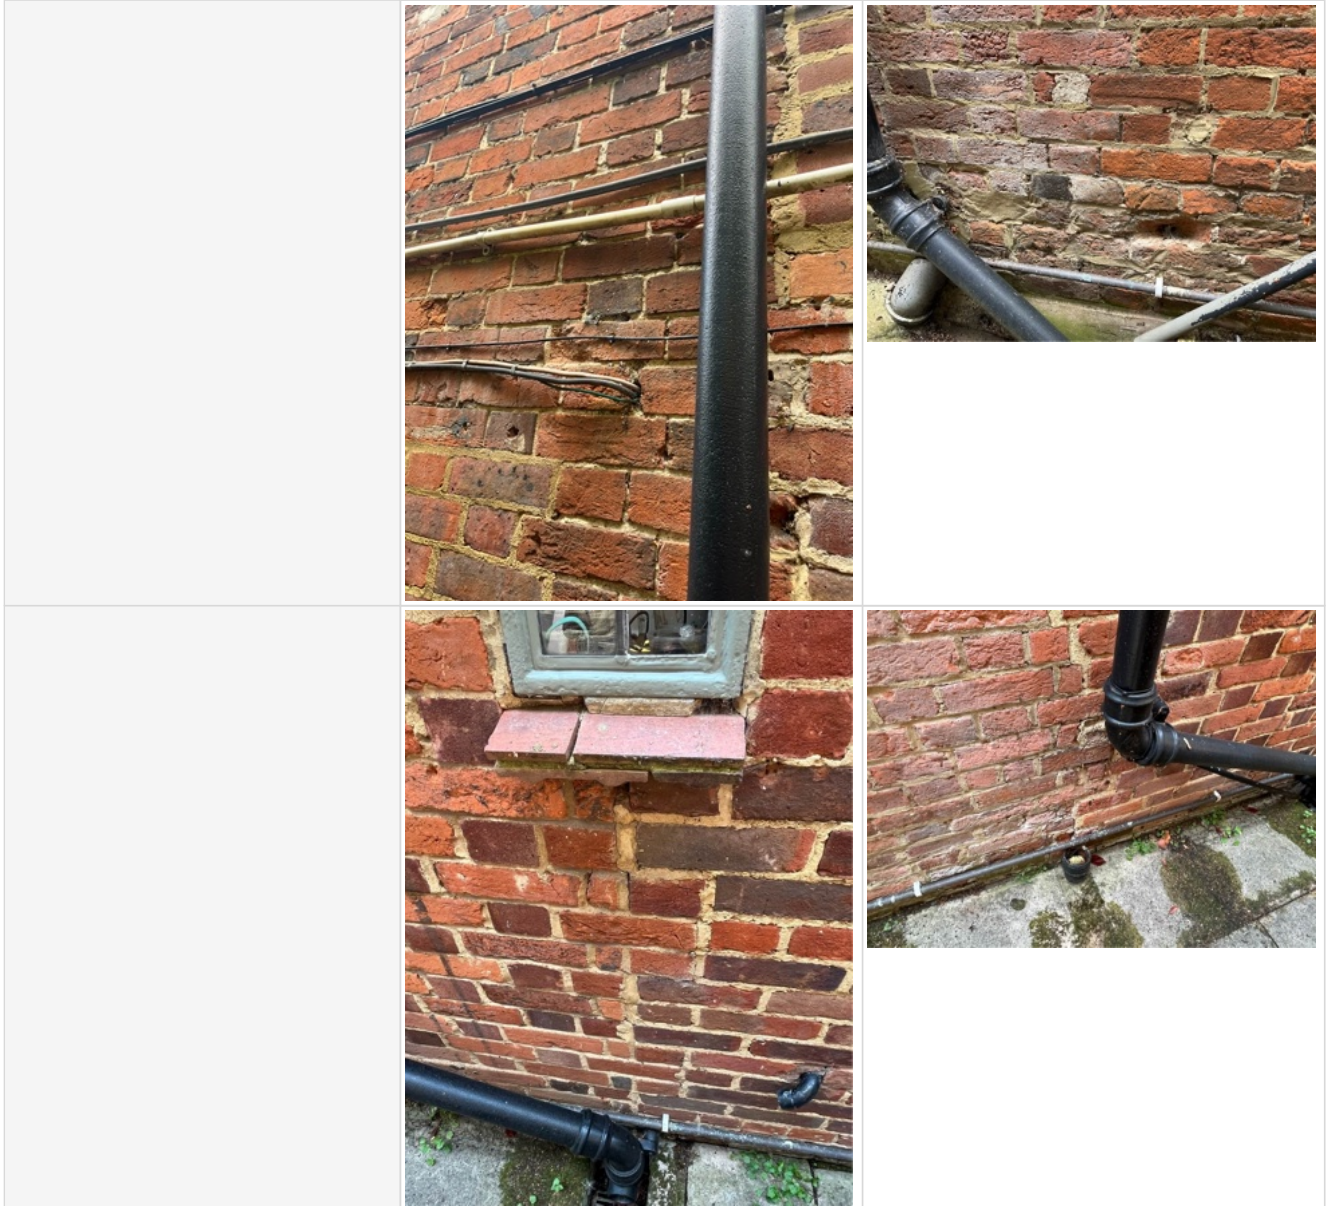
Brickwork Defects	Porous Brickwork or Stone, Perished or Defective Pointing, Spalled Brick Faces
Perished or Defective Pointing & Window Fillets	Some localised perished pointing areas were noted on the right-hand side elevation, including perished window fillets around the bathroom window. Weathered, cracked, or missing mortar joints allow rainwater to penetrate the external skin of the building and saturate masonry.
Porous Brickwork or Stone	Brickwork loses surface integrity over time, becoming more absorbent and leading to rain penetration during driving rain conditions.
Spalled Brick Faces	<p>Spalled bricks faces were note primarily on the left-hand side flank elevation, corresponding to the areas on the cloak room, where elevated damp readings were recorded.</p> <p>Some of the brick faces were repaired using incorrect materials such as cement type mortars, which can lead to further moisture ingress, given they are a lot harder than the bricks and trap moisture rather than allowing the bricks to breathe, as originally designed.</p> <p>Freeze-thaw cycles and prolonged saturation cause brick faces to spall (break off), exposing weaker core material.</p>

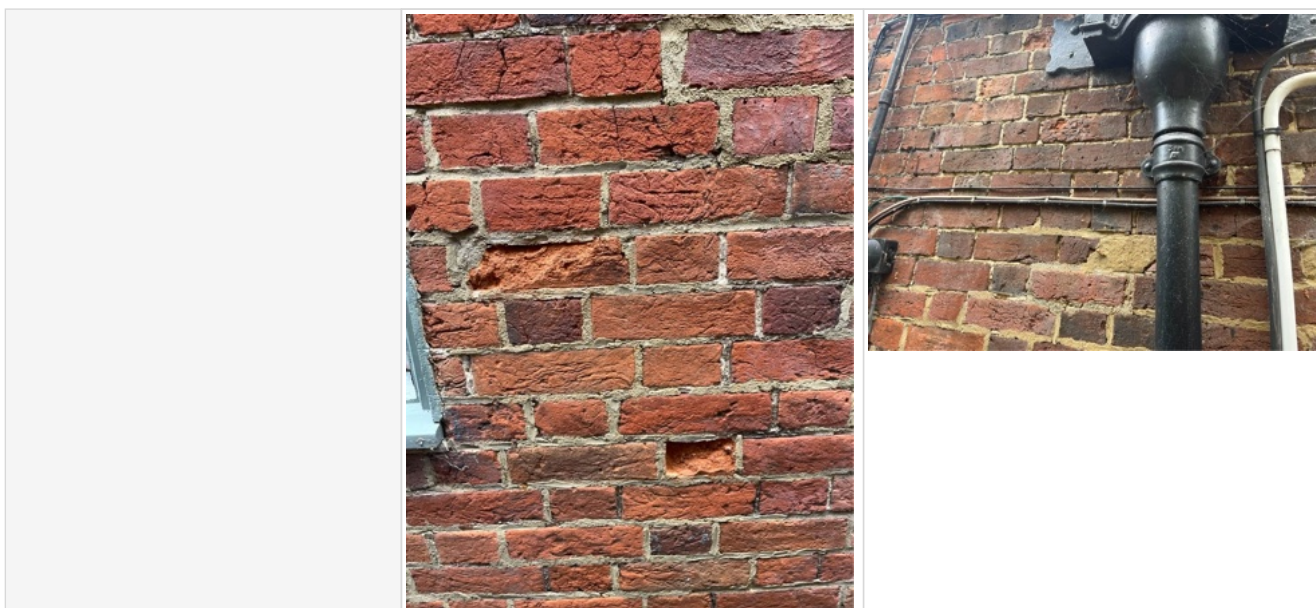
Number	1
Room(s)/ Area Affected	Lobby & Sitting Room
Specifically:	On the inside of the external elevations, sporadically
Moisture Meter Readings	200RS-999RS

Corresponding External Defects	<p>High brick porosity and lack of an original DPC are likely to be the main contributory factors for the sporadic damp readings obtained on localised sections of the external front wall in those rooms.</p> <p>The external brickwork looks in serviceable condition on the front elevation.</p>
Corresponding Internal Defects	<p>We noted that a section of the bottom of the front sitting room front wall is earth retaining (slightly below ground) due to the levels which step down from the rest of the floor levels on the ground floor.</p> <p>Some lateral damp is to be expected.</p>
Additional Notes	<p>Floorboard</p> <p>Floorboard were tested using the WME (Wood Moisture Equivalent) setting and readings were found to be acceptably dry.</p> <p>We were unable to access the subfloor void in the sitting room, where we believed the floor could be timber suspended and we cannot comment on how the subfloor is ventilated, due to the non-invasive nature of the survey.</p>

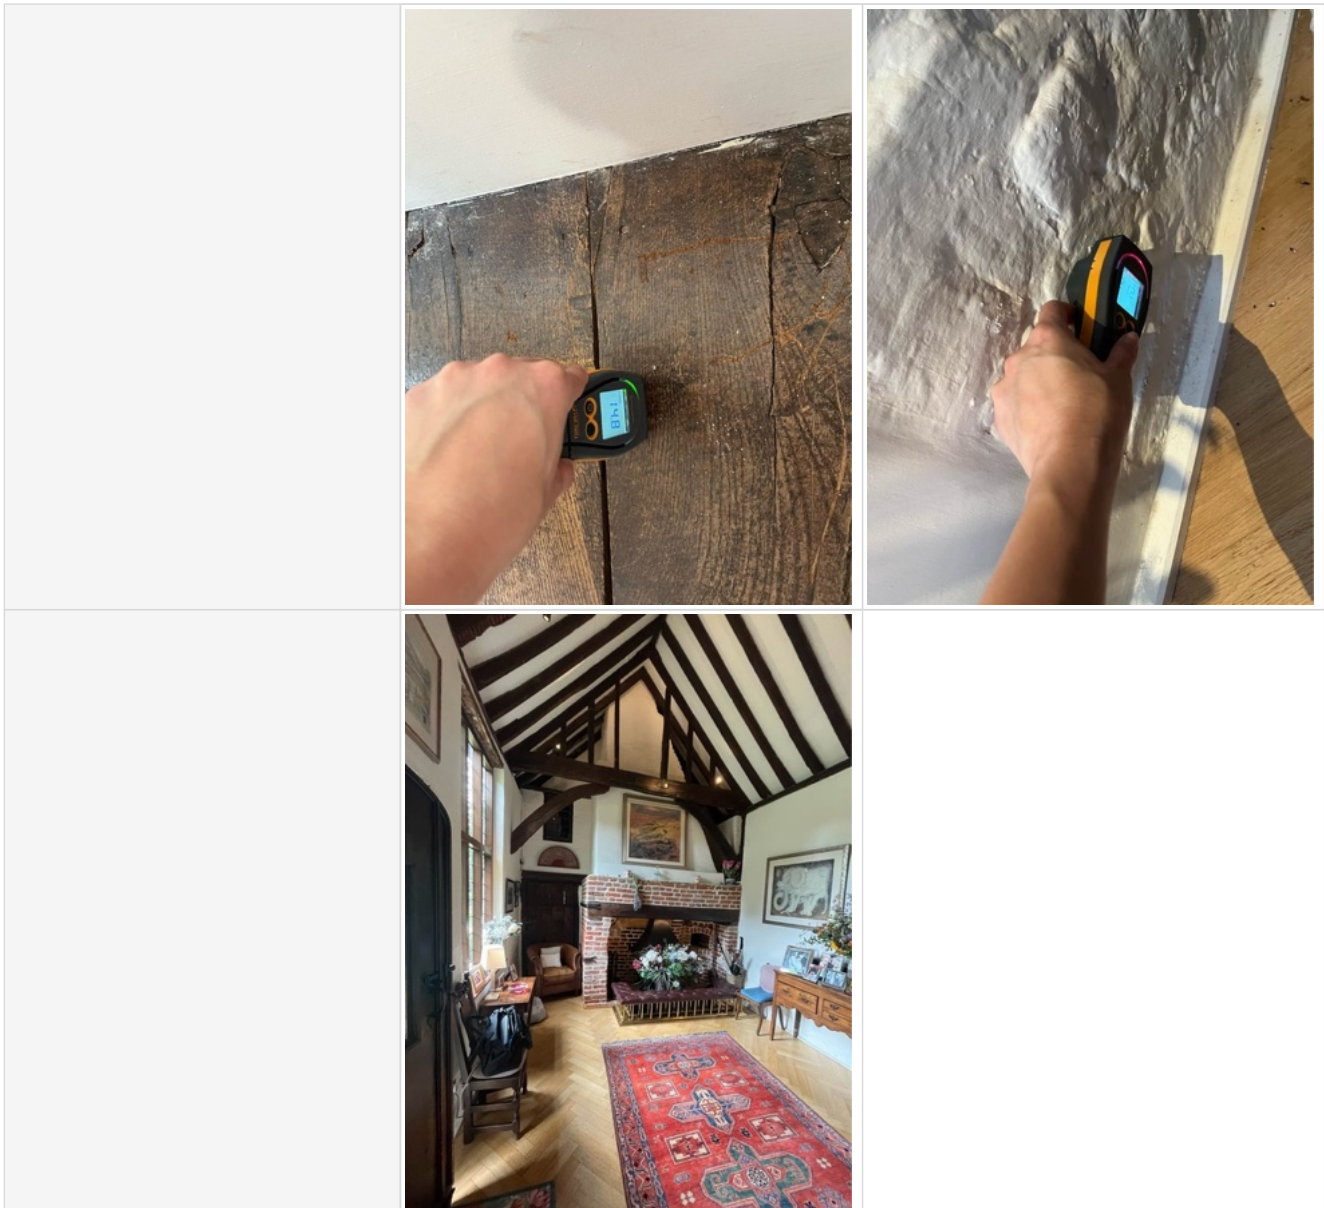
Number	2
Room(s)/ Area Affected	Cloakroom
Signs Of Water Damage Observed	Water Marks
Specifically:	Diving wall between the front storage room and cloakroom & on the inside of the right-hand side elevation
Moisture Meter Readings	200RS-999RS
Corresponding External Defects	The readings obtained from the inside of the right-hand side elevation in the cloak room are thought to be caused by the brickwork defects observed externally with the spalled bricks faces and perished pointing. Those defects are thought to be causing penetrating damp, which could be exacerbated by any leaks or overflow issues from the hopper above.

Corresponding Internal Defects	<p>The affected internal wall has a wallpaper finish and some minor water stains were also noted on this wall. The other side of the wall in the storage room was found to be dry, while the cloak room side of the wall was found to show some higher readings sporadically.</p> <p>Wallpaper finishes are usually plastic made/ non-breathable and can restrict the natural breathability of the wall structure and cause condensation and staining.</p> <p>We believe this could be the cause for the higher readings and staining observed on this wall.</p>
Annotated Pictures
